# 2024 PPS Seismic Assessments: All Schools

Version 1.1  
June 03, 2025

Submitted to:  
Portland Public Schools  
501 N. Dixon Street  
Portland, OR 97227

Submitted by:  
Holmes US  
555 SE MLK Jr. Blvd  
Portland, OR 97214

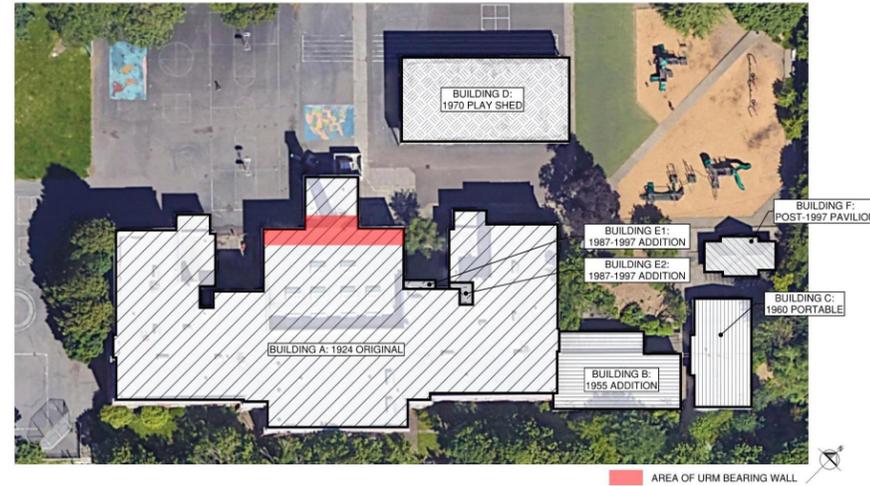
Building Part (See Diagram Above)	Year Built	URM (SF)	ROM URM Only Retrofit	ROM Total Retrofit	No. of Stories	Basement	Penthouse	Drawings Referenced	Structural Horizontal Gravity System(s)	Structural Vertical Gravity System(s)	Lateral System (ASCE Designation)	Lateral System (Description)	Likely Deficiencies	Deficiency Notes	Additional Notes
Bldg. A	1924	1800	\$450,000	\$11,525,000	2	Crawlspace	No	Approximately Complete Original Documents	Concrete 1-way Slab, Concrete Beams, Wood Trusses	Conc. CIP Walls, Concrete Columns	C2	Concrete Shear Walls (Stiff Diaphragms)	Inadequate Foundation Ties Split Levels Reentrant Corners Misc. Plan Irregularity Masonry Partition Walls Concrete Parapets exceed 2.5:1 URM Chimneys Inadequate In-Plane Shear Under-Reinforced Walls Under-Reinforced Flat Slabs No Diaphragm-Wall Connection Deflection Compatibility Diaphragm Reinforcement at Openings URM Bearing Wall Likely	End of wings soft HCT walls	recommend monitoring possible settlement at SW corner recommend further investigation of cracking/damage observed in 1st floor central corridor & adjacent rooms recommend verifying construction of rear (NW) wall of gym

Bldg. B	1955	0	\$0	\$360,000	1	None	No	Approximately Complete Original Documents	Wood T+G Plank, Wood Beams	Conc. CIP Walls, Steel Columns	C2a	Concrete Shear Walls (Flexible Diaphragms)	Misc. Plan Irregularity Seismic Separation (< 1%) Concrete Parapets exceed 2.5:1 Inadequate In-Plane Shear Under-Reinforced Walls Under-Reinforced Flat Slabs No Diaphragm-Wall Connection Deflection Compatibility Discontinuous Cross Ties Straight Sheathing (2:1, 24')	Porch roof lateral support Adjacent & untied to Bldg. A	recommend monitoring possible settlement at NE classroom
Bldg. C	1960	0	\$0	\$142,500	1	None	No	None	Wood Plywood/OSB, Steel Truss, Steel Beams	CFS Walls	CFS1	Sheathed Shear Wall System	Inadequate In-Plane Shear Plaster or Gypsum Shear Walls Large Unbraced Openings No Floor-to-Floor Connections (Shear and OT) Inadequate Sill-Foundation Connections (6 ft) Roof Chord Discontinuity		Unit appears to be built directly on SOG

Bldg. D	1970	0	\$0	\$250,000	1	None	No	None	Wood Plywood/OSB, Wood Trusses, Wood Beams	Timber Frame	Non-compliant	Cantilevered Wood Posts	Post Capacity Foundation Capacity		
Bldg. E	1987	0	\$0	\$15,000	1	None	No	None	Wood Plywood/OSB, Wood Joists	Wood Framed Walls	W2	Wood Frames (Commercial and Industrial Buildings)	Seismic Separation (< 1%) Wood Ledgers loaded across grain		
Bldg. F	1997	0	\$0	\$75,000	1	None	No	None	Wood Plywood/OSB, Wood Trusses, Wood Beams	Timber Frame	Non-compliant	Cantilevered Wood Posts	Post Capacity Foundation Capacity

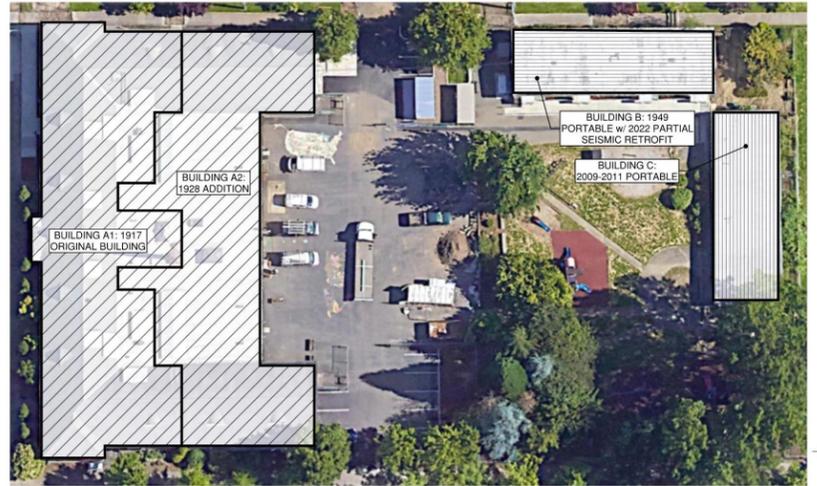
Building Part (See Diagram Above)	Year Built	URM (SF)	ROM URM Only Retrofit	ROM Total Retrofit	No. of Stories	Basement	Penthouse	Drawings Referenced	Structural Horizontal Gravity System(s)	Structural Vertical Gravity System(s)	Lateral System (ASCE Designation)	Lateral System (Description)	Likely Deficiencies	Deficiency Notes	Additional Notes
Bldg. A1	1916	0	\$0	\$1,550,000	1	Crawlspace	No	Approximately Complete Original Documents	Wood Straight/Diag Sheathing, Wood Joists, Wood Trusses	Wood Framed Walls	W2	Wood Frames (Commercial and Industrial Buildings)	Inadequate Foundation Ties Split Levels Reentrant Corners Non-redundant (< 2 bays in < 2 lines) Heavy Cladding System Inadequate In-Plane Shear Plaster or Gypsum Shear Walls Unbraced Cripple Walls Large Unbraced Openings No Floor-to-Floor Connections (Shear and OT) No Wood Post-Foundation Connections Inadequate Wood Sill-Foundation Connections (6 ft) No Girder-Column Connections Roof Chord Discontinuity Straight Sheathing (2:1, 24')	Brick veneer

Bldg. A2	1940	0	\$0	\$1,100,000	1	Crawlspace	No	Insufficient Original Documents	Wood Straight/Diag Sheathing, Wood Joists, Wood Trusses	Wood Framed Walls	W2	Wood Frames (Commercial and Industrial Buildings)	Inadequate Foundation Ties Split Levels Reentrant Corners Non-redundant (< 2 bays in < 2 lines) Heavy Cladding System Inadequate In-Plane Shear Plaster or Gypsum Shear Walls Unbraced Cripple Walls Large Unbraced Openings No Floor-to-Floor Connections (Shear and OT) No Wood Post-Foundation Connections Inadequate Wood Sill-Foundation Connections (6 ft) No Girder-Column Connections Roof Chord Discontinuity Straight Sheathing (2:1, 24')	Brick veneer	
Bldg. B	1940	0	\$0	\$70,000	1	Crawlspace	No	Insufficient Original Documents	Wood Straight/Diag Sheathing, Wood Joists	Wood Framed Walls	W2	Wood Frames (Commercial and Industrial Buildings)	Large Unbraced Openings No Floor-to-Floor Connections (Shear and OT) Inadequate Wood Sill-Foundation Connections (6 ft)		2022 Partial seismic retrofit

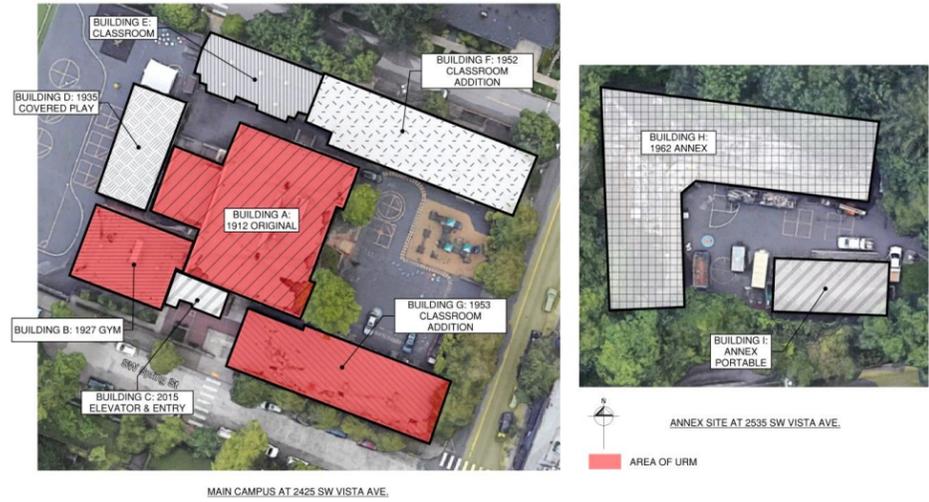
Building Part (See Diagram Above)	Year Built	URM (SF)	ROM URM Only Retrofit	ROM Total Retrofit	No. of Stories	Basement	Penthouse	Drawings Referenced	Structural Horizontal Gravity System(s)	Structural Vertical Gravity System(s)	Lateral System (ASCE Designation)	Lateral System (Description)	Likely Deficiencies	Deficiency Notes	Additional Notes
Bldg. A	1912	26000	\$6,500,000	\$6,500,000	2	Full	No	Insufficient Original Documents	Concrete Pan-Joists	Unreinforced Brick Walls	URMa	Unreinforced Masonry Bearing Walls (Stiff Diaphragms)	Inadequate Foundation Ties Inadequate Wall Anchorage Reentrant Corners Inadequate In-Plane Shear Beams, Girders, or Trusses bear on URM wall/pilaster No Diaphragm-Wall Connection Masonry Partition Walls	At bottom of URM Some locations improved in 2004 In N/S direction 2004 Retrofit of E/W direction only added concrete wall piers Retrofit at the roof 2015, not at second floor

Bldg. B	1927	3150	\$945,000	\$945,000	1	None	No	Insufficient Original Documents	Wood T+G Plank, Steel Beams	Unreinforced Brick Walls	URM	Unreinforced Brick Walls	Inadequate Foundation Ties Beams, Girders, or Trusses bear on URM wall/pilaster Inadequate In-Plane Shear	At bottom of URM Parapets and roof to wall connections retrofit 2004	
Bldg. C	2015	0	\$0	\$0	2	None	No	Approximately Complete Original Documents	Steel Beams	Reinforced CMU Walls, Steel Columns	RM2	Reinforced Masonry Bearing Walls (Stiff Diaphragms)		Benchmark building	
Bldg. D	1935 +/-	0	\$0	\$135,000	1	None	No	None	Wood Trusses	Timber Frame	W2	Timber Frame		Poles likely to have deterioration at or below grade	
Bldg. E	Pre-1950	0	\$0	\$345,000	1	None	No	None	Wood Trusses	Wood Framed Walls	W2	Wood Frames (Commercial and Industrial Buildings)	Inadequate In-Plane Shear Plaster or Gypsum Shear Walls Diagonal Sheathing (4:1, 40')	Wall sheathing unknown

Bldg. F	1952	0	\$0	\$810,000	1	None	No	Partial Set of Original Documents	Wood Beams	Timber Frame, Wood Framed Walls	W2	Wood Frames (Commercial and Industrial Buildings)	Inadequate In-Plane Shear Diagonal Sheathing (4:1, 40')	Interior is let-in bracing	
Bldg. G	1953	2800	\$420,000	\$420,000	1	None	No	Partial Set of Original Documents	Wood Beams	Timber Frame, Wood Framed Walls, Unreinforced Brick Walls	URM	Unreinforced Masonry Bearing Walls (Flexible Diaphragms)	Beams, Girders, or Trusses bear on URM wall/pilaster		Wall anchorage retrofit in 2015 Parapets braced in 2015
Bldg. H	1962	0	\$0	\$830,000	1	Crawlspace	No	None	Wood Truss-Joists, Wood Joists	Wood Framed Walls, Steel Columns	W2, S2a	Wood frame over steel braced frame	Sloping Site (full story difference across site) Misc. Moderate Vertical Irregularity Inadequate In-Plane Shear Inadequate Brace Capacity Non-compact Braces Slender Braces Inadequate brace connections	Shear wall system atop braced frame Wall sheathing unknown

Bldg. I	1962	0	\$0	\$135,000	1	Crawlspace	No	None	Wood Trusses	Wood Framed Walls	W2	Wood Frames (Commercial and Industrial Buildings)	Inadequate In-Plane Shear	Unknown sheathing

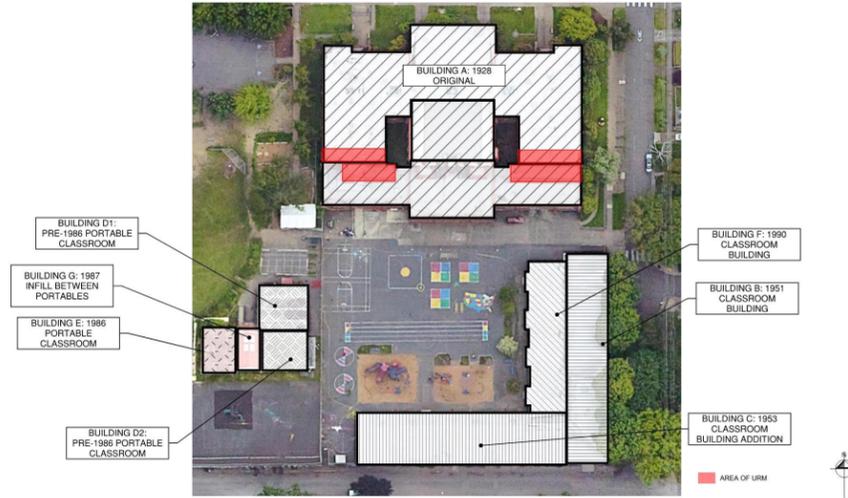
Building Part (See Diagram Above)	Year Built	URM (SF)	ROM URM Only Retrofit	ROM Total Retrofit	No. of Stories	Basement	Penthouse	Drawings Referenced	Structural Horizontal Gravity System(s)	Structural Vertical Gravity System(s)	Lateral System (ASCE Designation)	Lateral System (Description)	Likely Deficiencies	Deficiency Notes	Additional Notes
Bldg. A	1928	3000	\$1,350,000	\$12,975,000	2	Partial	No	Approximately Complete Original Documents	Concrete Pan-Joists, Wood Joists	Reinforced Concrete Walls, Unreinforced Brick Walls	C2, URM	Concrete Shear Walls (Stiff Diaphragms), Unreinforced Masonry Bearing Walls (Flexible Diaphragms)	Sloping Site (full story difference across site) Inadequate Wall Anchorage Split Levels Reentrant Corners Non-redundant (< 2 bays in < 2 lines) Inadequate In-Plane Shear Under-Reinforced Walls No Diaphragm-Wall Connection Deflection Compatibility Beams, Girders, or Trusses bear on URM wall/pilaster Walls Spaced Far Apart No Diaphragm-Wall Connection Masonry Partition Walls URM Parapets exceed 1.5:1 URM Chimneys Heavy Cladding System Other observed nonstructural falling hazard	8-13 ft (slopes parallel to Humbolt St) HCT/Brick wall stair hall 3 and 4 level 1-2 Diaphragm step at boiler room Each side of gymnasium HCT/URM walls at classroom, restroom, hall Dowels Present but likely insufficient Recommend reviewing column detailing in greater detail Likely Prior Retrofit URM Local Exterior Cladding Wall	Sht 5 Wall section X-X Section A-A Sheet 9 Sheet 4 and 5 will not provide proper lat. resistance

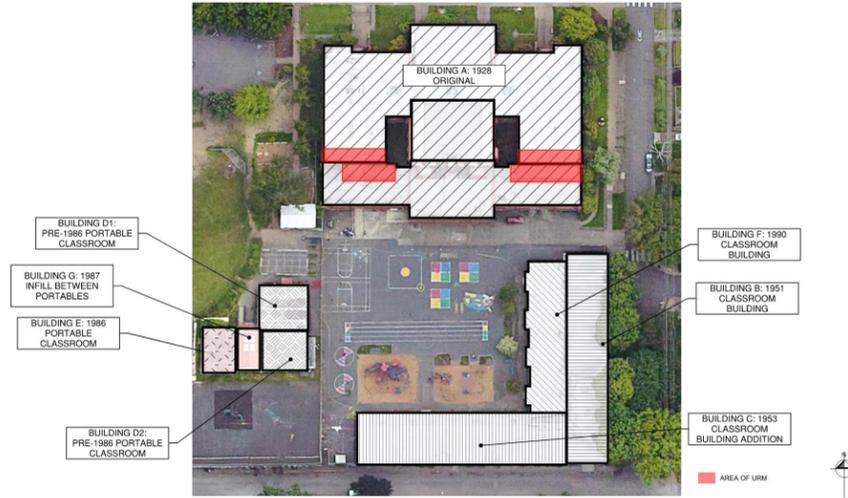
Building Part (See Diagram Above)	Year Built	URM (SF)	ROM URM Only Retrofit	ROM Total Retrofit	No. of Stories	Basement	Penthouse	Drawings Referenced	Structural Horizontal Gravity System(s)	Structural Vertical Gravity System(s)	Lateral System (ASCE Designation)	Lateral System (Description)	Likely Deficiencies	Deficiency Notes	Additional Notes
Bldg. D1/D2	1953	0	\$0	\$180,000	1	None, Crawlspace	No	None	CFS Joists, Wood Plywood/OSB	Unknown, Wood Framed Walls, CFS Walls	W2, CFS2	Wood Frames (Commercial and Industrial Buildings), Sheathed Shear Wall System	Misc. Load Path Issue Inadequate Foundation Ties Inadequate Wall Anchorage Seismic Separation (< 1%) Inadequate In-Plane Shear Inadequate Sill-Foundation Connections (6 ft) Diaphragm discontinuity between units		
Bldg. E	1986 (Relocated)	0	\$0	\$82,500	1	None	No	Approximately Complete Original Documents	Steel Joists	Wood Framed Walls, CFS Walls, Wood Framed Walls, CFS Walls, Unknown	W2	Wood Frames (Commercial and Industrial Buildings)	Misc. Load Path Issue Inadequate Foundation Ties Inadequate Wall Anchorage Seismic Separation (< 1%) Inadequate In-Plane Shear Inadequate Sill-Foundation Connections (6 ft) Diaphragm discontinuity between units

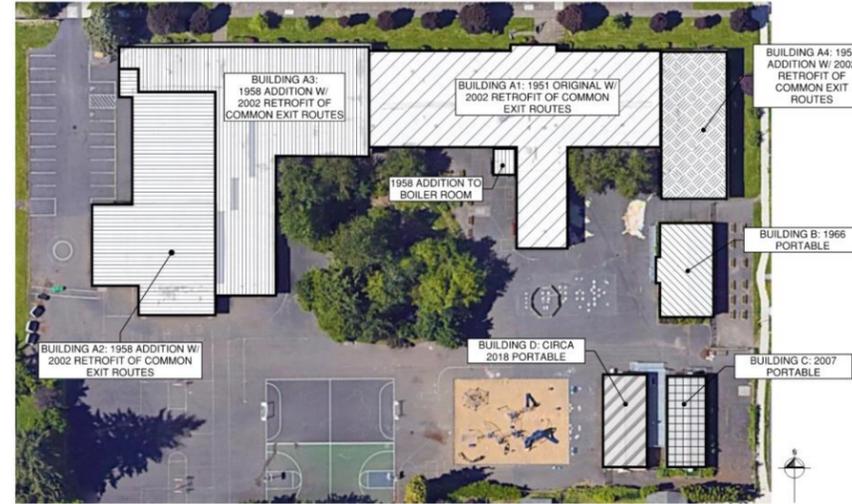
Building Part (See Diagram Above)	Year Built	URM (SF)	ROM URM Only Retrofit	ROM Total Retrofit	No. of Stories	Basement	Penthouse	Drawings Referenced	Structural Horizontal Gravity System(s)	Structural Vertical Gravity System(s)	Lateral System (ASCE Designation)	Lateral System (Description)	Likely Deficiencies	Deficiency Notes	Additional Notes
Bldg. A1	1951	0	\$0	\$1,530,000	1	None	No	Approximately Complete Original Documents	Wood Straight/Diag Sheathing, Wood Joists	Timber Frame	W2	Wood Frames (Commercial and Industrial Buildings)	Reentrant Corners Seismic Separation (< 1%) Heavy Cladding System Inadequate In-Plane Shear Straight Sheathing (2:1, 24')	To library. No gap to 1958 structures Brick veneer East and west wall library	Original structure circa 1951. Addition to boiler room in 1958 w/ similar construction materials. Seismic upgrades in 2002 included (1) reducing the height of the URM chimney, (2) adding blocking & connections between the tops of stud walls and the roof diaphragm at the exterior perimeter walls, and (3) improving connections from the tops of 8 interior transverse walls to the roof diaphragm.

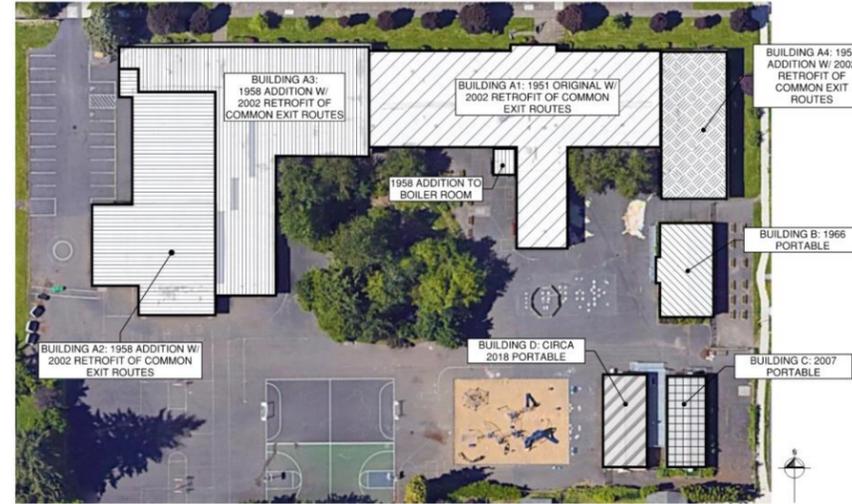
Building Part (See Diagram Above)	Year Built	URM (SF)	ROM URM Only Retrofit	ROM Total Retrofit	No. of Stories	Basement	Penthouse	Drawings Referenced	Structural Horizontal Gravity System(s)	Structural Vertical Gravity System(s)	Lateral System (ASCE Designation)	Lateral System (Description)	Likely Deficiencies	Deficiency Notes	Additional Notes
Bldg. A4	1958	0	\$0	\$420,000	1	None	No	Approximately Complete Original Documents	Wood Straight/Diag Sheathing, Wood Beams	Timber Frame	W2	Wood Frames (Commercial and Industrial Buildings)	Reentrant Corners Seismic Separation (< 1%) Heavy Cladding System Inadequate In-Plane Shear Inadequate Wood Sill-Foundation Connections (6 ft) No Girder-Column Connections Diagonal Sheathing (4:1, 40')	No gap to existing, though also wood framed Brick veneer Check 5/8" di bolts @ 8'-0" o.c. per section A/19 Check connection between rafters and corridor wall	Seismic upgrades in 2002 included adding blocking & connections between the tops of stud walls and the roof diaphragm at the exterior perimeter walls

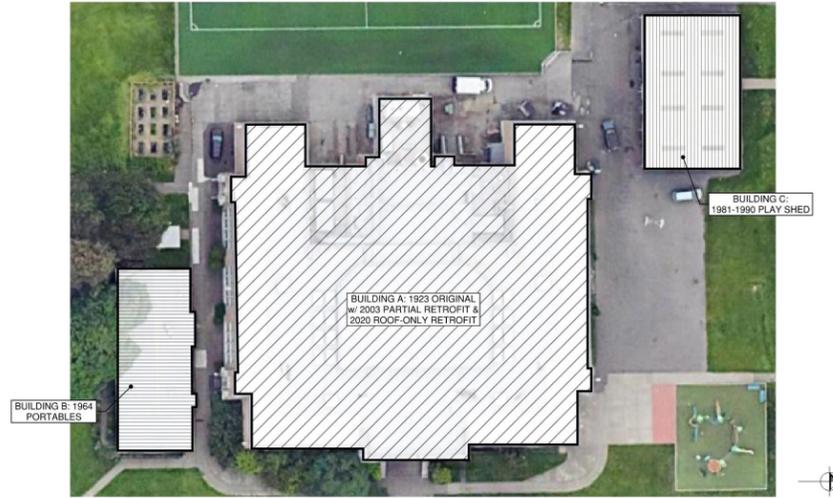
Building Part (See Diagram Above)	Year Built	URM (SF)	ROM URM Only Retrofit	ROM Total Retrofit	No. of Stories	Basement	Penthouse	Drawings Referenced	Structural Horizontal Gravity System(s)	Structural Vertical Gravity System(s)	Lateral System (ASCE Designation)	Lateral System (Description)	Likely Deficiencies	Deficiency Notes	Additional Notes
Bldg. A	1923	0	\$0	\$13,905,000	2	Partial, Daylight	No	Insufficient Original Documents	Wood Straight/Diag Sheathing, Wood Joists, Concrete Beams, Concrete Pan-Joists, Concrete 1-way Slab, Wood Trusses	Concrete Columns, Conc. CIP Walls	C2, C2a, C3	Concrete Shear Walls & Concrete Frames with Infill Masonry Shear Walls (Both Diaphragms)	High Landslide Susceptibility (DOGAMI State Overview) Near-fault location (250ft, DOGAMI Active Faults) Severe Vertical Element Size Discontinuity (<50%) Split Levels Reentrant Corners Masonry Partition Walls Masonry ceiling Heavy Cladding System Deep Spandrels/Narrow Piers (50%, interfering walls) Inadequate In-Plane Shear (conc. Walls) Under-Reinforced Walls Under-Reinforced Flat Slabs No Diaphragm-Wall Connection Inadequate Wall-Foundation Connection Deflection Compatibility Discontinuous Cross Ties Straight Sheathing (2:1, 24') Thin HCT Walls (>1:9) Inadequate In-Plane Shear (HCT walls)	Infilled frames not continuous to end roof level steps Local areas braced in 2003, 2020 thin slabs Local areas reinforced in 2003	Large lightwells have been infilled (drawings not available) 2003 - partial seismic upgrade 2020 - roof-only seismic upgrade

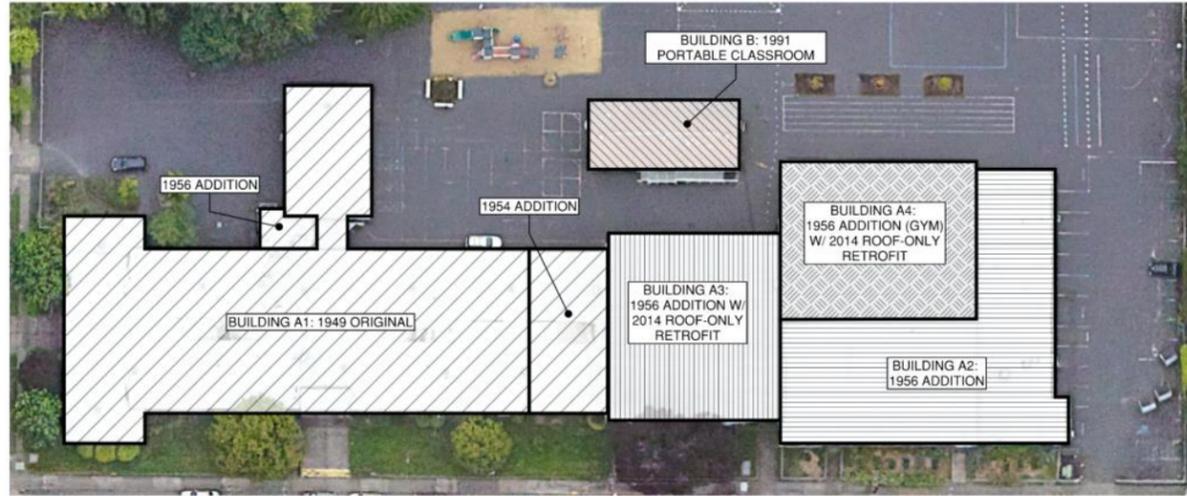
Building Part (See Diagram Above)	Year Built	URM (SF)	ROM URM Only Retrofit	ROM Total Retrofit	No. of Stories	Basement	Penthouse	Drawings Referenced	Structural Horizontal Gravity System(s)	Structural Vertical Gravity System(s)	Lateral System (ASCE Designation)	Lateral System (Description)	Likely Deficiencies	Deficiency Notes	Additional Notes
Bldg. A1	1949	0	\$0	\$1,770,000	1	None	No	Approximately Complete Original Documents	Wood Straight/Diag Sheathing, Wood Beams, Wood Joists	Wood Framed Walls	W2	Wood Frames (Commercial and Industrial Buildings)	Misc. Load Path Issue Split Levels Reentrant Corners Overturning Seismic Separation (< 1%) Inadequate In-Plane Shear Inadequate Wood Sill-Foundation Connections (6 ft) Roof Chord Discontinuity Diagonal Sheathing (4:1, 40')	The east edge of the 1949 building should be anchored to the west wall of the 1954 addition (identified per the 2014 improvement project) To library Likely at library walls No gap to 1956 addition Spacing of connections was not specified in drawings, needs investigation	1949 Original Structure. Addition of two classroom on east side in 1954 using similar materials and construction detailing. Addition to boiler room in 1966, also using similar materials. In 2014, the height of the brick chimney was reduced as part of an improvement project.

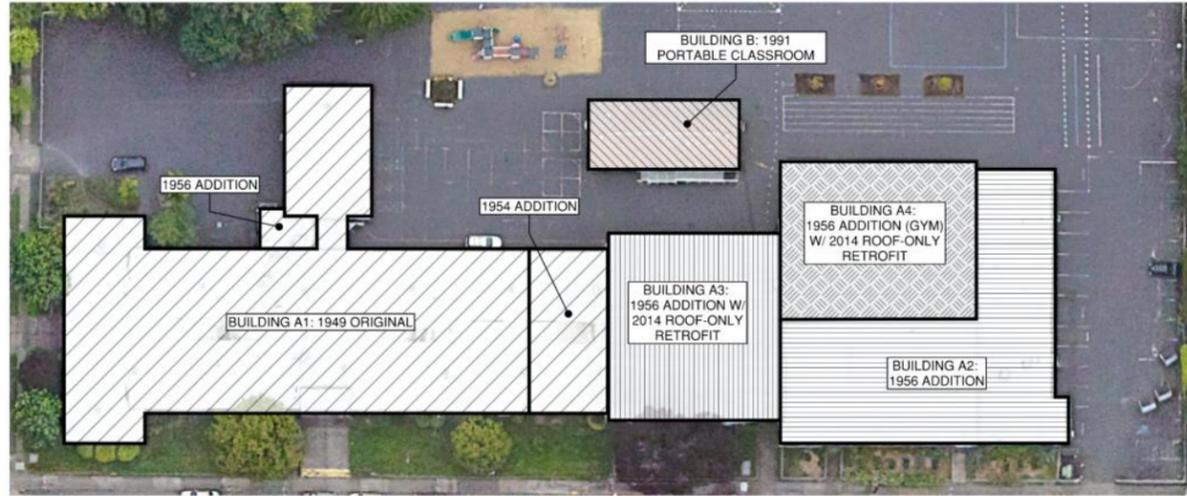
Building Part (See Diagram Above)	Year Built	URM (SF)	ROM URM Only Retrofit	ROM Total Retrofit	No. of Stories	Basement	Penthouse	Drawings Referenced	Structural Horizontal Gravity System(s)	Structural Vertical Gravity System(s)	Lateral System (ASCE Designation)	Lateral System (Description)	Likely Deficiencies	Deficiency Notes	Additional Notes
Bldg. A4	1956	0	\$0	\$430,000	1	None	No	Approximately Complete Original Documents	Wood Plywood/OSB, Wood Straight/Diag Sheathing, Wood Beams, Wood Joists	Conc. CIP Walls	C2a	Concrete Shear Walls (Flexible Diaphragms)	Misc. Load Path Issue Split Levels Reentrant Corners Overturning Seismic Separation (< 1%) Inadequate In-Plane Shear Inadequate Wood Sill-Foundation Connections (6 ft) Roof Chord Discontinuity Diagonal Sheathing (4:1, 40')	Dowels appear to extend from wall to foundation stem, but not continue to foundation base per details on S4	1956 addition to east side of original structure. Partial re-roof circa 2014 - structural upgrades for upper roof diaphragm & connects (gym, fan room & classroom wing). No structural work at lower roof (multi-purpose room, kitchen, & locker room)

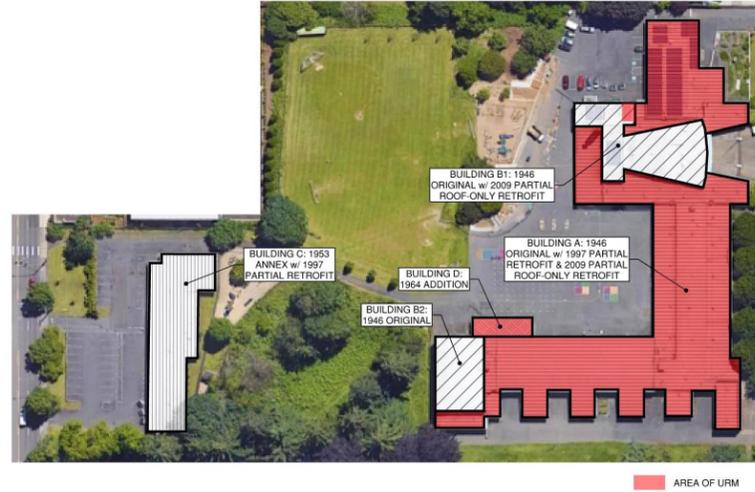
Building Part (See Diagram Above)	Year Built	URM (SF)	ROM URM Only Retrofit	ROM Total Retrofit	No. of Stories	Basement	Penthouse	Drawings Referenced	Structural Horizontal Gravity System(s)	Structural Vertical Gravity System(s)	Lateral System (ASCE Designation)	Lateral System (Description)	Likely Deficiencies	Deficiency Notes	Additional Notes
Bldg. A	1946	53600	\$10,720,000	\$10,720,000	1	None	No	Insufficient Original Documents	Wood Plywood/OSB, Wood Joists, Wood Trusses, Wood Beams	Wood Framed Walls, Steel Columns, Structural Glazed Tile Walls	W2, URM	Wood Frames (Commercial and Industrial Buildings), Unreinforced Masonry Bearing Walls (Flexible Diaphragms)	Misc. Load Path Issue Split Levels Reentrant Corners Non-redundant (< 2 bays in < 2 lines) Beams, Girders, or Trusses bear on URM wall/pilaster Walls Spaced Far Apart Inadequate In-Plane Shear (URM) Thin Walls (9 top, 15 first, 13 other/single) Wood Ledgers loaded across grain No Diaphragm-Wall Connection No Girder-Column Connections Discontinuous Cross Ties Straight Sheathing (2:1, 24') Inadequate In-Plane Shear (Wood) Plaster or Gypsum Shear Walls Unbraced Cripple Walls Large Unbraced Openings No Floor-to-Floor Connections (Shear and OT) Inadequate Wood Sill-Foundation Connections (6 ft) Roof Chord Discontinuity Masonry Partition Walls	Corridor ceiling braced by SGT walls Few exterior shear walls 1997 work was not comprehensive Cafeteria 1997 work was not comprehensive	recommend scanning walls to verify URM bearing walls 1997 - Partial seismic retrofit 2009 - Roof-only seismic retrofit in eastern portion only 2014 - documentation not available

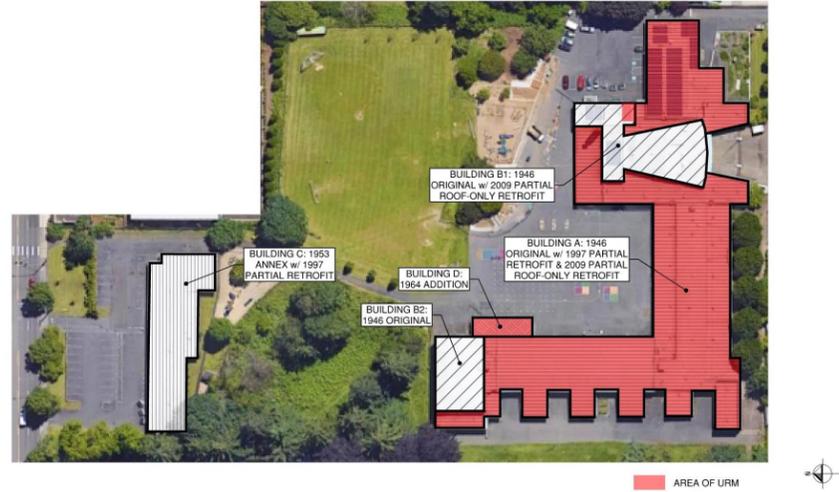
Building Part (See Diagram Above)	Year Built	URM (SF)	ROM URM Only Retrofit	ROM Total Retrofit	No. of Stories	Basement	Penthouse	Drawings Referenced	Structural Horizontal Gravity System(s)	Structural Vertical Gravity System(s)	Lateral System (ASCE Designation)	Lateral System (Description)	Likely Deficiencies	Deficiency Notes	Additional Notes
Bldg. C	1953	0	\$0	\$1,050,000	1	None	No	0	Wood Plywood/OSB, Wood Joists, Wood Beams	Wood Framed Walls	W2	Wood Frames (Commercial and Industrial Buildings)	High Landslide Susceptibility (DOGAMI State Overview) Reentrant Corners Inadequate In-Plane Shear Plaster or Gypsum Shear Walls Large Unbraced Openings No Floor-to-Floor Connections (Shear and OT) Roof Chord Discontinuity Unblocked Diaphragms (4:1, 40')		1997 - partial seismic retrofit
Bldg. D	1964	600	\$150,000	\$150,000	1	None	No	Approximately Complete Original Documents	Wood Plywood/OSB, Wood Joists, Wood Beams	CFS Walls, Unreinforced CMU Walls	URM	Unreinforced Masonry Bearing Walls (Flexible Diaphragms)	Misc. Load Path Issue Beams, Girders, or Trusses bear on URM wall/pilaster Inadequate In-Plane Shear Thin Walls (9 top, 15 first, 13 other/single) Wood Ledgers loaded across grain No Diaphragm-Wall Connection Discontinuous Cross Ties Unblocked Diaphragms (4:1, 40')	Inadequate tie to existing bldg.

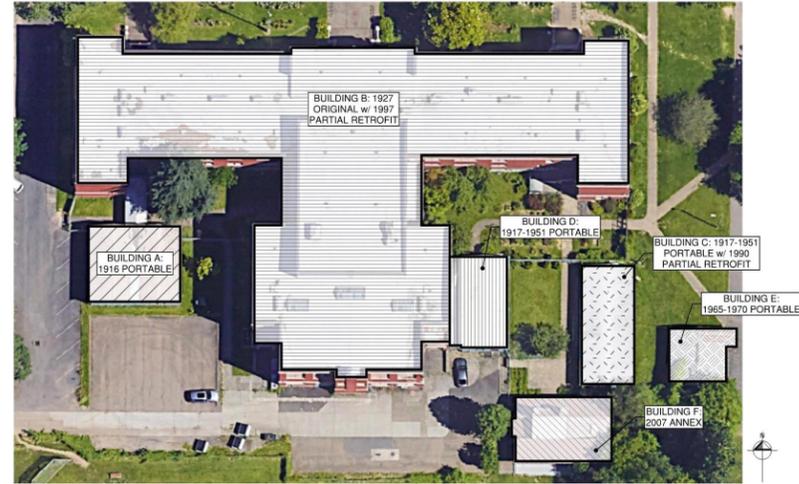
Building Part (See Diagram Above)	Year Built	URM (SF)	ROM URM Only Retrofit	ROM Total Retrofit	No. of Stories	Basement	Penthouse	Drawings Referenced	Structural Horizontal Gravity System(s)	Structural Vertical Gravity System(s)	Lateral System (ASCE Designation)	Lateral System (Description)	Likely Deficiencies	Deficiency Notes	Additional Notes
Bldg. A	1916	0	\$0	\$200,000	1	Crawlspace	No	Insufficient Original Documents	Wood Straight/Diag Sheathing, Wood Joists	Wood Framed Walls	W2	Wood Frames (Commercial and Industrial Buildings)	Inadequate Foundation Ties Inadequate In-Plane Shear Plaster or Gypsum Shear Walls Narrow Wood Shear Walls Unbraced Cripple Walls Large Unbraced Openings No Floor-to-Floor Connections (Shear and OT) Inadequate Wood Sill-Foundation Connections (6 ft) Roof Chord Discontinuity Straight Sheathing (2:1, 24')		
Bldg. B	1927	0	\$0	\$20,175,000	3	Crawlspace	No	Approximately Complete Original Documents	Concrete 1-way Slab, Concrete Pan-Joists, Concrete Beams, Steel Truss	Concrete Columns, Conc. CIP Walls, Unreinforced Brick Walls	C2	Concrete Shear Walls (Stiff Diaphragms)	Inadequate Foundation Ties Reentrant Corners Masonry Partition Walls Concrete Parapets exceed 2.5:1 URM Chimneys Heavy Cladding System Deep Spandrels/Narrow Piers (50%, interfering walls) Inadequate In-Plane Shear Under-Reinforced Walls Under-Reinforced Flat Slabs No Diaphragm-Wall Connection Inadequate Wall-Foundation Connection Diaphragm Reinforcement at Openings	Some exitways appear to be braced  thin slabs	1997 - Partial seismic upgrade

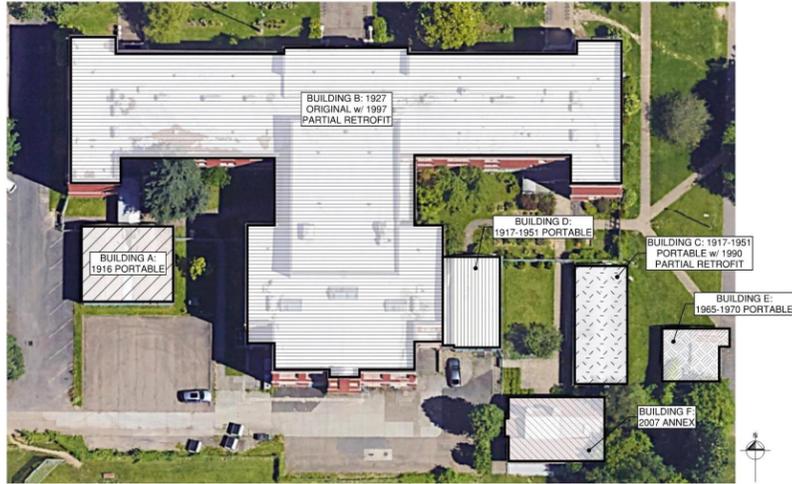
Building Part (See Diagram Above)	Year Built	URM (SF)	ROM URM Only Retrofit	ROM Total Retrofit	No. of Stories	Basement	Penthouse	Drawings Referenced	Structural Horizontal Gravity System(s)	Structural Vertical Gravity System(s)	Lateral System (ASCE Designation)	Lateral System (Description)	Likely Deficiencies	Deficiency Notes	Additional Notes
Bldg. E	1965	0	\$0	\$67,500	1	Crawlspace	No	None	Wood Straight/Diag Sheathing, CFS Joists	CFS Walls	CFS1	Sheathed Shear Wall System	Inadequate Foundation Ties Inadequate In-Plane Shear Unbraced Cripple Walls Large Unbraced Openings No Floor-to-Floor Connections (Shear and OT) Roof Chord Discontinuity Long, Non-Wood Structural Panel Diaphragms (24')		
Bldg. F	2007	0	\$0	\$0	1	None	No	Approximately Complete Original Documents	Wood Straight/Diag Sheathing, Wood Trusses	Wood Framed Walls	W2	Wood Frames (Commercial and Industrial Buildings)			Appears to be a benchmark building

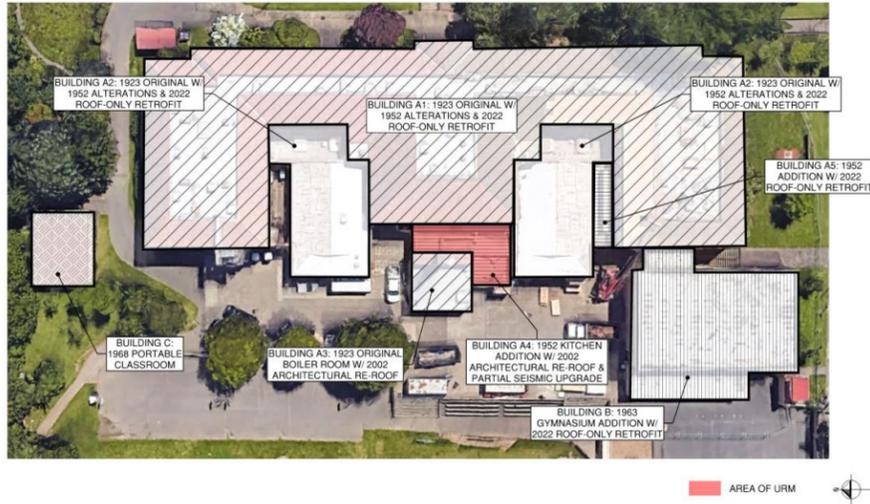
Building Part (See Diagram Above)	Year Built	URM (SF)	ROM URM Only Retrofit	ROM Total Retrofit	No. of Stories	Basement	Penthouse	Drawings Referenced	Structural Horizontal Gravity System(s)	Structural Vertical Gravity System(s)	Lateral System (ASCE Designation)	Lateral System (Description)	Likely Deficiencies	Deficiency Notes	Additional Notes
Bldg. A1	1923	0	\$0	\$10,923,750	2	Partial, Crawlspace	No	Approximately Complete Original Documents	Concrete Beams, Concrete 1-way Slab, Wood Trusses, Steel Truss	Conc. CIP Walls	C2	Concrete Shear Walls (Stiff Diaphragms)	Sloping Site (full story difference across site) Inadequate Foundation Ties Split Levels Reentrant Corners Seismic Separation (< 1%) Masonry Partition Walls Inadequate In-Plane Shear Under-Reinforced Walls Under-Reinforced Flat Slabs Inadequate Wall-Foundation Connection Deflection Compatibility	Double height auditorium space with offset roof height from main building re-entrant corners at wings Buildings Interconnected Hollow tile partition walls Interconnected buildings	1923 original W/ 1952 alterations & 2022 roof-only retrofit (re-roof). Supports Building A3.

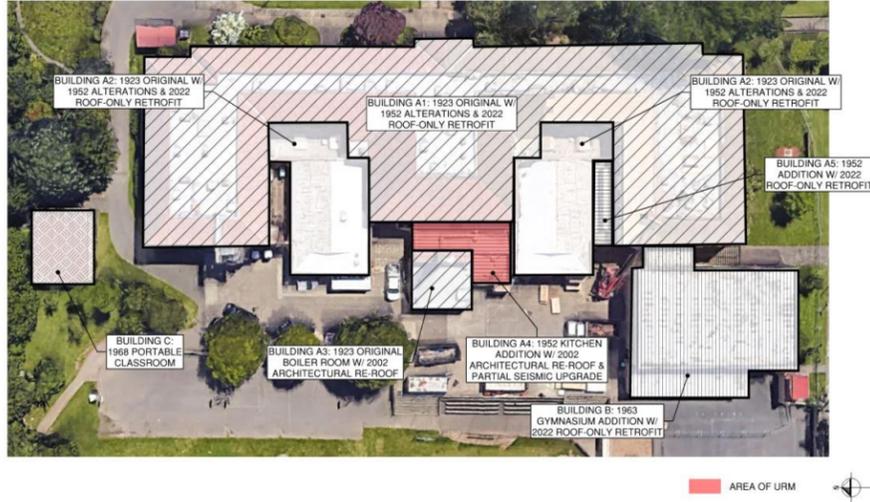
Building Part (See Diagram Above)	Year Built	URM (SF)	ROM URM Only Retrofit	ROM Total Retrofit	No. of Stories	Basement	Penthouse	Drawings Referenced	Structural Horizontal Gravity System(s)	Structural Vertical Gravity System(s)	Lateral System (ASCE Designation)	Lateral System (Description)	Likely Deficiencies	Deficiency Notes	Additional Notes
Bldg. A5	1952	0	\$0	\$0	1	None	No	Approximately Complete Original Documents	Wood Joists	Conc. CIP Walls	C2	Concrete Shear Walls (Stiff Diaphragms)	Seismic Separation (< 1%)	Buildings Interconnected	Covered area between Building A1 zones. Gravity structure supported on Building A1
Bldg. B	1964	0	\$0	\$570,000	1	Partial	No	Approximately Complete Original Documents	Steel Truss	Concrete Columns, Reinforced CMU Walls	C3a	Concrete Frames with Infill Masonry Shear Walls (Flexible Diaphragms)	Split Levels Seismic Separation (< 1%) Heavy Cladding System Cavity Wall Construction Inadequate In-Plane Shear Deflection Compatibility	Locker rooms split level Buildings Interconnected Brick veneer Limited reinforcing in masonry walls Interconnected buildings	1963 gymnasium addition. 2022 roof only retrofit (re-roof)

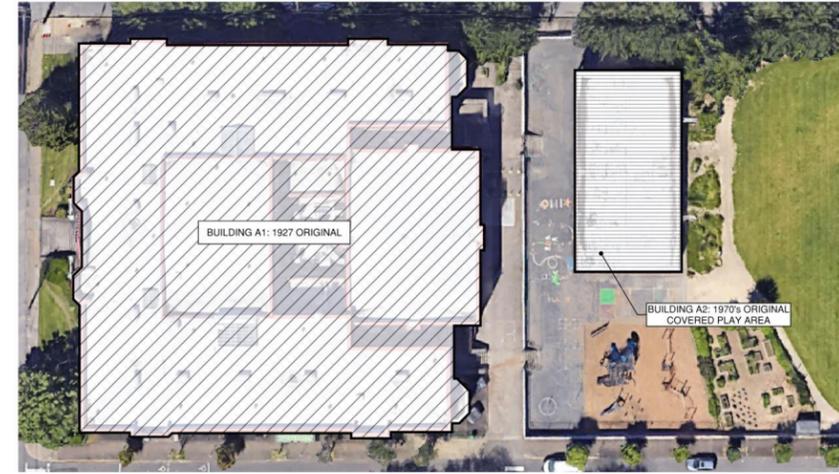
Building Part (See Diagram Above)	Year Built	URM (SF)	ROM URM Only Retrofit	ROM Total Retrofit	No. of Stories	Basement	Penthouse	Drawings Referenced	Structural Horizontal Gravity System(s)	Structural Vertical Gravity System(s)	Lateral System (ASCE Designation)	Lateral System (Description)	Likely Deficiencies	Deficiency Notes	Additional Notes
Bldg. A1	1927	0	\$0	\$18,292,500	2	Daylight, Partial	No	Approximately Complete Original Documents	Steel Truss, Concrete 1-way Slab, Concrete Beams	Conc. CIP Walls, Concrete Columns	C2	Concrete Shear Walls (Stiff Diaphragms)	Sloping Site (full story difference across site) Inadequate Foundation Ties Split Levels Reentrant Corners Masonry Partition Walls Heavy Cladding System Inadequate In-Plane Shear Under-Reinforced Walls Under-Reinforced Flat Slabs No Diaphragm-Wall Connection Inadequate Wall-Foundation Connection Large Diaphragm Openings Adj. Walls (25%)	Brick & tile partition walls Brick cladding Floor slab reinforcing not continuous Auditorium opening	1927 original school building

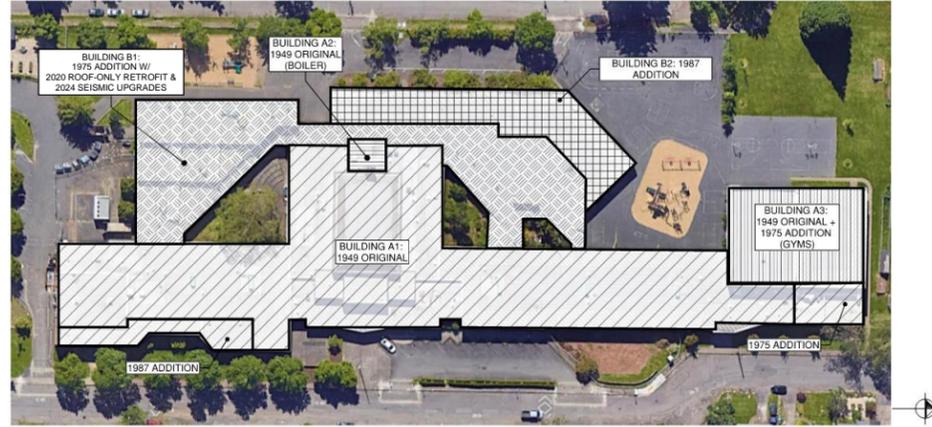
Building Part (See Diagram Above)	Year Built	URM (SF)	ROM URM Only Retrofit	ROM Total Retrofit	No. of Stories	Basement	Penthouse	Drawings Referenced	Structural Horizontal Gravity System(s)	Structural Vertical Gravity System(s)	Lateral System (ASCE Designation)	Lateral System (Description)	Likely Deficiencies	Deficiency Notes	Additional Notes
Bldg. A1	1949	0	\$0	\$7,712,500	1	Crawlspace	No	Approximately Complete Original Documents	Wood Straight/Diag Sheathing, Wood Joists, Wood Beams, Wood Trusses	Wood Framed Walls, Steel Columns	W2, URMa	Wood Frames (Commercial and Industrial Buildings), Unreinforced Masonry Bearing Walls (Stiff Diaphragms)	Inadequate Foundation Ties Inadequate Wall Anchorage Split Levels Reentrant Corners Seismic Separation (< 1%) 1" gap @ GL 11 & 20 Heavy Cladding System Inadequate In-Plane Shear Narrow Wood Shear Walls Inadequate Wood Sill-Foundation Connections (6 ft) No Girder-Column Connections Roof Chord Discontinuity Diagonal Sheathing (4:1, 40') Unblocked Wood Panel Diaphragms (4:1, 40') No Diaphragm-Wall Connection	Needs investigation Potential deficiency of diaphragm-wood wall connections Brick veneer Some new shear walls added in 2024, not full retrofit Bolts @ 8'-0" o.c. per section 1-1 on A1-8 Unclear from section 3-3 on A1-8 At assembly hall Check IP and OOP connection of URM walls - detail not found in review	Original school building consists of light framed wood over a suspended concrete slab and spread footing foundation system. Also includes low roof portion of 1975 addition to north end & 1987 addition to east side. There are 8" brick walls (firewalls & loadbearing) w / a 1" expansion joint at gridlines 11 & 20. (N) Ply shear walls were added in 2024 in response to remodel.

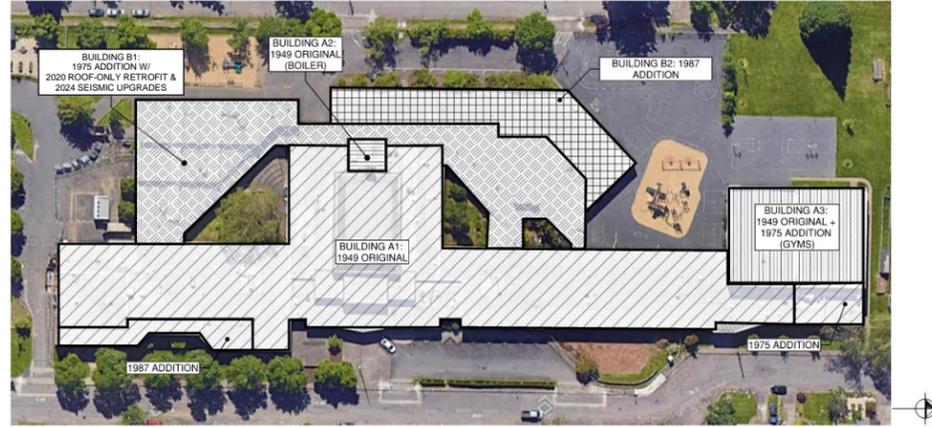
Building Part (See Diagram Above)	Year Built	URM (SF)	ROM URM Only Retrofit	ROM Total Retrofit	No. of Stories	Basement	Penthouse	Drawings Referenced	Structural Horizontal Gravity System(s)	Structural Vertical Gravity System(s)	Lateral System (ASCE Designation)	Lateral System (Description)	Likely Deficiencies	Deficiency Notes	Additional Notes
Bldg. B1	1975	0	\$0	\$2,690,000	2	None	No	Approximately Complete Original Documents	Wood Plywood/OSB, Wood Straight/Diag Sheathing, Wood Joists, Wood Beams	Reinforced CMU Walls, Conc. CIP Walls	RM1, W2	Reinforced Masonry Bearing Walls (Flexible Diaphragms), Wood Frames (Commercial and Industrial Buildings)	Misc. Load Path Issue Inadequate Wall Anchorage Split Levels Non-orthogonal System Reentrant Corners Seismic Separation (< 1%) Inadequate In-Plane Shear No Diaphragm-Wall Connection Discontinuous Cross Ties	There is no continuous load path from roof diaphragm to CMU shear walls in South & West wall of south section and south skewed wall and clerestories of north section Updated in 2020 typ. Exception noted in 'misc. load path issue' No gap to original structure North section may still not meet ASCE 41 load levels Updated in 2020 typ. Exception noted in 'misc. load path issue' Roof chord is discontinuous at steps in roof	1975 classroom addition to west side of the original building. Roof-only retrofit in 2020. Any seismic upgrades in 2024 were primarily in response to remodel scope & aren't necessarily expected to improve overall seismic performance significantly. Upgrades/changes include (N) ply shear walls added to the south section plus new shear walls at roof steps. In the north section, (N) CMU walls added and (E) CMU walls strengthened (vertical bars added each end).

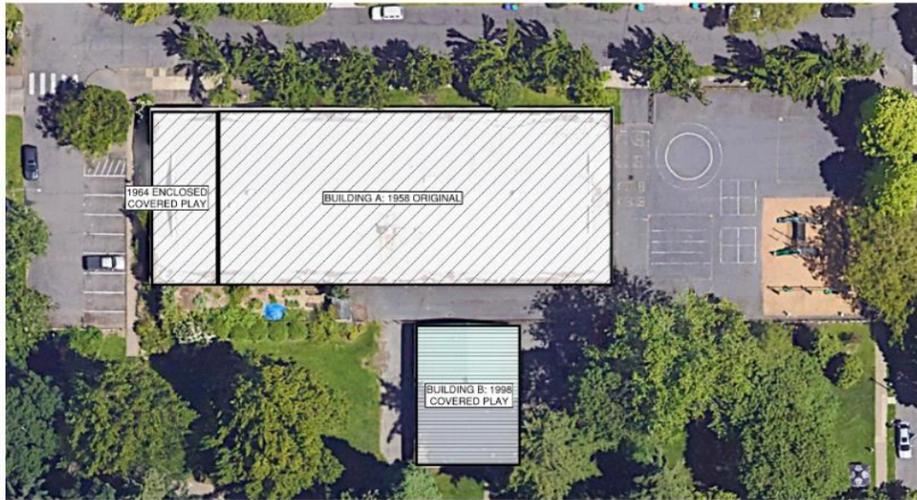
Building Part (See Diagram Above)	Year Built	URM (SF)	ROM URM Only Retrofit	ROM Total Retrofit	No. of Stories	Basement	Penthouse	Drawings Referenced	Structural Horizontal Gravity System(s)	Structural Vertical Gravity System(s)	Lateral System (ASCE Designation)	Lateral System (Description)	Likely Deficiencies	Deficiency Notes	Additional Notes
Bldg. A	1958	0	\$0	\$1,540,000	1	Partial	No	Approximately Complete Original Documents	Tectum, Steel Truss	Steel Columns, CFS Walls	CFS2	Strap-Braced Wall System	URM Chimneys Inadequate axial capacity in braces No Diaphragm-Frame Connection No Diaphragm-Roof Framing Connection Strap Brace Axial Capacity Non-wood panel Diaphragms (2:1, 24') Other Diaphragms	Check - 5/8" rod X-bracing Unquantifiable load path from diaphragm to frame Connection between tectum panels and roof bulbs unknown StrapU braces are typ approx 32' long Tectum diaphragm	Original 1958 structure, plus 1964 modifications to enclose the covered play area to make addition classrooms (matches original construction LFRS & materials). LFRS is strap bracing in transverse direction and rod X bracing in longitudinal direction. Roof is comprised of tectum substrate between bulb-tee purlins supported by steel roof trusses.

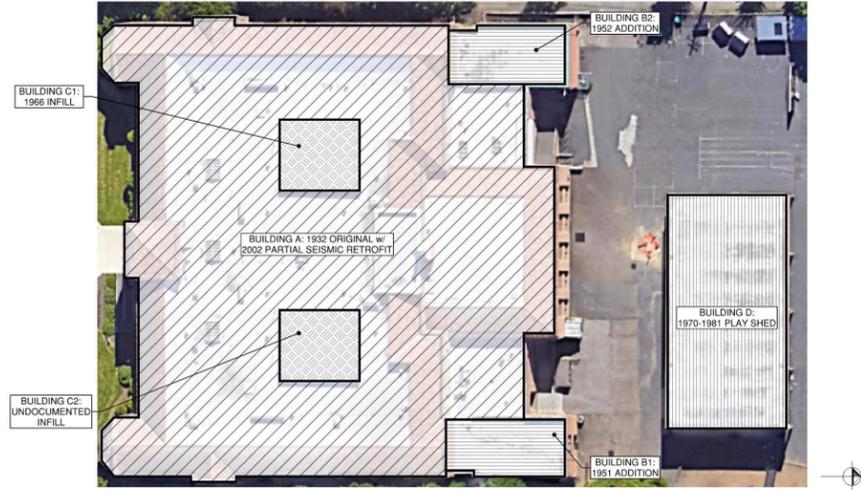
Building Part (See Diagram Above)	Year Built	URM (SF)	ROM URM Only Retrofit	ROM Total Retrofit	No. of Stories	Basement	Penthouse	Drawings Referenced	Structural Horizontal Gravity System(s)	Structural Vertical Gravity System(s)	Lateral System (ASCE Designation)	Lateral System (Description)	Likely Deficiencies	Deficiency Notes	Additional Notes
Bldg. A	1932	0	\$0	\$15,225,000	2	Partial, Daylight	No	Approximately Complete Original Documents	Concrete 1-way Slab, Concrete Pan-Joists, Steel Beams, Steel Truss	Concrete Columns, Conc. CIP Walls	C2	Concrete Shear Walls (Stiff Diaphragms)	Inadequate Foundation Ties Split Levels Reentrant Corners Masonry Partition Walls Masonry ceiling Concrete Parapets exceed 2.5:1 Heavy Cladding System Deep Spandrels/Narrow Piers (50%, interfering walls) Inadequate In-Plane Shear Under-Reinforced Walls Under-Reinforced Flat Slabs No Diaphragm-Wall Connection Inadequate Wall-Foundation Connection Deflection Compatibility Diaphragm Reinforcement at Openings	some improved in 2002  thin slabs	1986 - Auditorium floor raised 2002 - Partial seismic bracing

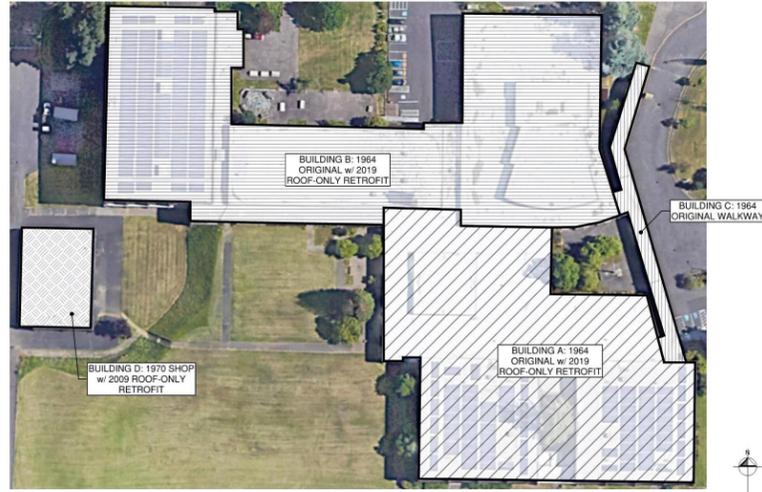
Building Part (See Diagram Above)	Year Built	URM (SF)	ROM URM Only Retrofit	ROM Total Retrofit	No. of Stories	Basement	Penthouse	Drawings Referenced	Structural Horizontal Gravity System(s)	Structural Vertical Gravity System(s)	Lateral System (ASCE Designation)	Lateral System (Description)	Likely Deficiencies	Deficiency Notes	Additional Notes
Bldg. A	1964	0	\$0	\$14,220,000	2	Partial	No	Approximately Complete Original Documents	Concrete Waffle Slab, Concrete Pan-Joists, Concrete Beams, Precast/stressed Concrete 1-way Slab	Concrete Columns, Conc. CIP Walls, Concrete Tilt-up Walls	PC1a	Precast or Tilt-up Concrete Shear Walls (Stiff Diaphragm)	Inadequate Wall Anchorage Split Levels Reentrant Corners Masonry Partition Walls Walls Spaced Far Apart Inadequate In-Plane Shear Under-Reinforced Walls Thin Walls (>1:40, 4 in) No Diaphragm-Wall Connection Inadequate Girder-Wall/Pilaster Connections No Wall-Foundation Connection Deflection Compatibility at rigid diaphragms Diaphragm Reinforcement at Openings Inadequate wall chord detailing		It appears SW portions were never constructed 2019 - Partial roof-only strengthening reported by PPS at this campus (no drawings available) Walls are poorly documented - an investigative program will be required prior to retrofit

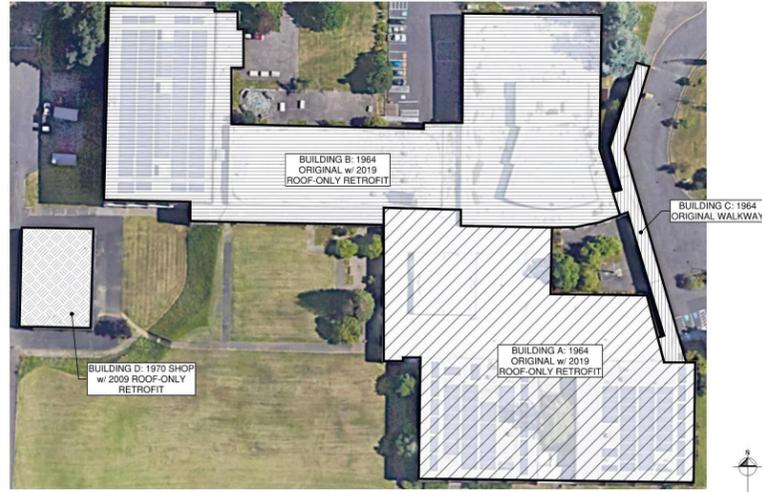
Building Part (See Diagram Above)	Year Built	URM (SF)	ROM URM Only Retrofit	ROM Total Retrofit	No. of Stories	Basement	Penthouse	Drawings Referenced	Structural Horizontal Gravity System(s)	Structural Vertical Gravity System(s)	Lateral System (ASCE Designation)	Lateral System (Description)	Likely Deficiencies	Deficiency Notes	Additional Notes
Bldg. D	1970	0	\$0	\$315,000	1	None	No	Insufficient Original Documents	Wood T+G Plank, Wood Beams	Concrete Tilt-up Walls	PC1	Precast or Tilt-up Concrete Shear Walls (Flexible Diaphragm)	No Wall-Foundation Connection Discontinuous Cross Ties Inadequate wall chord detailing		2009 - Partial roof-only seismic retrofit

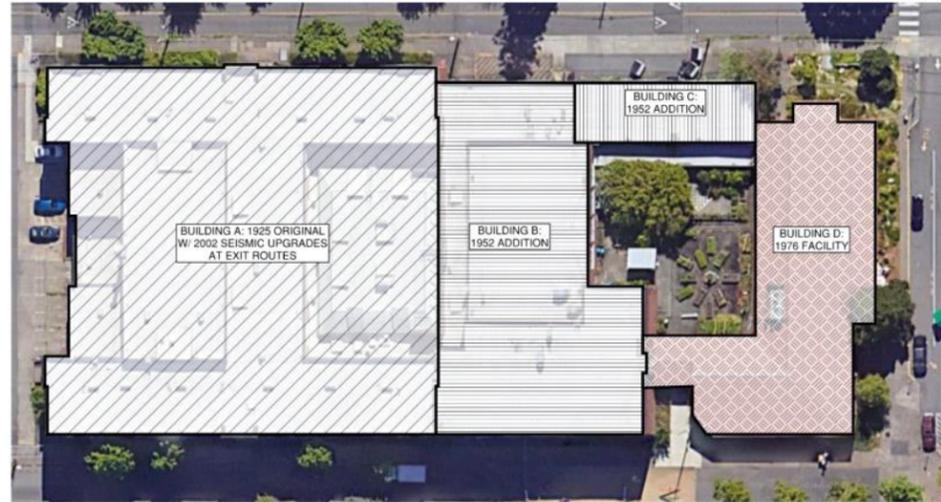
Building Part (See Diagram Above)	Year Built	URM (SF)	ROM URM Only Retrofit	ROM Total Retrofit	No. of Stories	Basement	Penthouse	Drawings Referenced	Structural Horizontal Gravity System(s)	Structural Vertical Gravity System(s)	Lateral System (ASCE Designation)	Lateral System (Description)	Likely Deficiencies	Deficiency Notes	Additional Notes
Bldg. A	1925	0	\$0	\$16,375,000	2	Partial, Crawlspace	No	Approximately Complete Original Documents	Concrete Pan-Joists, Steel Truss, Concrete 1-way Slab	Conc. CIP Walls	C2	Concrete Shear Walls (Stiff Diaphragms)	Inadequate Wall Anchorage Reentrant Corners Seismic Separation (< 1%) Masonry Partition Walls URM Parapets exceed 1.5:1 Concrete Parapets exceed 2.5:1 Heavy Cladding System Other observed nonstructural falling hazard Inadequate In-Plane Shear Under-Reinforced Walls Under-Reinforced Flat Slabs No Diaphragm-Wall Connection Inadequate Wall-Foundation Connection Deflection Compatibility	No gap Locations not over exit doors only All locations Brick veneer Unbraced suspended plaster ceilings Analysis required	1925 Original Structure by Jones. Classroom wings are 2-stories and 'H'-shaped. Double-height single story portions fill in the top and bottom of the 'H' - auditorium to the north and gym to the south. Partial seismic upgrade was undertaken in 2002 to protect egress paths, included (1) bracing hollow clay tiles corridor walls, (2) bracing URM parapets over exit doors, and (2) chimneys.

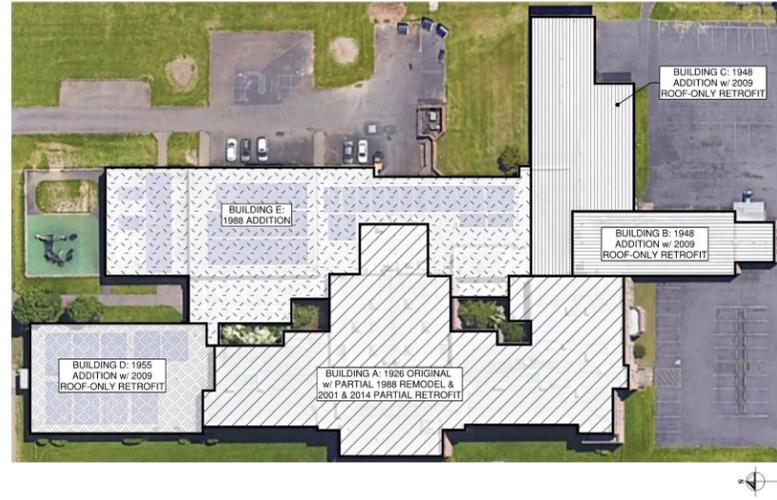
Building Part (See Diagram Above)	Year Built	URM (SF)	ROM URM Only Retrofit	ROM Total Retrofit	No. of Stories	Basement	Penthouse	Drawings Referenced	Structural Horizontal Gravity System(s)	Structural Vertical Gravity System(s)	Lateral System (ASCE Designation)	Lateral System (Description)	Likely Deficiencies	Deficiency Notes	Additional Notes
Bldg. A	1926	0	\$0	\$12,400,000	2	Crawlspace	No	Approximately Complete Original Documents	Concrete 1-way Slab, Concrete Pan-Joists, Steel Truss, Concrete Beams	Concrete Columns, Conc. CIP Walls	C2	Concrete Shear Walls (Stiff Diaphragms)	Inadequate Foundation Ties Severe Vertical Element Size Discontinuity (<50%) Torsional Irregularity Masonry Partition Walls URM Parapets exceed 1.5:1 Concrete Parapets exceed 2.5:1 Heavy Cladding System Deep Spandrels/Narrow Piers (50%, interfering walls) Inadequate In-Plane Shear Under-Reinforced Walls Under-Reinforced Flat Slabs No Diaphragm-Wall Connection Inadequate Wall-Foundation Connection Deflection Compatibility	Footings req'd below '01 shear walls No shear walls at north end Local areas braced in '01 & '09 Thin slabs	1988 - Local areas renovated 2001 - partial seismic upgrade 2014 - partial bracing upgrade

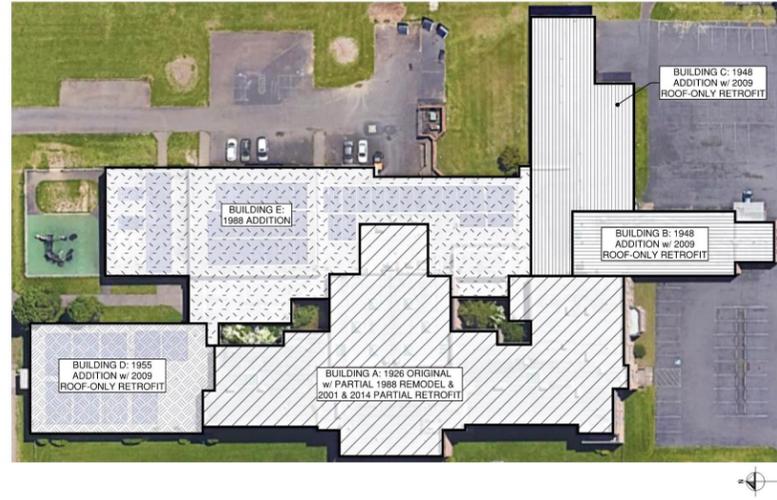
Building Part (See Diagram Above)	Year Built	URM (SF)	ROM URM Only Retrofit	ROM Total Retrofit	No. of Stories	Basement	Penthouse	Drawings Referenced	Structural Horizontal Gravity System(s)	Structural Vertical Gravity System(s)	Lateral System (ASCE Designation)	Lateral System (Description)	Likely Deficiencies	Deficiency Notes	Additional Notes
Bldg. E	1988	0	\$0	\$3,330,000	1	None	No	Approximately Complete Original Documents	Steel Sheet Deck, Steel Joists, Steel Beams	Reinforced CMU Walls, Concrete Columns	RM1	Reinforced Masonry Bearing Walls (Flexible Diaphragms)	Inadequate Wall Anchorage Split Levels Seismic Separation (< 1%) Walls Spaced Far Apart Inadequate In-Plane Shear Under-Reinforced Walls Discontinuous Cross Ties	Adjacent to A, C, D

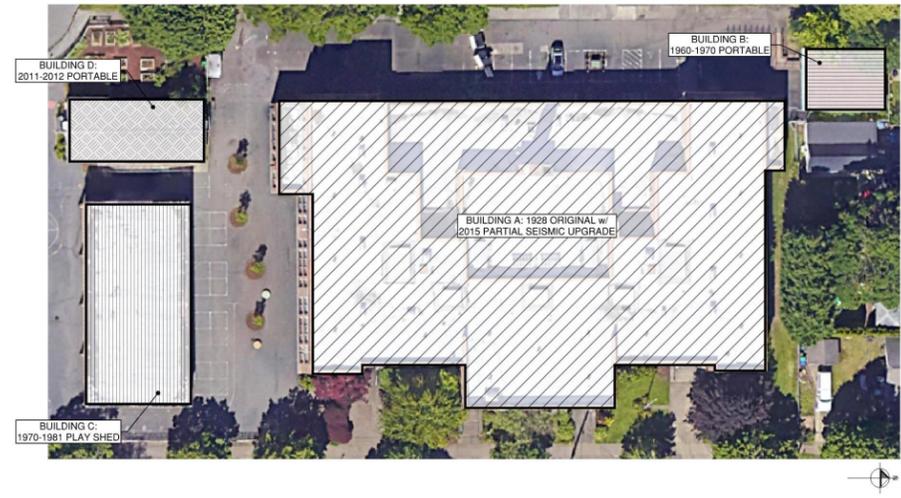
Building Part (See Diagram Above)	Year Built	URM (SF)	ROM URM Only Retrofit	ROM Total Retrofit	No. of Stories	Basement	Penthouse	Drawings Referenced	Structural Horizontal Gravity System(s)	Structural Vertical Gravity System(s)	Lateral System (ASCE Designation)	Lateral System (Description)	Likely Deficiencies	Deficiency Notes	Additional Notes
Bldg. A	1928	0	\$0	\$12,550,000	2	Crawlspace	No	Approximately Complete Original Documents	Concrete 1-way Slab, Concrete Pan-Joists, Steel Beams, Steel Truss	Concrete Columns, Conc. CIP Walls, Steel Columns	C2	Concrete Shear Walls (Stiff Diaphragms)	Inadequate Foundation Ties Reentrant Corners Concrete Parapets exceed 2.5:1 URM Chimneys Heavy Cladding System Deep Spandrels/Narrow Piers (50%, interfering walls) Inadequate In-Plane Shear Under-Reinforced Walls Under-Reinforced Flat Slabs No Diaphragm-Wall Connection Inadequate Wall-Foundation Connection Diaphragm Reinforcement at Openings	Thin slab	1977 - cafeteria floor raised 2015 - local bracing upgrades (structural drawings not available)
