# 2024 PPS Seismic Assessments: All Schools

Version 1.1  
June 03, 2025

Submitted to:  
Portland Public Schools  
501 N. Dixon Street  
Portland, OR 97227

Submitted by:  
Holmes US  
555 SE MLK Jr. Blvd  
Portland, OR 97214

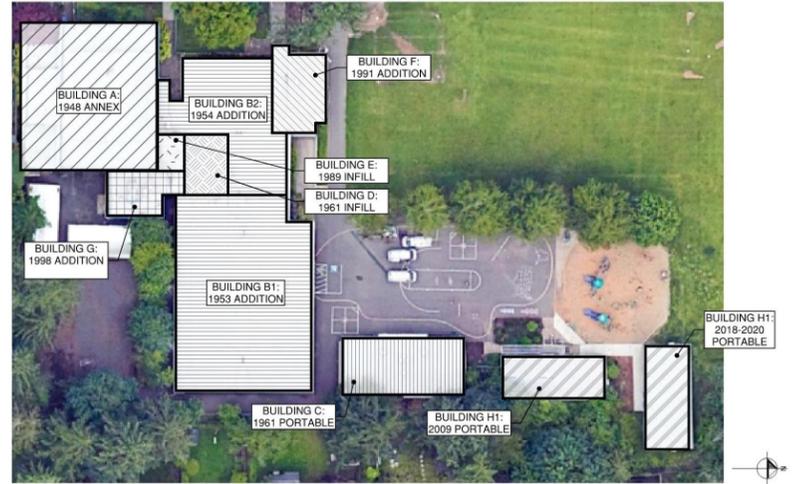
Building Part (See Diagram Above)	Year Built	URM (SF)	ROM URM Only Retrofit	ROM Total Retrofit	No. of Stories	Basement	Penthouse	Drawings Referenced	Structural Horizontal Gravity System(s)	Structural Vertical Gravity System(s)	Lateral System (ASCE Designation)	Lateral System (Description)	Likely Deficiencies	Deficiency Notes	Additional Notes
Bldg. D	1961	0	\$0	\$110,000	1	None	No	Approximately Complete Original Documents	Wood Plywood/OSB, Wood Joists	Wood Framed Walls	W2	Wood Frames (Commercial and Industrial Buildings)	Inadequate In-Plane Shear Narrow Wood Shear Walls No Wood Post-Foundation Connections Inadequate Wood Sill-Foundation Connections (6 ft) Roof Chord Discontinuity		2015 roof-only seismic upgrade reported
Bldg. E	1989	0	\$0	\$120,000	2	None	Yes	Approximately Complete Original Documents	0	0	W2	Wood Frames (Commercial and Industrial Buildings)	Seismic Separation (< 1%) Inadequate In-Plane Shear Roof Chord Discontinuity	Inadequate tie-back	2015 roof-only seismic upgrade reported

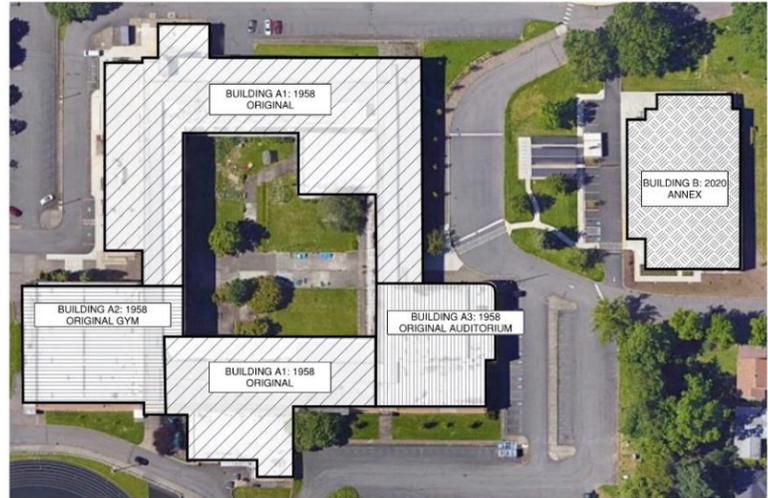
Building Part (See Diagram Above)	Year Built	URM (SF)	ROM URM Only Retrofit	ROM Total Retrofit	No. of Stories	Basement	Penthouse	Drawings Referenced	Structural Horizontal Gravity System(s)	Structural Vertical Gravity System(s)	Lateral System (ASCE Designation)	Lateral System (Description)	Likely Deficiencies	Deficiency Notes	Additional Notes
Bldg. A1	1958	0	\$0	\$35,800,000	3	Partial	No	Approximately Complete Original Documents	Concrete 1-way Slab, Concrete Beams, Concrete over Metal Deck, Steel Joists	Concrete Columns, Conc. CIP Walls	C1, C2	Concrete Moment Frames, Concrete Shear Walls (Stiff Diaphragms)	Sloping Site (full story difference across site) Inadequate Foundation Ties Severe Vertical Element Size Discontinuity (<50%) Reentrant Corners Torsional Irregularity Seismic Separation (< 1%) Masonry Partition Walls URM Chimneys Heavy Cladding System Inadequate Column Capacity Inadequate Column Shear Capacity Strong Column - Weak Beam Issue Shear Controlled Frame Members Inadequate Column-Bar Splices (35db, tied) Inadequate Column Ties (d/4, 8db at hinges) Discontinuous Beam Bars Inadequate Beam-Bar Splices (none in 1/4) Inadequate Beam Stirrups (d/2, 8db at hinges) Inadequate Joint Ties (8db) Deflection Incompatibility	Dowels do not continue to foundation base Concrete walls on west end of building start at the first floor Shear walls not regularly spaced, e.g. in sector A 2" expansion joints typical structural support added in 1997. Check adequacy. Brick veneer. Check required Check required. Tie spacing is roughly the depth of the column Check required Check required	Original Classroom portions (sectors A,C,D,&E per plans). Up to three stories tall. Non-ductile concrete detailing. Floors & roof are typically concrete slab supported by concrete beams. Reading room, shop classes & kitchen area are single story portions with concrete over metal deck roof supported on long span steel trusses.

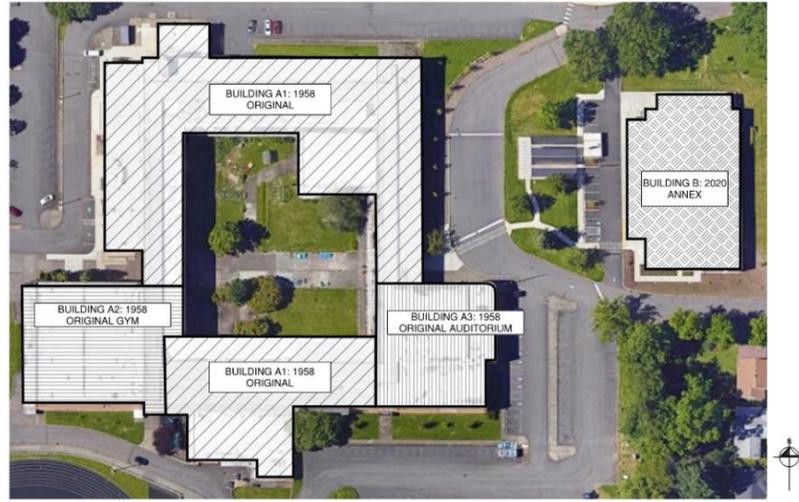
Building Part (See Diagram Above)	Year Built	URM (SF)	ROM URM Only Retrofit	ROM Total Retrofit	No. of Stories	Basement	Penthouse	Drawings Referenced	Structural Horizontal Gravity System(s)	Structural Vertical Gravity System(s)	Lateral System (ASCE Designation)	Lateral System (Description)	Likely Deficiencies	Deficiency Notes	Additional Notes
Bldg. B	2020	0	\$0	\$0	1	None	No	None	Unknown	Unknown	Unknown				2020 Annex Building. No structural or architectural information was provided, but it is a benchmark building.

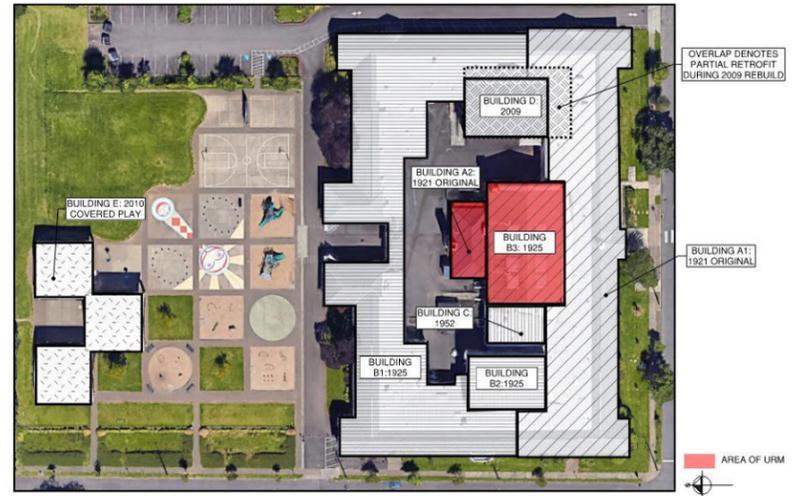
Building Part (See Diagram Above)	Year Built	URM (SF)	ROM URM Only Retrofit	ROM Total Retrofit	No. of Stories	Basement	Penthouse	Drawings Referenced	Structural Horizontal Gravity System(s)	Structural Vertical Gravity System(s)	Lateral System (ASCE Designation)	Lateral System (Description)	Likely Deficiencies	Deficiency Notes	Additional Notes
Bldg. A1	1921	N/A	N/A	N/A	1	Crawlspace	No	Approximately Complete Original Documents	Wood Joists, Wood Plywood/OSB	Wood Framed Walls	W2	Wood Frames (Commercial and Industrial Buildings)	Currently being addressed with seismic retrofit		
Bldg. A2	1921	N/A	N/A	N/A	1	1	No	Approximately Complete Original Documents	Wood Joists	Unreinforced Brick Walls	URM	Unreinforced Masonry Bearing Walls (Flexible Diaphragms)	Currently being addressed with seismic retrofit		
Bldg B1	1925	N/A	N/A	N/A	1	Crawlspace	No	Approximately Complete Original Documents	Wood Joists, Wood Plywood/OSB	Wood Framed Walls	W2	Wood Frames (Commercial and Industrial Buildings)	Currently being addressed with seismic retrofit

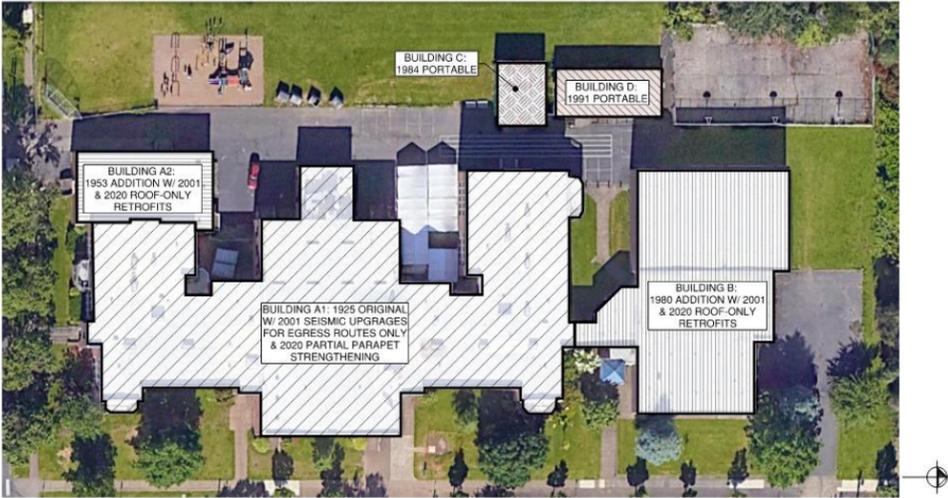
Building Part (See Diagram Above)	Year Built	URM (SF)	ROM URM Only Retrofit	ROM Total Retrofit	No. of Stories	Basement	Penthouse	Drawings Referenced	Structural Horizontal Gravity System(s)	Structural Vertical Gravity System(s)	Lateral System (ASCE Designation)	Lateral System (Description)	Likely Deficiencies	Deficiency Notes	Additional Notes
Bldg. A1	1925	0	\$0	\$8,000,000	1	Partial, Crawlspace	No	Approximately Complete Original Documents	Concrete Pan-Joists, Concrete Beams, Steel Joists, Steel Truss	Conc. CIP Walls, Concrete Columns	C2	Concrete Shear Walls (Stiff Diaphragms)	Inadequate Wall Anchorage Moderate Vertical Element Size Discontinuity (50-75%) Split Levels Reentrant Corners Masonry Diaphragm Seismic Separation (< 1%) Masonry Partition Walls Masonry ceiling URM Parapets exceed 1.5:1 Heavy Cladding System Other observed nonstructural falling hazard Inadequate In-Plane Shear Under-Reinforced Walls Under-Reinforced Flat Slabs No Diaphragm-Wall Connection Inadequate Wall-Foundation Connection Deflection Compatibility	Check anchorage of steel trusses and "I"-joists East wall of classroom 205 and 217 do not continue to foundation Section D-D and E-E on pg 16 indicate tile used in ceiling No gap Section D-D and E-E on pg 16 indicate tile used in ceiling Parapet bracing over stairs #2 & #3 exits only (circa 2001) & bracing around boiler room added in 2020 Brick veneer E.g., cast stone parapets & Plaster ceilings hung from trusses Few continuous walls around classrooms Walls appear to be typically unreinforced Check adequacy of connections to slabs & steel members Walls appear to be typically unreinforced	1925 Original Structure - Jones School. Two-story structure with classrooms, auditorium and gyms (boys & girls). Roof and floors typically pan joist system with topping slab. Auditorium and gyms have 2" conc. slab supported by steel I-joists and steel trusses. Some seismic upgrades in 2001 - mostly along egress routes, included installation of strong backs along stairways and parapet bracing over stairs #2 & #3 exits. Also, strong backs installed at masonry wall adjacent to 1953 addition and chimney height was reduced. Further parapet and chimney bracing added in 2020

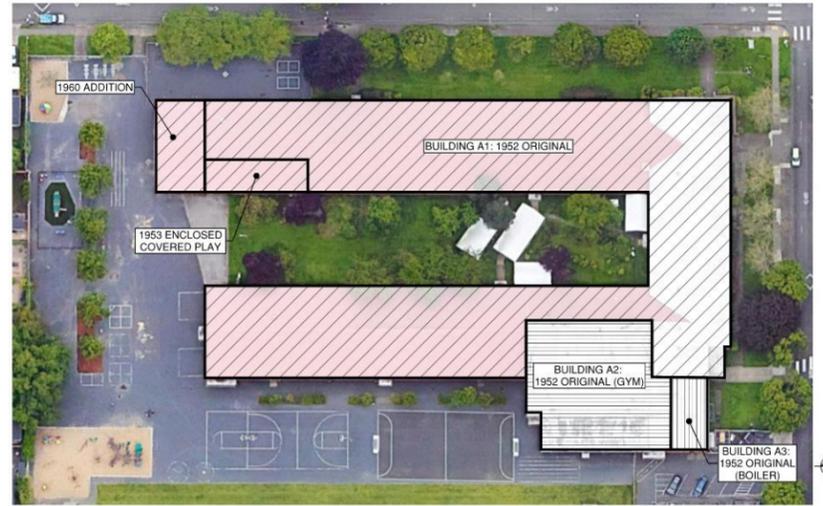
Building Part (See Diagram Above)	Year Built	URM (SF)	ROM URM Only Retrofit	ROM Total Retrofit	No. of Stories	Basement	Penthouse	Drawings Referenced	Structural Horizontal Gravity System(s)	Structural Vertical Gravity System(s)	Lateral System (ASCE Designation)	Lateral System (Description)	Likely Deficiencies	Deficiency Notes	Additional Notes
Bldg. A1	1952, 1960	0	\$0	\$5,250,000	1	None	No	Approximately Complete Original Documents	Wood Straight/Diag Sheathing, Wood Beams, Wood Joists	Wood Framed Walls	W2, C2	Wood Frames (Commercial and Industrial Buildings), Concrete Shear Walls (Stiff Diaphragms)	Split Levels Reentrant Corners Misc. Plan Irregularity Seismic Separation (< 1%) Heavy Cladding System Inadequate In-Plane Shear Inadequate Wood Sill-Foundation Connections (6 ft) Roof Chord Discontinuity Straight Sheathing (2:1, 24')	At gym & boiler room U-shaped building Deformation incompatibility concrete walls of boiler room & adjacent structure No gap between building portions Brick veneer Check walls between classrooms (See detail 46)	Original Structure - U-shaped building. Classrooms are timber framed with trussed rafter roof. Cafeteria is timber framed with glum-lam beam roof. Alterations to the west end of the north wing include enclosing the covered play to make 3 new classrooms in 1953 and adding toilets and two new classrooms in 1960. Construction materials and detailing matches original construction.

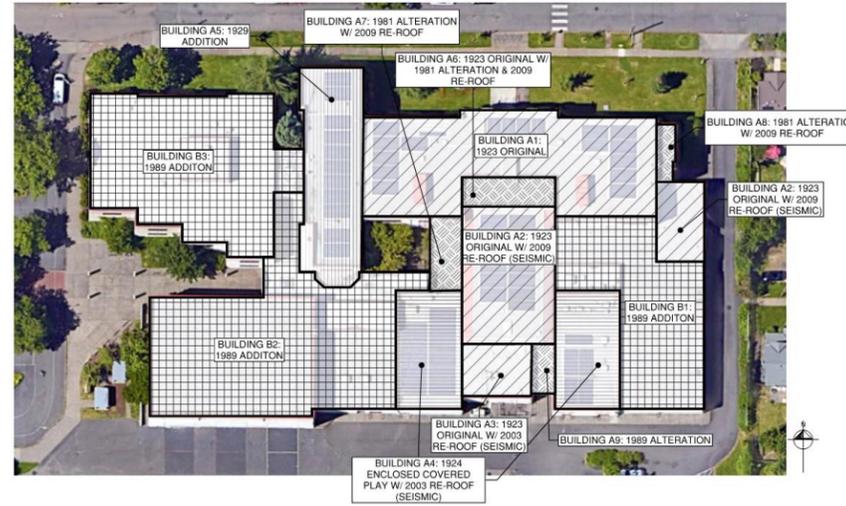
Building Part (See Diagram Above)	Year Built	URM (SF)	ROM URM Only Retrofit	ROM Total Retrofit	No. of Stories	Basement	Penthouse	Drawings Referenced	Structural Horizontal Gravity System(s)	Structural Vertical Gravity System(s)	Lateral System (ASCE Designation)	Lateral System (Description)	Likely Deficiencies	Deficiency Notes	Additional Notes
Bldg. A1	1923	0	\$0	\$5,467,500	2	None	No	Approximately Complete Original Documents	Concrete 1-way Slab, Concrete Beams, Concrete Pan-Joists, Wood Plywood/OSB, Wood Trusses, Wood Beams	Conc. CIP Walls, Concrete Columns	C2	Concrete Shear Walls (Stiff Diaphragms)	Inadequate Wall Anchorage Split Levels Reentrant Corners Seismic Separation (< 1%) Masonry Partition Walls Concrete Parapets exceed 2.5:1 Heavy Cladding System URM Appendages over Exitway Under-Reinforced Walls Under-Reinforced Flat Slabs No Diaphragm-Wall Connection Inadequate Wall-Foundation Connection	Minimal reinforcing dowels from concrete diaphragms to walls To Auditorium No separation to adjacent building portions Clay tile partitions between classrooms & clay tile furring on interior walls Parapets are ~5' tall and likely unreinforced Brick veneer at entrance Wall reinforcing unknown (if any).	Original structure - non-ductile concrete. Includes classrooms (RC slab roof, pan joist 2nd level), assembly hall w/ stage (wood trusses), & boiler room (wood beam). Classrooms, 2009 reroof w/ no seismic upgrades.

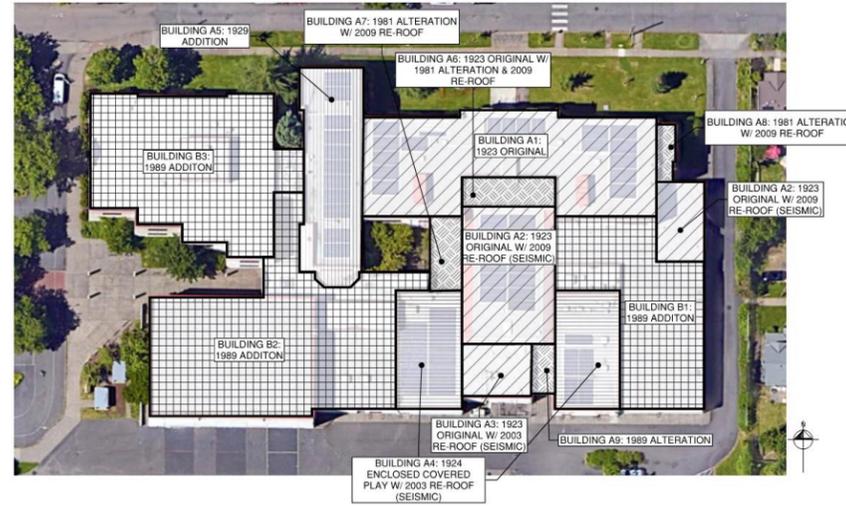
Building Part (See Diagram Above)	Year Built	URM (SF)	ROM URM Only Retrofit	ROM Total Retrofit	No. of Stories	Basement	Penthouse	Drawings Referenced	Structural Horizontal Gravity System(s)	Structural Vertical Gravity System(s)	Lateral System (ASCE Designation)	Lateral System (Description)	Likely Deficiencies	Deficiency Notes	Additional Notes
Bldg. A5	1929	0	\$0	\$3,275,000	2	Partial	No	Approximately Complete Original Documents	Concrete Pan-Joists	Conc. CIP Walls, Concrete Columns	C1, C2	Concrete Moment Frames, Concrete Shear Walls (Stiff Diaphragms)	Inadequate Wall Anchorage Seismic Separation (< 1%) Masonry Partition Walls Concrete Parapets exceed 2.5:1 Heavy Cladding System Under-Reinforced Walls No Diaphragm-Wall Connection Inadequate Wall-Foundation Connection Inadequate Column Shear Capacity Interfering Concrete and Masonry Walls Inadequate Column-Bar Splices (35db, tied) Inadequate Column Ties (d/4, 8db at hinges) Discontinuous Beam Bars Inadequate Beam-Bar Splices (none in 1/4) Inadequate Beam Stirrups (d/2, 8db at hinges) Inadequate Joint Ties (8db)	Minimal reinforcing dowels from concrete diaphragms to walls ap 1" @ 2nd floor & roof (1989 drawings, details 1/510 & 18/58) Several clay tile walls appear to have been removed, uncertain if all have been. Clay tile furring @ wall interior Widely spaced ties (8" o.c. typ) Possibly clay tile partition infill Widely spaced ties (8" o.c. typ), lap splice length unknown Widely spaced ties (8" o.c. typ) Top bars bend - not continuous Splices @ columns	1929 Original Structure. Appears to be C1 in short direction (E/W) and RC shear walls in long direction (N/S). Central staircase removed in 1989 Addition/remodel - (N) floor is metal deck w/ concrete topping.

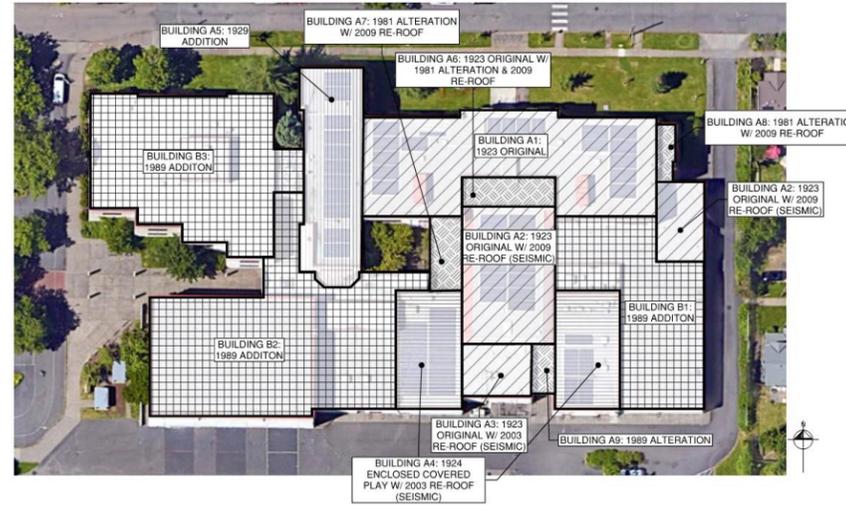
Building Part (See Diagram Above)	Year Built	URM (SF)	ROM URM Only Retrofit	ROM Total Retrofit	No. of Stories	Basement	Penthouse	Drawings Referenced	Structural Horizontal Gravity System(s)	Structural Vertical Gravity System(s)	Lateral System (ASCE Designation)	Lateral System (Description)	Likely Deficiencies	Deficiency Notes	Additional Notes
Bldg. B3	1989	0	\$0	\$3,403,500	2	None	Yes	Approximately Complete Original Documents	Steel Sheet, Steel Beams, Hollow-Core Floor, Pre-Cast Concrete Beams	Conc. CIP Walls, Reinforced CMU Walls, Pre-Cast Concrete Columns	PC2, RM1, S2a	Precast Concrete Frames with Shear Walls, Reinforced Masonry Bearing Walls (Flexible Diaphragms), Steel Braced Frames (Flexible Diaphragms)	Inadequate Wall Anchorage Split Levels Seismic Separation (< 1%) Walls Spaced Far Apart No Girder-Column Connections Inadequate precast connection capacity Deflection incompatibility Eccentrically Braced Frames Inadequate brace connections	Diaphragm positively attached to CMU walls, connection capacity to be confirmed At roof 1" gap @ 2nd floor & roof (1989 drawings, details 1/S10 & 18/S8) Connection capacity should be checked Check deformation compatibility between precast elements and of stairs One side of X-brace does not align with a column. Check beam capacity.	1989 addition of classrooms on the northwest corner of the building. First floor is precast concrete frames with CMU shear walls and hollow core flooring. 2nd floor is steel framing with CMU shear walls and metal deck roofing. Penthouse is steel framing with braced frames and metal deck roofing.

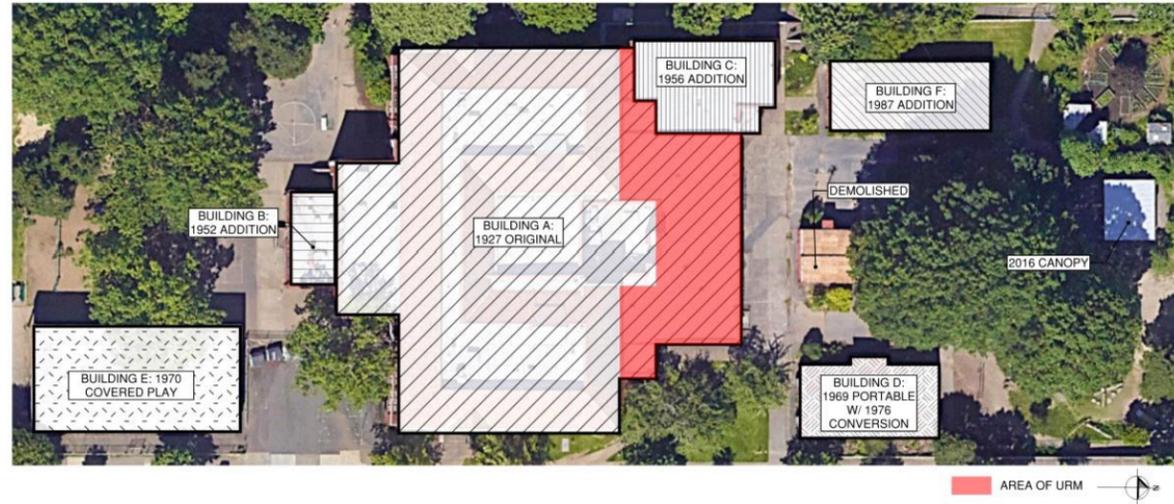
Building Part (See Diagram Above)	Year Built	URM (SF)	ROM URM Only Retrofit	ROM Total Retrofit	No. of Stories	Basement	Penthouse	Drawings Referenced	Structural Horizontal Gravity System(s)	Structural Vertical Gravity System(s)	Lateral System (ASCE Designation)	Lateral System (Description)	Likely Deficiencies	Deficiency Notes	Additional Notes
Bldg. A	1927	6500	\$2,600,000	\$17,500,000	2	Daylight, Partial	No	Approximately Complete Original Documents	Concrete Pan-Joists, Steel Truss, Steel Beams	Reinforced Concrete Walls, Unreinforced Brick Walls	C2	Concrete Shear Walls (Stiff Diaphragms)	Inadequate Foundation Ties Mass Discontinuity Deep Spandrels/Narrow Piers (50%, interfering walls) Under-Reinforced Walls Under-Reinforced Flat Slabs Inadequate Wall-Foundation Connection Masonry Partition Walls Concrete Parapets exceed 2.5:1 Heavy Cladding System URM Appendages over Exit way	U-shaped level 2  Hollow clay tile walls throughout Brick veneer	URM at gym and north exterior walls at entries. Slender steel gravity columns in URM at gym, but likely deficient for gravity loads alone.

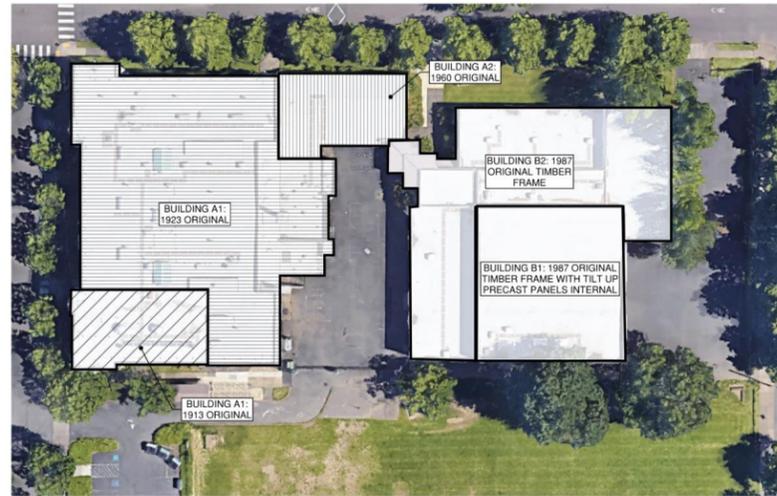
Building Part (See Diagram Above)	Year Built	URM (SF)	ROM URM Only Retrofit	ROM Total Retrofit	No. of Stories	Basement	Penthouse	Drawings Referenced	Structural Horizontal Gravity System(s)	Structural Vertical Gravity System(s)	Lateral System (ASCE Designation)	Lateral System (Description)	Likely Deficiencies	Deficiency Notes	Additional Notes
Bldg. A1	1913 & 1927	0	\$0	\$16,550,000	3	Partial, Crawlspace	No	Approximately Complete Original Documents	Steel Truss, Concrete 1-way Slab, Concrete Beams	Conc. CIP Walls	C2	Concrete Shear Walls (Stiff Diaphragms)	Inadequate Foundation Ties Split Levels Reentrant Corners Seismic Separation (< 1%) Masonry Partition Walls Inadequate In-Plane Shear Under-Reinforced Walls Under-Reinforced Flat Slabs Deflection Compatibility	Buildings Interconnected Original tile portion walls shown on plan Floor slab reinforcing not continuous Interconnected buildings	Built in stages, first stage in 1913 and second stage in 1923. Various architectural upgrades completed. Interconnected with building A2

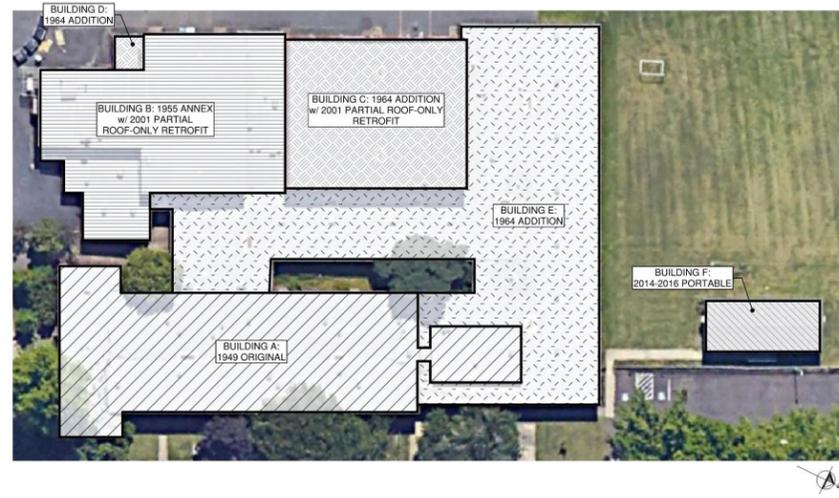
Building Part (See Diagram Above)	Year Built	URM (SF)	ROM URM Only Retrofit	ROM Total Retrofit	No. of Stories	Basement	Penthouse	Drawings Referenced	Structural Horizontal Gravity System(s)	Structural Vertical Gravity System(s)	Lateral System (ASCE Designation)	Lateral System (Description)	Likely Deficiencies	Deficiency Notes	Additional Notes
Bldg. E	1964	0	\$0	\$2,590,000	1	None	No	Approximately Complete Original Documents	Wood Plywood/OSB, Wood Trusses, Wood Joists	Wood Framed Walls	W2	Wood Frames (Commercial and Industrial Buildings)	Near-fault location (250ft, DOGAMI Active Faults) Reentrant Corners Seismic Separation (< 1%) Inadequate In-Plane Shear Plaster or Gypsum Shear Walls Large Unbraced Openings Roof Chord Discontinuity Unblocked Diaphragms (4:1, 40')	Adjacent to parts B & C	
Bldg. F	2014	0	\$0	\$0	1	Crawlspace	No	None	Wood Plywood/OSB, Wood Joists, Wood Beams	Wood Framed Walls	W2	Wood Frames (Commercial and Industrial Buildings)			Appears to be a benchmark building

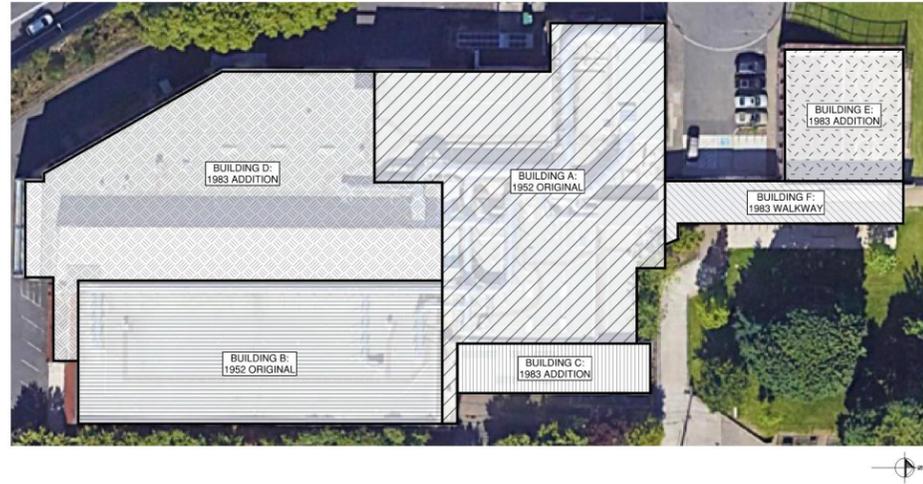
Building Part (See Diagram Above)	Year Built	URM (SF)	ROM URM Only Retrofit	ROM Total Retrofit	No. of Stories	Basement	Penthouse	Drawings Referenced	Structural Horizontal Gravity System(s)	Structural Vertical Gravity System(s)	Lateral System (ASCE Designation)	Lateral System (Description)	Likely Deficiencies	Deficiency Notes	Additional Notes
Bldg. A	1952	0	\$0	\$2,955,000	1	None	No	Approximately Complete Original Documents	Wood Straight/Diag Sheathing, Wood Joists, Wood Beams	Conc. CIP Walls, Steel Columns	C2a	Concrete Shear Walls (Flexible Diaphragms)	Near-fault location (250ft, DOGAMI Active Faults) Inadequate Wall Anchorage Reentrant Corners Heavy Cladding System Deep Spandrels/Narrow Piers (50%, interfering walls) Inadequate In-Plane Shear Under-Reinforced Walls Inadequate Wall-Foundation Connection Discontinuous Cross Ties Diagonal Sheathing (4:1, 40')	Wood ledgers Brick	2019 Partial reroof somewhere on this campus reported by PPS (no drawings available)

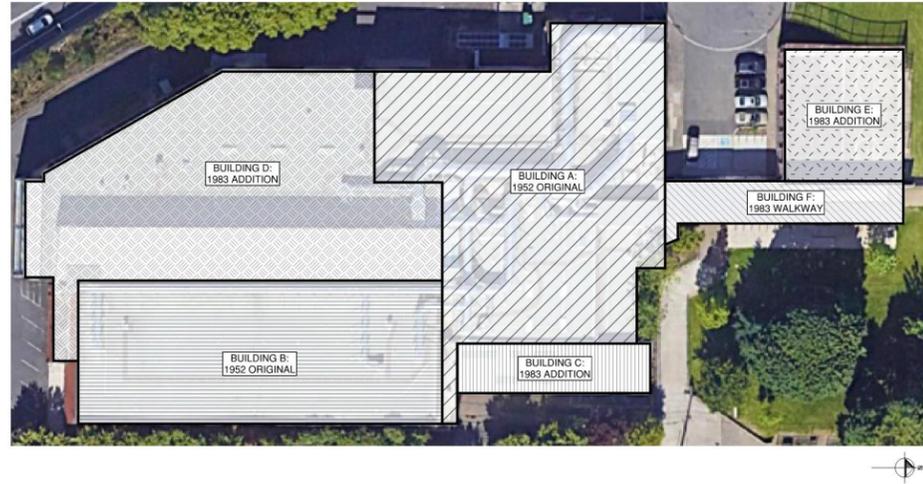
Building Part (See Diagram Above)	Year Built	URM (SF)	ROM URM Only Retrofit	ROM Total Retrofit	No. of Stories	Basement	Penthouse	Drawings Referenced	Structural Horizontal Gravity System(s)	Structural Vertical Gravity System(s)	Lateral System (ASCE Designation)	Lateral System (Description)	Likely Deficiencies	Deficiency Notes	Additional Notes
Bldg. E	1983	0	\$0	\$645,000	1	None	No	Approximately Complete Original Documents	Hollow-Core Floor, Concrete Beams	Conc. CIP Walls	C2	Concrete Shear Walls (Stiff Diaphragms)	Sloping Site (full story difference across site) Near-fault location (250ft, DOGAMI Active Faults) Inadequate Wall Anchorage Under-Reinforced Walls Under-Reinforced Flat Slabs		
Bldg. F	1983	0	\$0	\$375,000	1	None	No	Approximately Complete Original Documents	Steel Truss	Concrete Columns	C2a	Concrete Shear Walls (Flexible Diaphragms)	Seismic Separation (< 1%) Inadequate cross-braces	Inadequate tieback to parts A, E	Laterally supported by building parts A & E

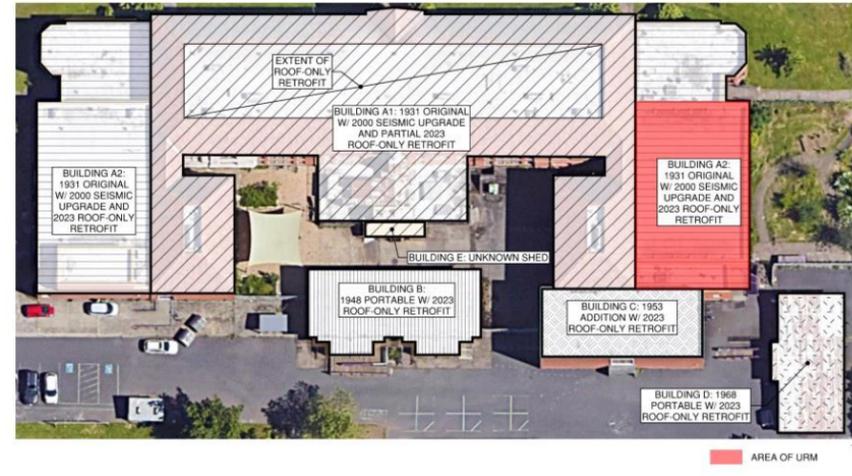
Building Part (See Diagram Above)	Year Built	URM (SF)	ROM URM Only Retrofit	ROM Total Retrofit	No. of Stories	Basement	Penthouse	Drawings Referenced	Structural Horizontal Gravity System(s)	Structural Vertical Gravity System(s)	Lateral System (ASCE Designation)	Lateral System (Description)	Likely Deficiencies	Deficiency Notes	Additional Notes
Bldg. A1	1931	0	\$0	\$2,165,000	2	Daylight	No	Approximately Complete Original Documents	Concrete Beams, Steel Beams, Concrete Pan-Joists, Steel Truss	Reinforced Concrete Walls	C2	Concrete Shear Walls (Stiff Diaphragms)	Sloping Site (full story difference across site) Inadequate Foundation Ties Misc. Load Path Issue Reentrant Corners Exterior beams do not align with columns Under-Reinforced Walls Under-Reinforced Flat Slabs Inadequate Wall-Foundation Connection Masonry Partition Walls Heavy Cladding System	Slope at front of school Concrete pan-joists have thin diaphragms Shotcrete overlays provided in 2000 to mitigate this Reinf at concrete walls continue to wall footings but are not developed Hollow Clay Tile (some cavity walls) assumed to be mostly removed in 2000 Brick veneer
