# 2024 PPS Seismic Assessments: All Schools

Version 1.1  
June 03, 2025

Submitted to:  
Portland Public Schools  
501 N. Dixon Street  
Portland, OR 97227

Submitted by:  
Holmes US  
555 SE MLK Jr. Blvd  
Portland, OR 97214

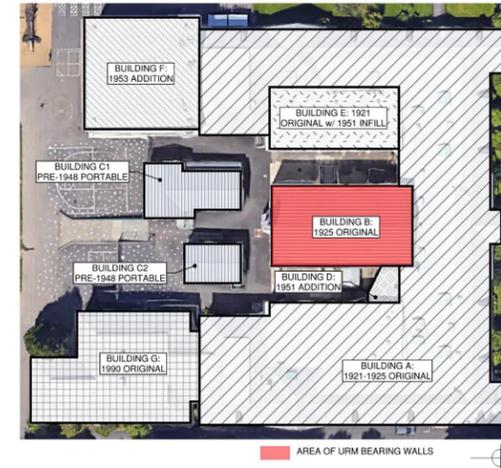
Building Part (See Diagram Above)	Year Built	URM (SF)	ROM URM Only Retrofit	ROM Total Retrofit	No. of Stories	Basement	Penthouse	Drawings Referenced	Structural Horizontal Gravity System(s)	Structural Vertical Gravity System(s)	Lateral System (ASCE Designation)	Lateral System (Description)	Likely Deficiencies	Deficiency Notes	Additional Notes
Bldg. A	1921	0	\$0	\$3,340,000	1	Crawlspace	No	Approximately Complete Original Documents	Wood Battens, Wood Joists, Wood Beams, Wood Straight/Diag Sheathing	Wood Framed Walls, Timber Frame	W2	Wood Frames (Commercial and Industrial Buildings)	Inadequate Foundation Ties Severe Vertical Element Size Discontinuity (<50%) Reentrant Corners Inadequate In-Plane Shear Large Unbraced Openings No Wood Post-Foundation Connections No Girder-Column Connections Roof Chord Discontinuity	Verify scope of retrofit sufficient Verify scope of retrofit sufficient Verify scope of retrofit sufficient	Constructed in 1921 & 1925 Partial SRGP retrofit in 2013

Bldg. B	1925	7000	\$350,000	\$350,000	1	Partial	No	Approximately Complete Original Documents	Wood T+G Plank, Wood Joists, Wood Trusses, Wood Straight/Diag Sheathing, Concrete 1-way Slab, Concrete Beams	Concrete Columns, Unreinforced Brick Walls, Timber Frame	URM, C2a	Unreinforced Masonry Bearing Walls (Flexible Diaphragms), Concrete Shear Walls (Flexible Diaphragms)	Inadequate Foundation Ties	Further analysis required to confirm if adequate	Partial seismic retrofit in 2013
Bldg. C1	1930	0	\$0	\$135,000	1	Crawlspace	No	None	Wood Straight/Diag Sheathing, Wood Trusses, Wood Joists, Wood Beams	Wood Framed Walls	W2	Wood Frames (Commercial and Industrial Buildings)	Sloping Site (full story difference across site) Inadequate Foundation Ties Reentrant Corners Inadequate In-Plane Shear Plaster or Gypsum Shear Walls Narrow Wood Shear Walls No Floor-to-Floor Connections (Shear and OT) Inadequate Wood Sill-Foundation Connections (6 ft) Roof Chord Discontinuity Straight Sheathing (2:1, 24')

Bldg. C2	1930	0	\$0	\$67,500	1	Crawlspace	No	None	Wood Straight/Diag Sheathing, Wood Trusses, Wood Joists, Wood Beams	Wood Framed Walls	W2	Wood Frames (Commercial and Industrial Buildings)	Inadequate Foundation Ties Inadequate In-Plane Shear Plaster or Gypsum Shear Walls Narrow Wood Shear Walls No Floor-to-Floor Connections (Shear and OT) Inadequate Wood Sill-Foundation Connections (6 ft) Roof Chord Discontinuity Straight Sheathing (2:1, 24')		
Bldg. D	1951	0	\$0	\$50,000	1	Crawlspace	No	Approximately Complete Original Documents	Wood Straight/Diag Sheathing, Wood Joists, Wood Beams	Wood Framed Walls	W2	Wood Frames (Commercial and Industrial Buildings)	Inadequate Foundation Ties Seismic Separation (< 1%) Inadequate In-Plane Shear Large Unbraced Openings No Floor-to-Floor Connections (Shear and OT) Inadequate Wood Sill-Foundation Connections (6 ft) Roof Chord Discontinuity Straight Sheathing (2:1, 24')	Inadequate ties to parts A, B

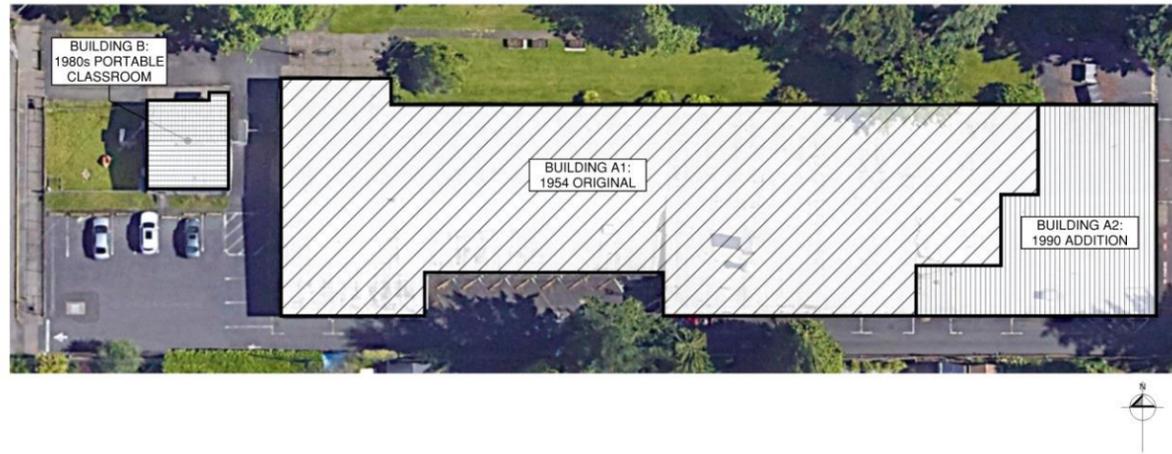
Building Part (See Diagram Above)	Year Built	URM (SF)	ROM URM Only Retrofit	ROM Total Retrofit	No. of Stories	Basement	Penthouse	Drawings Referenced	Structural Horizontal Gravity System(s)	Structural Vertical Gravity System(s)	Lateral System (ASCE Designation)	Lateral System (Description)	Likely Deficiencies	Deficiency Notes	Additional Notes
Bldg. A1	1954	0	\$0	\$1,871,000	1	None	No	Approximately Complete Original Documents	Wood Straight/Diag Sheathing, Wood Beams	Wood Framed Walls	W2	Wood Frames (Commercial and Industrial Buildings)	URM Chimneys Inadequate In-Plane Shear Roof Chord Discontinuity Straight Sheathing (2:1, 24') 1" sheathing		Original structure.
Bldg. A2	1990	0	\$0	\$402,000	1	None	No	Approximately Complete Original Documents	Wood Plywood/OSB, Wood Truss-Joists, Wood Joists	Wood Framed Walls	W2	Wood Frames (Commercial and Industrial Buildings)	Inadequate In-Plane Shear Roof Chord Discontinuity		Addition on east end of building

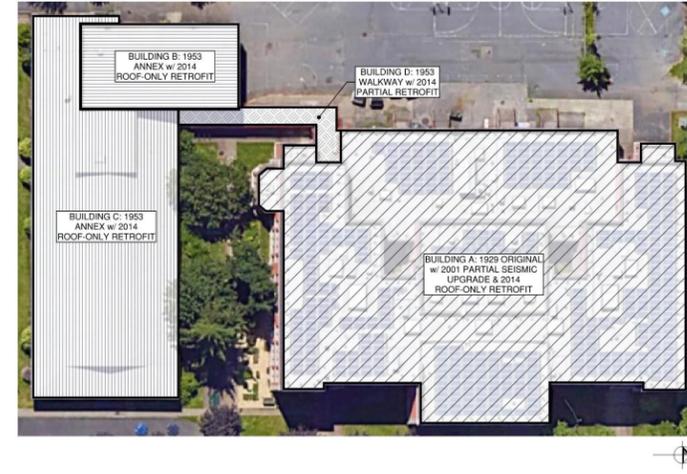
Building Part (See Diagram Above)	Year Built	URM (SF)	ROM URM Only Retrofit	ROM Total Retrofit	No. of Stories	Basement	Penthouse	Drawings Referenced	Structural Horizontal Gravity System(s)	Structural Vertical Gravity System(s)	Lateral System (ASCE Designation)	Lateral System (Description)	Likely Deficiencies	Deficiency Notes	Additional Notes
Bldg. A	1929	0	\$0	\$11,025,000	2	Crawlspace	No	Approximately Complete Original Documents	Concrete 1-way Slab, Concrete Beams, Steel Truss	Conc. CIP Walls, Concrete Columns, Unreinforced Brick Walls	C2	Concrete Shear Walls (Stiff Diaphragms)	Inadequate Foundation Ties Reentrant Corners Masonry Partition Walls URM Chimneys Heavy Cladding System Inadequate In-Plane Shear Under-Reinforced Walls Under-Reinforced Flat Slabs No Diaphragm-Wall Connection Inadequate Wall-Foundation Connection Deflection Compatibility URM bearing walls	Partially braced in 2001 and 2014  Thin slabs Only roof upgraded in 2014  At West oriels/frmr conservatories	2001 - partial seismic bracing upgrade 2014 - roof-only seismic upgrade

Bldg. B	1953	0	\$0	\$315,000	1	None	No	Insufficient Original Documents	Wood T+G Plank, Steel Joists	Conc. CIP Walls	C2a	Concrete Shear Walls (Flexible Diaphragms)	Heavy Cladding System Under-Reinforced Walls Inadequate Wall-Foundation Connection	Incl. glass block	2014 - roof-only seismic upgrade
Bldg. C	1953	0	\$0	\$945,000	1	None	Yes	Insufficient Original Documents	Wood Straight/Diag Sheathing, Wood Trusses	Wood Framed Walls	W2	Wood Frames (Commercial and Industrial Buildings)	Split Levels Reentrant Corners Non-redundant (< 2 bays in < 2 lines) Heavy Cladding System Inadequate In-Plane Shear Plaster or Gypsum Shear Walls Large Unbraced Openings No Floor-to-Floor Connections (Shear and OT) Inadequate Wood Sill-Foundation Connections (6 ft)	Only roof upgraded in 2014	2014 - roof-only seismic upgrade
Bldg. D	1953	0	\$0	\$70,000	1	None	Yes	Insufficient Original Documents	Wood Straight/Diag Sheathing, Wood Joists	Steel Columns	Non-compliant	Cantilevered Steel Posts	Seismic Separation (< 1%) Inadequate base connection Inadequate foundation	Inadequate tie-back	2014 - partial seismic upgrade

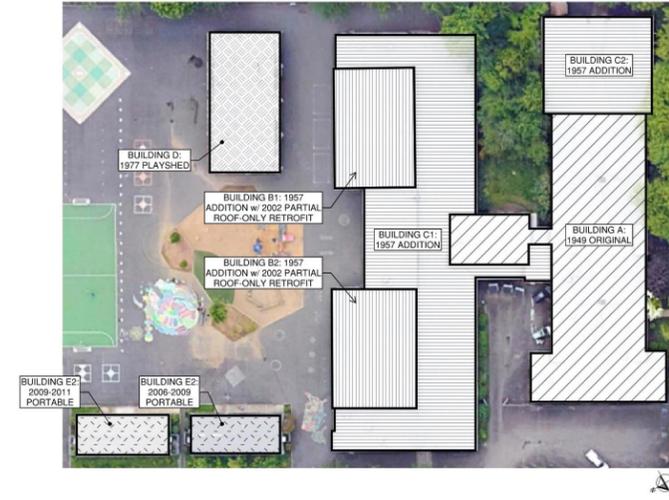
Building Part (See Diagram Above)	Year Built	URM (SF)	ROM URM Only Retrofit	ROM Total Retrofit	No. of Stories	Basement	Penthouse	Drawings Referenced	Structural Horizontal Gravity System(s)	Structural Vertical Gravity System(s)	Lateral System (ASCE Designation)	Lateral System (Description)	Likely Deficiencies	Deficiency Notes	Additional Notes
Bldg. A	1949	0	\$0	\$1,570,000	1	None	No	Insufficient Original Documents	Wood Straight/Diag Sheathing, Wood Joists	Wood Framed Walls	W2	Wood Frames (Commercial and Industrial Buildings)	Near-fault location (250ft, DOGAMI Active Faults) Split Levels Reentrant Corners Non-redundant (< 2 bays in < 2 lines) URM Appendages over Exitway Inadequate In-Plane Shear Plaster or Gypsum Shear Walls Narrow Wood Shear Walls Large Unbraced Openings No Floor-to-Floor Connections (Shear and OT) Inadequate Wood Sill-Foundation Connections (6 ft) Roof Chord Discontinuity Diagonal Sheathing (4:1, 40')	brick at entry

Bldg. B1	1957	0	\$0	\$537,500	1	None	No	Approximately Complete Original Documents	Wood Straight/Diag Sheathing, Wood Joists, Wood Beams	Conc. CIP Walls	C2a	Concrete Shear Walls (Flexible Diaphragms)	Near-fault location (250ft, DOGAMI Active Faults) Inadequate Foundation Ties Inadequate Wall Anchorage Under-Reinforced Walls Inadequate Wall-Foundation Connection Discontinuous Cross Ties Straight Sheathing (2:1, 24')	Keyway Only	2002 partial roof-only seismic upgrade (not re-sheathed)
Bldg. B2	1957	0	\$0	\$562,500	1	None	No	Approximately Complete Original Documents	Wood Straight/Diag Sheathing, Wood Joists, Wood Beams	Conc. CIP Walls	C2a	Concrete Shear Walls (Flexible Diaphragms)	Near-fault location (250ft, DOGAMI Active Faults) Inadequate Foundation Ties Inadequate Wall Anchorage Under-Reinforced Walls Inadequate Wall-Foundation Connection Discontinuous Cross Ties Straight Sheathing (2:1, 24')	Keyway Only	2002 partial roof-only seismic upgrade (not re-sheathed)

Bldg. C1	1957	0	\$0	\$1,690,000	1	None	Yes	Approximately Complete Original Documents	Wood Straight/Diag Sheathing, Wood Joists	Wood Framed Walls	W2	Wood Frames (Commercial and Industrial Buildings)	Near-fault location (250ft, DOGAMI Active Faults) Split Levels Reentrant Corners Masonry Partition Walls Inadequate In-Plane Shear Plaster or Gypsum Shear Walls Large Unbraced Openings No Floor-to-Floor Connections (Shear and OT) Roof Chord Discontinuity Straight Sheathing (2:1, 24')

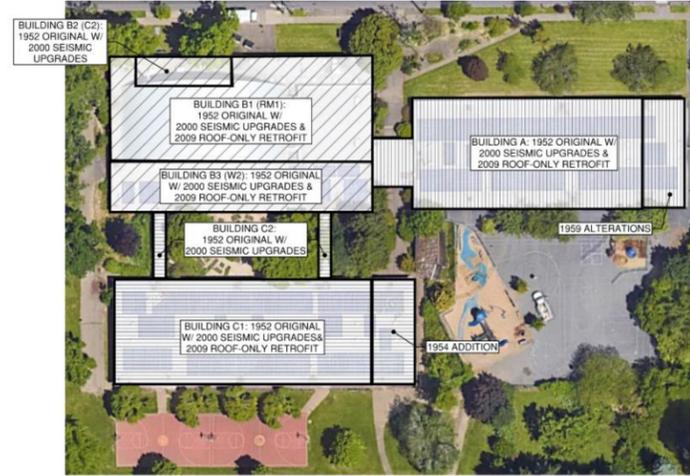
Building Part (See Diagram Above)	Year Built	URM (SF)	ROM URM Only Retrofit	ROM Total Retrofit	No. of Stories	Basement	Penthouse	Drawings Referenced	Structural Horizontal Gravity System(s)	Structural Vertical Gravity System(s)	Lateral System (ASCE Designation)	Lateral System (Description)	Likely Deficiencies	Deficiency Notes	Additional Notes
Bldg. A	1952	0	\$0	\$735,000	1	None	No	Approximately Complete Original Documents	Wood Plywood/OSB, Wood T+G Plank, Wood Joists, Wood Beams	Timber Frame	W2	Wood Frames (Commercial and Industrial Buildings)	Misc. Plan Irregularity Seismic Separation (< 1%) Inadequate In-Plane Shear	Deflection incompatibility with walkway to Building B No gap to Sector B T&G sheathing for walls typical	Alteration in 1959 to enclose covered play area on east end to make classrooms (generally matches original construction). Structural upgrades in 2000 include seismic bracing work at roof eave overhangs and new shear walls in N/S corridors w/ new collectors. Also 2009 Roof-only retrofit.

Bldg. B1	1952	0	\$0	\$1,440,000	1	None	No	Approximately Complete Original Documents	Wood T+G Plank, Wood Trusses, Wood Joists, Wood Beams	Reinforced Brick Walls	RM1	Reinforced Masonry Bearing Walls (Flexible Diaphragms)	Inadequate Wall Anchorage Split Levels Misc. Plan Irregularity Seismic Separation (< 1%) Heavy Cladding System Under-Reinforced Walls No Wall-Foundation Connection	Strongbacks installed at east and west wall exterior in 2000, however no other walls retrofitted Roof has split levels @ gym & cafeteria Concrete roof (Bldg. B2) is immediately adjacent to the flexible diaphragm No gap to walkway to Building A Brick veneer #5@15" o.c. in 12.5" walls = 0.0016 < 0.002 Dowels do not appear to extend fully into foundation	Structural upgrades in 2000 include strong backs @ east and west exterior walls, new shear walls at the ends of the gym roof trusses, and new roof/beam connections. The truss over the gym was strengthened in 2002. 2009 reroof included adding (N) plywood on top of (E) T&G and strengthening in-plane shear transfer between gym roof diaphragm and masonry walls.

Bldg. B2	1952	0	\$0	\$500,000	1	None	No	Approximately Complete Original Documents	Concrete 1-way Slab, Concrete Beams	Conc. CIP Walls	C2	Concrete Shear Walls (Stiff Diaphragms)	Misc. Plan Irregularity Masonry Partition Walls Heavy Cladding System No Diaphragm-Wall Connection Inadequate Wall-Foundation Connection Deflection Compatibility	Concrete roof adjacent to wood T&G roof CMU wall (likely unreinforced) @ toilet near boiler. Brick veneer Unclear from section J-J and schedules on S-4 if roof slab is adequately dowelled to walls Dowels do not appear to extend fully into foundation With adjacent timber framed portion	The 2000 structural upgrades in this area appears to focus on tying in the adjacent flexible diaphragm into the concrete walls.
Bldg. B3	1952	0	\$0	\$320,000	1	None	No	Approximately Complete Original Documents	Wood Plywood/OSB, Wood T+G Plank, Wood Joists, Wood Beams	Timber Frame	W2	Wood Frames (Commercial and Industrial Buildings)	Seismic Separation (< 1%) Heavy Cladding System Inadequate In-Plane Shear	No gap to walkways to Building A or Building C Brick veneer T&G sheathing for walls on southern side	Structural upgrades in 2000 include seismic bracing work at roof eave overhangs. Also 2009 Roof-only retrofit.

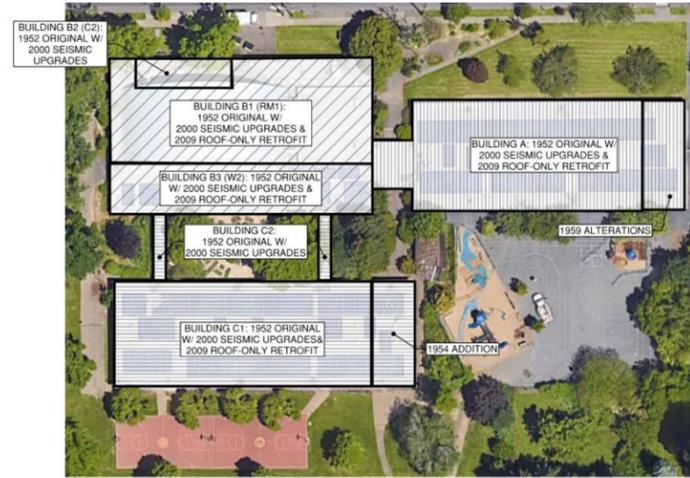
Building Part (See Diagram Above)	Year Built	URM (SF)	ROM URM Only Retrofit	ROM Total Retrofit	No. of Stories	Basement	Penthouse	Drawings Referenced	Structural Horizontal Gravity System(s)	Structural Vertical Gravity System(s)	Lateral System (ASCE Designation)	Lateral System (Description)	Likely Deficiencies	Deficiency Notes	Additional Notes
Bldg. C1	1952	0	\$0	\$850,000	1	None	No	Approximately Complete Original Documents	Wood Plywood/OSB, Wood T+G Plank, Wood Joists, Wood Beams	Timber Frame	W2	Wood Frames (Commercial and Industrial Buildings)	Seismic Separation (< 1%) Inadequate In-Plane Shear	No gap to walkways to Sector B T&G sheathing for walls typical	1954 addition of two classroom on east end (matches original construction). Structural upgrades in 2000 include seismic bracing work at roof eave overhangs and new shear walls in N/S corridors w/ new collectors. Also 2009 Roof-only retrofit.

Bldg. C2	1952	0	\$0	\$25,000	1	None	No	Approximately Complete Original Documents	Wood T+G Plank, Wood Beams	Timber Frame	W2, S3	Wood Frames (Commercial and Industrial Buildings), Metal Building Frames	Seismic Separation (< 1%) Inadequate In-Plane Shear Roof Chord Discontinuity Straight Sheathing (2:1, 24') Inadequate Moment-Resisting Connections (non-ductile)	No gap to buildings to north & south Relies on adjacent buildings in long direction. Unknown connection detailing	Structural upgrades in 2000 included construction of external steel moment frames.

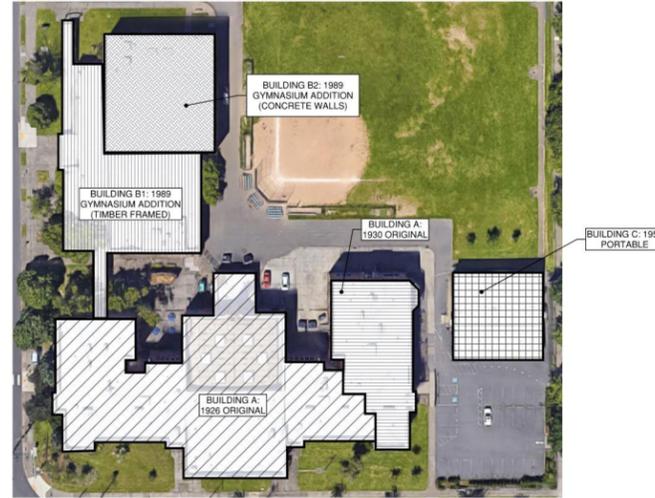
Building Part (See Diagram Above)	Year Built	URM (SF)	ROM URM Only Retrofit	ROM Total Retrofit	No. of Stories	Basement	Penthouse	Drawings Referenced	Structural Horizontal Gravity System(s)	Structural Vertical Gravity System(s)	Lateral System (ASCE Designation)	Lateral System (Description)	Likely Deficiencies	Deficiency Notes	Additional Notes
Bldg. A	1926 & 1930 (two stage construction)	0	\$0	\$16,350,000	2	Partial	No	Approximately Complete Original Documents	Concrete Beams, Concrete 1-way Slab	Conc. CIP Walls	C2	Concrete Shear Walls (Stiff Diaphragms)	Inadequate Foundation Ties Inadequate Wall Anchorage Split Levels Seismic Separation (< 1%) Masonry Partition Walls URM Chimneys Heavy Cladding System Under-Reinforced Walls Under-Reinforced Flat Slabs Inadequate Wall-Foundation Connection Deflection Compatibility Diaphragm Reinforcement at Openings	Various adjacent structures added Tall chimney Brick cladding	Original School Building

Bldg. B1	1989	0	\$0	\$1,170,000	1	None	No	Insufficient Original Documents	Steel Joists, Wood Beams	Wood Framed Walls, CFS Walls	W2	Wood Frames (Commercial and Industrial Buildings)	Misc. Load Path Issue Inadequate Wall Anchorage Split Levels Torsional Irregularity Seismic Separation (< 1%) Heavy Cladding System No Diaphragm-Wall Connection Inadequate Wall-Foundation Connection No Floor-to-Floor Connections (Shear and OT) Other Diaphragms	Connection to primary building Connection to primary building Double height at gym Mixed systems Brick cladding Connection back to primary structure Unknown condition Wood construction unknown	Cafeteria, office and covered walkways
Bldg. B2	1989	0	\$0	\$1,350,000	1	None	No	Insufficient Original Documents	Steel Joists, Wood Beams	Conc. CIP Walls	C2	Concrete Shear Walls (Stiff Diaphragms)	Misc. Load Path Issue Inadequate Wall Anchorage Split Levels Torsional Irregularity Seismic Separation (< 1%) Heavy Cladding System No Diaphragm-Wall Connection Inadequate Wall-Foundation Connection	Connection to primary building Connection to primary building Double height at gym Mixed systems Brick cladding Connection back to primary structure	High Gymnasium

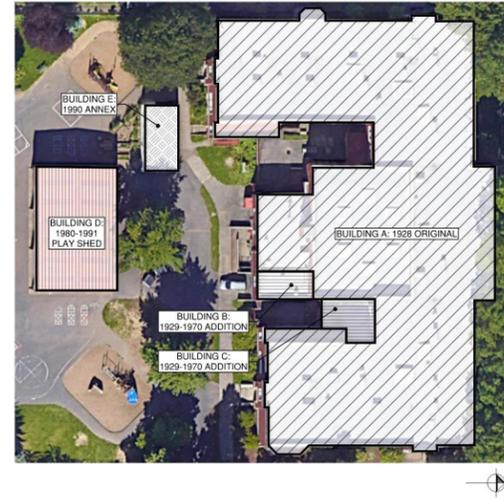
Building Part (See Diagram Above)	Year Built	URM (SF)	ROM URM Only Retrofit	ROM Total Retrofit	No. of Stories	Basement	Penthouse	Drawings Referenced	Structural Horizontal Gravity System(s)	Structural Vertical Gravity System(s)	Lateral System (ASCE Designation)	Lateral System (Description)	Likely Deficiencies	Deficiency Notes	Additional Notes
Bldg. A	1928	0	\$0	\$16,400,000	2	Crawlspace	No	Insufficient Original Documents	Concrete 1-way Slab, Concrete Pan-Joists, Steel Truss	Concrete Columns/Conc. CIP Walls	C2	Concrete Shear Walls (Stiff Diaphragms)	Inadequate Foundation Ties Split Levels Reentrant Corners Masonry Partition Walls Concrete Parapets exceed 2.5:1 URM Chimneys Heavy Cladding System Deep Spandrels/Narrow Piers (50%, interfering walls) Inadequate In-Plane Shear Under-Reinforced Walls Under-Reinforced Flat Slabs No Diaphragm-Wall Connection Inadequate Wall-Foundation Connection Deflection Compatibility Diaphragm Reinforcement at Openings

Bldg. B	1930	0	\$0	\$175,000	1	Crawlspace	No	None	Wood Straight/Diag Sheathing, Wood Joists, Concrete Pan-Joists	Conc. CIP Walls	C2a	Concrete Shear Walls (Flexible Diaphragms)	Inadequate Foundation Ties Inadequate Wall Anchorage Seismic Separation (< 1%) URM Parapets exceed 1.5:1 Deep Spandrels/Narrow Piers (50%, interfering walls) Under-Reinforced Walls Under-Reinforced Flat Slabs No Diaphragm-Wall Connection Inadequate Wall-Foundation Connection Discontinuous Cross Ties Straight Sheathing (2:1, 24')	Inadequate tie to part A	Wall construction assumed to be similar to part A in absence of structural drawings or further exploration
Bldg. C	1960	0	\$0	\$52,500	1	Crawlspace	No	None	Steel Sheet Deck, Steel Joists	Reinforced CMU Walls	RM1	Reinforced Masonry Bearing Walls (Flexible Diaphragms)	Inadequate Foundation Ties Seismic Separation (< 1%) Under-Reinforced Walls No Diaphragm-Wall Connection Discontinuous Cross Ties	Inadequate tie to part A	Wall construction assumed based on type of construction in absence of structural drawings or further exploration

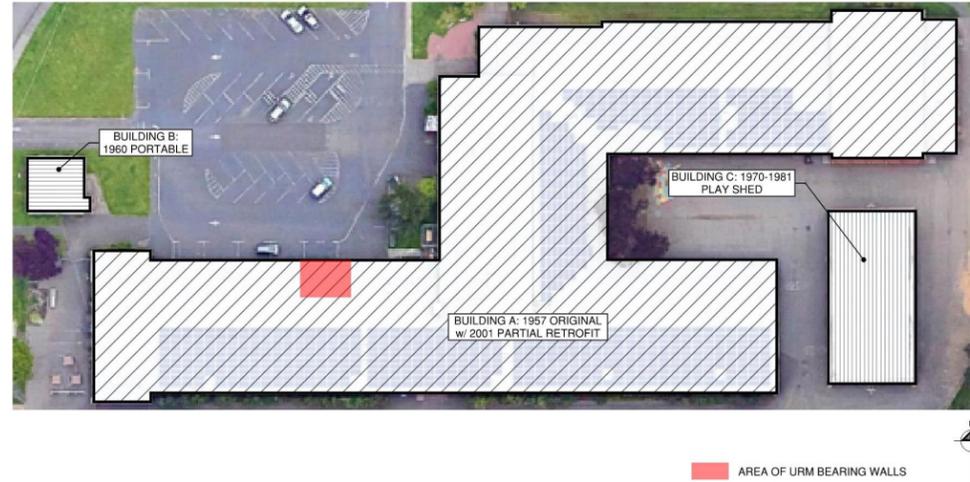
Building Part (See Diagram Above)	Year Built	URM (SF)	ROM URM Only Retrofit	ROM Total Retrofit	No. of Stories	Basement	Penthouse	Drawings Referenced	Structural Horizontal Gravity System(s)	Structural Vertical Gravity System(s)	Lateral System (ASCE Designation)	Lateral System (Description)	Likely Deficiencies	Deficiency Notes	Additional Notes
Bldg. A	1957	100	\$25,000	\$11,125,000	1	Crawlspace	No	Approximately Complete Original Documents	Wood T+G Plank, Steel Joists, Steel Beams, Wood Beams, Concrete 1-way Slab, Concrete Beams	Wood Framed Walls, Steel Columns, Reinforced Brick Walls, Unreinforced Brick Walls, Concrete Columns, Conc. CIP Walls	W2, URM, RM1, C2	Wood Frames (Commercial and Industrial Buildings), Unreinforced Masonry Bearing Walls (Flexible Diaphragms)	Sloping Site (full story difference across site) Near-fault location (250ft, DOGAMI Active Faults) Inadequate Foundation Ties Misc. Plan Irregularity incompatible    systems Non-redundant (< 2 bays in < 2 lines) Masonry Partition Walls Heavy Cladding System Inadequate In-Plane Shear Plaster or Gypsum Shear Walls Large Unbraced Openings No Floor-to-Floor Connections (Shear and OT) Roof Chord Discontinuity Straight Sheathing (2:1, 24') Walls Spaced Far Apart Inadequate In-Plane Shear Under-Reinforced Walls Wood Ledgers loaded across grain No Diaphragm-Wall Connection Discontinuous Cross Ties Straight Sheathing (2:1, 24') Inadequate Composite Behavior Beams, Girders, or Trusses bear on URM wall/pilaster Thin Walls (9 top, 15 first, 13 other/single) Under-Reinforced Walls	partial retrofit in 2001 partial retrofit in 2001 transformer vault	Fmr play area infill not documented, construction appears similar. Retrofit in 2001 of unknown scope (documents not available). Extent of unreinforced masonry bearing wall appears to be limited to the transformer vault.

Bldg. B	1960	0	\$0	\$75,000	1	Crawlspace	No	None	Wood Plywood/OSB, CFS Joists, Wood Joists	Wood Framed Walls	w2	Wood Frames (Commercial and Industrial Buildings)	Near-fault location (250ft, DOGAMI Active Faults) Inadequate In-Plane Shear Narrow Wood Shear Walls No Floor-to-Floor Connections (Shear and OT) No Wood Post-Foundation Connections Inadequate Wood Sill-Foundation Connections (6 ft) No Girder-Column Connections Roof Chord Discontinuity Straight Sheathing (2:1, 24')		
Bldg. C	1970	0	\$0	\$250,000	1	None	No	None	Wood Plywood/OSB, Wood Truss-Joists, Wood Beams	Timber Frame	Non-compliant	Cantilevered Wood Posts	Near-fault location (250ft, DOGAMI Active Faults) Post Capacity Foundation Capacity

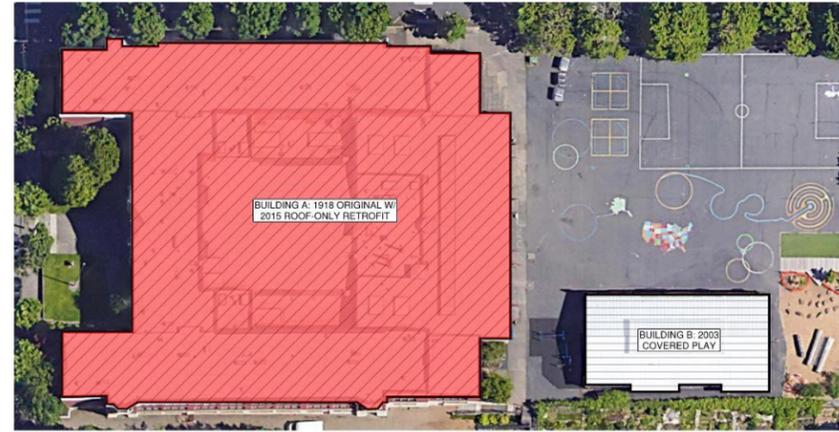
Building Part (See Diagram Above)	Year Built	URM (SF)	ROM URM Only Retrofit	ROM Total Retrofit	No. of Stories	Basement	Penthouse	Drawings Referenced	Structural Horizontal Gravity System(s)	Structural Vertical Gravity System(s)	Lateral System (ASCE Designation)	Lateral System (Description)	Likely Deficiencies	Deficiency Notes	Additional Notes
Bldg. A	1918	79000	\$19,750,000	\$21,100,000	2	Crawlspace, Daylight	No	Insufficient Original Documents	Wood Trusses, Wood Joists, Concrete Pan-Joists	Unreinforced Brick Walls, Reinforced Concrete Walls	URM	Unreinforced Masonry Bearing Walls (Flexible Diaphragms)	Sloping Site (full story difference across site) Misc. Load Path Issue Inadequate Foundation Ties Inadequate Wall Anchorage Beams, Girders, or Trusses bear on URM wall/pilaster Deep Spandrels/Narrow Piers (50%, interfering walls) Inadequate In-Plane Shear Thin Walls (9 top, 15 first, 13 other/single) Large Diaphragm Openings Adj. Walls (25%, 8' at Ext.) Straight Sheathing (2:1, 24') Under-Reinforced Walls Under-Reinforced Flat Slabs Masonry Partition Walls URM Parapets exceed 1.5:1 URM Appendages over Exit way	Clear story at main hallway Unknown from insufficient drawings and unable to determine on site 1995 Seismic Improvement, 2015 reroof likely to have resolved Upper level walls are thin Large skylights at low roofs 2015 Reroof likely to have resolved (drawings not available) Hollow Clay Tile walls, 150 sf of discontinuous CMU walls in basement 1995 Seismic Improvement, 2015 reroof likely to have resolved Large cornices, window appendages	Solid URM walls throughout (all levels). Concrete framing and Concrete walls at basement.

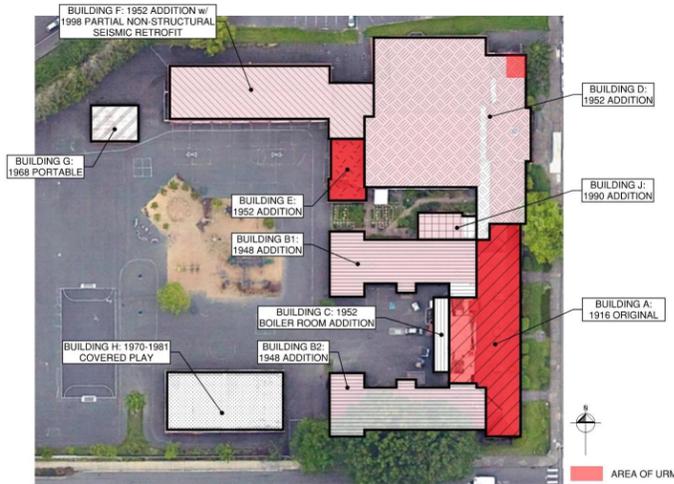
Building Part (See Diagram Above)	Year Built	URM (SF)	ROM URM Only Retrofit	ROM Total Retrofit	No. of Stories	Basement	Penthouse	Drawings Referenced	Structural Horizontal Gravity System(s)	Structural Vertical Gravity System(s)	Lateral System (ASCE Designation)	Lateral System (Description)	Likely Deficiencies	Deficiency Notes	Additional Notes
Bldg. A	1916	7000	\$2,800,000	\$2,800,000	1	Crawlspace	No	Insufficient Original Documents	Wood Batten, Wood T+G Plank, Wood Trusses, Wood Beams	Wood Framed Walls, Unreinforced Brick Walls	URM, W2	Wood Frames (Commercial and Industrial Buildings), Unreinforced Masonry Bearing Walls (Flexible Diaphragms)	Inadequate Foundation Ties Severe Vertical Element Size Discontinuity (<50%) Reentrant Corners Non-redundant (< 2 bays in < 2 lines) Seismic Separation (< 1%) Inadequate In-Plane Shear Plaster or Gypsum Shear Walls Unbraced Cripple Walls No Floor-to-Floor Connections (Shear and OT) No Wood Post-Foundation Connections Inadequate Wood Sill-Foundation Connections (6 ft) No Girder-Column Connections Roof Chord Discontinuity Other Diaphragms Beams, Girders, or Trusses bear on URM wall/pilaster Unbraced Gable Walls No Diaphragm-Wall Connection Heavy Cladding System	Interior walls not continuous Exterior all windows HCT & Brick Foundation Walls Likely insufficient	Foundation is URM (Brick and HCT)

Bldg. B1	1948	0	\$0	\$612,500	1	Crawlspace	No	Insufficient Original Documents	Wood Battens, Wood Trusses, Wood Plywood/OSB, Wood Joists, Wood Beams	Wood Framed Walls	W2	Wood Frames (Commercial and Industrial Buildings)	Inadequate Foundation Ties Severe Vertical Element Size Discontinuity (<50%) Reentrant Corners Non-redundant (< 2 bays in < 2 lines) Inadequate In-Plane Shear Plaster or Gypsum Shear Walls No Floor-to-Floor Connections (Shear and OT) No Girder-Column Connections Roof Chord Discontinuity Other Diaphragms Heavy Cladding System	Interior walls not continuous Likely insufficient	
Bldg. B2	1948	0	\$0	\$612,500	1	Crawlspace	No	Insufficient Original Documents	Wood Battens, Wood Trusses, Wood Plywood/OSB, Wood Joists, Wood Beams	Wood Framed Walls	W2	Wood Frames (Commercial and Industrial Buildings)	Inadequate Foundation Ties Severe Vertical Element Size Discontinuity (<50%) Reentrant Corners Non-redundant (< 2 bays in < 2 lines) Inadequate In-Plane Shear Plaster or Gypsum Shear Walls No Floor-to-Floor Connections (Shear and OT) No Girder-Column Connections Roof Chord Discontinuity Other Diaphragms Heavy Cladding System	Interior walls not continuous Likely insufficient

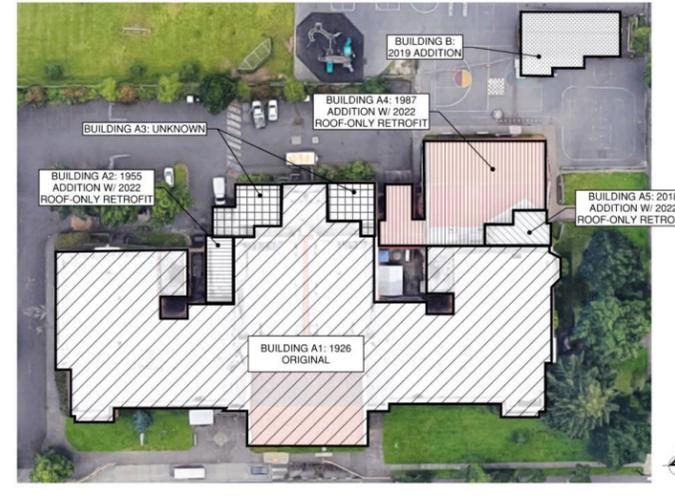
Building Part (See Diagram Above)	Year Built	URM (SF)	ROM URM Only Retrofit	ROM Total Retrofit	No. of Stories	Basement	Penthouse	Drawings Referenced	Structural Horizontal Gravity System(s)	Structural Vertical Gravity System(s)	Lateral System (ASCE Designation)	Lateral System (Description)	Likely Deficiencies	Deficiency Notes	Additional Notes
Bldg. A1	1927	0	\$0	\$16,152,500	2	Partial	No	Approximately Complete Original Documents	Concrete Beams, Concrete 1-way Slab, Concrete Pan-Joists, Steel Truss	Conc. CIP Walls	C2	Concrete Shear Walls (Stiff Diaphragms)	Inadequate Foundation Ties Inadequate Wall Anchorage Split Levels Seismic Separation (< 1%) Masonry Partition Walls Heavy Cladding System Under-Reinforced Walls Under-Reinforced Flat Slabs Inadequate Wall-Foundation Connection Deflection Compatibility Diaphragm Reinforcement at Openings	Gymnasium double height Various adjacent structures added Brick cladding	Original School Building

Bldg. A2	1955	0	\$0	\$213,750	1	None	No	Approximately Complete Original Documents	Concrete 1-way Slab, Concrete Beams, Concrete Waffle Slab	Conc. CIP Walls	C2	Concrete Shear Walls (Stiff Diaphragms)	Misc. Load Path Issue Inadequate Wall Anchorage Non-orthogonal System Seismic Separation (< 1%) Masonry Partition Walls Heavy Cladding System Under-Reinforced Walls Under-Reinforced Flat Slabs No Diaphragm-Wall Connection Inadequate Wall-Foundation Connection	Connection to primary building Connection to primary building Relies upon primary building for lateral Brick cladding Connection back to primary structure	
Bldg. A3	UNKNOW	0	\$0	\$1,053,000	2	Partial	No	None	0	Conc. CIP Walls	C2	Concrete Shear Walls (Stiff Diaphragms)			Unknown additions to the north face of the building
Bldg. A4	1987	0	\$0	\$1,080,000	2	Partial	No	Approximately Complete Original Documents	Concrete 1-way Slab	Concrete Columns, Conc. CIP Walls, CFS Walls	C2	Concrete Shear Walls (Stiff Diaphragms)	Misc. Load Path Issue Seismic Separation (< 1%) Masonry Partition Walls	Supported by original building Connected to original building

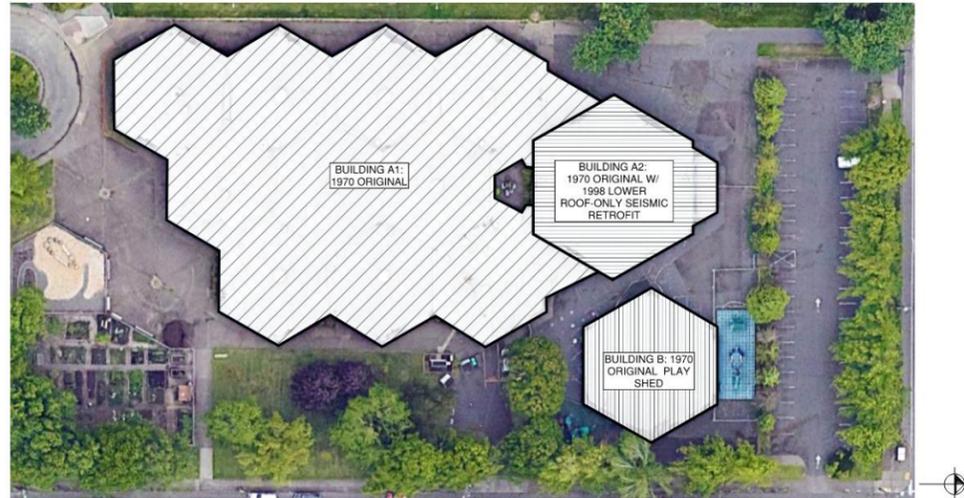
Building Part (See Diagram Above)	Year Built	URM (SF)	ROM URM Only Retrofit	ROM Total Retrofit	No. of Stories	Basement	Penthouse	Drawings Referenced	Structural Horizontal Gravity System(s)	Structural Vertical Gravity System(s)	Lateral System (ASCE Designation)	Lateral System (Description)	Likely Deficiencies	Deficiency Notes	Additional Notes
Bldg. A1	1970	0	\$0	\$4,212,500	1	None	No	Approximately Complete Original Documents	Wood Straight/Diag Sheathing, Wood Joists, Wood Beams	Concrete Columns, Wood Framed Walls	W2	Wood Frames (Commercial and Industrial Buildings)	Misc. Load Path Issue Split Levels Non-orthogonal System Reentrant Corners Misc. Plan Irregularity URM Chimneys Heavy Cladding System Inadequate In-Plane Shear Plaster or Gypsum Shear Walls Roof Chord Discontinuity Straight Sheathing (2:1, 24') Deflection incompatibility	Possible collapse hazard. LFRS relies on gypsum shear walls. If/when they fail, precast column connections have limited capacity to resist lateral loads. At roof to gym Hexagonal grid Gym will be stiffer than classroom sections Brick veneer Gypsum shear walls w/ relatively large areas & heavy conc. elements Roof material is just described as 'sheathing' Precast columns & connections are unlikely to have adequate capacity to resist seismic loads if/when gypsum shear walls fail	1970 Original Building. Building is constructed on a grid of hexagons. At the center of each hexagon is a concrete column in the shape of a tree. The column is comprised of a cast in place core and 6 precast concrete elements that form at trunk & branch. Glulam beams span from these branches to precast columns located at each point of the hexagonal grid. Walls are typically wood-framed with gyp sheathing and appear to be the primary LFRS. The project folder shows re-roof circa 2006 and roof replacement circa 2012. The seismic scope of these projects (if any) is unknown as drawings were not available.

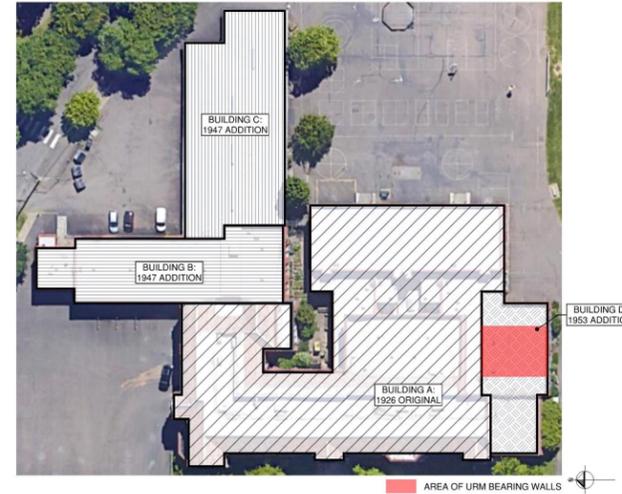
Building Part (See Diagram Above)	Year Built	URM (SF)	ROM URM Only Retrofit	ROM Total Retrofit	No. of Stories	Basement	Penthouse	Drawings Referenced	Structural Horizontal Gravity System(s)	Structural Vertical Gravity System(s)	Lateral System (ASCE Designation)	Lateral System (Description)	Likely Deficiencies	Deficiency Notes	Additional Notes
Bldg. A	1926	0	\$0	\$11,700,000	2	Crawlspace	No	Approximately Complete Original Documents	Concrete 1-way Slab, Concrete Pan-Joists, Concrete Beams, Steel Truss	Concrete Columns, Conc. CIP Walls, Unreinforced Brick Walls	C2	Concrete Shear Walls (Stiff Diaphragms)	Inadequate Foundation Ties Split Levels Reentrant Corners Misc. Plan Irregularity Masonry Partition Walls URM Parapets exceed 1.5:1 Concrete Parapets exceed 2.5:1 Heavy Cladding System Deep Spandrels/Narrow Piers (50%, interfering walls) Inadequate In-Plane Shear Under-Reinforced Walls Under-Reinforced Flat Slabs No Diaphragm-Wall Connection Inadequate Wall-Foundation Connection Deflection Compatibility Diaphragm Reinforcement at Openings URM bearing walls	End of N wing soft            Thin slabs Wall b/w cafeteria addition	2023 reroof somewhere on this campus (drawings not available)

Bldg. B	1947	0	\$0	\$1,110,000	1	None	Yes	Approximately Complete Original Documents	Wood T+G Plank, Concrete 1-way Slab, Steel Joists, Wood Joists	Conc. CIP Walls	C2, C2a	Concrete Shear Walls (Stiff & Flexible Diaphragms)	Inadequate Wall Anchorage Seismic Separation (< 1%) Concrete Parapets exceed 2.5:1 Heavy Cladding System Deep Spandrels/Narrow Piers (50%, interfering walls) Inadequate In-Plane Shear Under-Reinforced Walls Under-Reinforced Flat Slabs No Diaphragm-Wall Connection Inadequate Wall-Foundation Connection Discontinuous Cross Ties Straight Sheathing (2:1, 24')	Wood Ledgers loaded across grain Attached to parts A & C	
Bldg. C	1947	0	\$0	\$840,000	1	None	No	Approximately Complete Original Documents	Wood Trusses	Wood Framed Walls	W2	Wood Frames (Commercial and Industrial Buildings)	Non-redundant (< 2 bays in < 2 lines) Seismic Separation (< 1%) Heavy Cladding System Inadequate In-Plane Shear Plaster or Gypsum Shear Walls Large Unbraced Openings No Floor-to-Floor Connections (Shear and OT) Roof Chord Discontinuity Straight Sheathing (2:1, 24')	Attached to part B

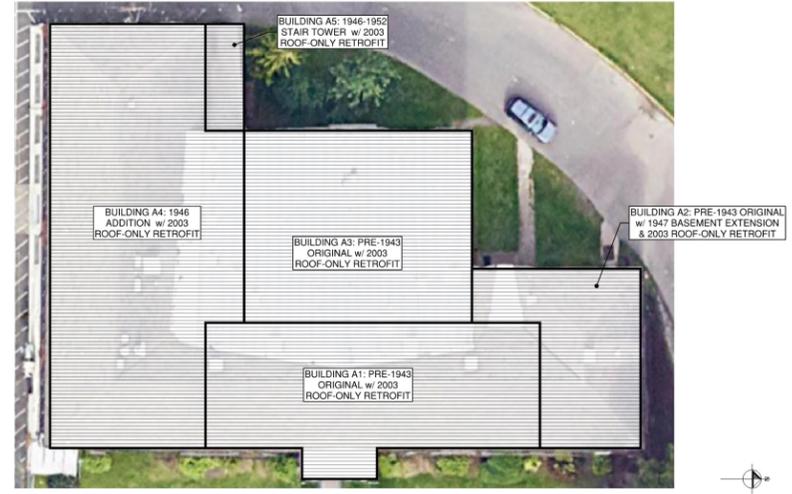
Building Part (See Diagram Above)	Year Built	URM (SF)	ROM URM Only Retrofit	ROM Total Retrofit	No. of Stories	Basement	Penthouse	Drawings Referenced	Structural Horizontal Gravity System(s)	Structural Vertical Gravity System(s)	Lateral System (ASCE Designation)	Lateral System (Description)	Likely Deficiencies	Deficiency Notes	Additional Notes
Bldg. A1	1910	0	\$0	\$350,000	1	Crawlspace	No	None	Wood Plywood/OSB, Wood Straight/Diag Sheathing, Wood Joists, Wood Beams, Wood Trusses	Timber Frame, Conc. CIP Walls	W2, C2a	Wood Frames (Commercial and Industrial Buildings), Concrete Shear Walls (Flexible Diaphragms)	Sloping Site (full story difference across site) Near-fault location (250ft, DOGAMI Active Faults) Inadequate Foundation Ties Split Levels Non-redundant (< 2 bays in < 2 lines) Heavy Cladding System Deep Spandrels/Narrow Piers (50%, interfering walls) Inadequate In-Plane Shear (concrete walls) Under-Reinforced Walls No Diaphragm-Wall Connection Inadequate Wall-Foundation Connection Discontinuous Cross Ties Straight Sheathing (2:1, 24') Inadequate In-Plane Shear (Wood Walls) Plaster or Gypsum Shear Walls Unbraced Cripple Walls Large Unbraced Openings No Floor-to-Floor Connections (Shear and OT) No Wood Post-Foundation Connections Inadequate Wood Sill-Foundation Connections (6 ft) No Girder-Column Connections Roof Chord Discontinuity		2003 partial seismic upgrade at roof level only Building poorly documented, exploratory demo required to enable further assessment.

Bldg. A2	1910	0	\$0	\$462,500	1	Daylight	No	None	Wood Plywood/OSB, Wood Straight/Diag Sheathing, Wood Joists, Wood Beams, Wood Trusses	Timber Frame, Conc. CIP Walls	W2, C2a	Wood Frames (Commercial and Industrial Buildings), Concrete Shear Walls (Flexible Diaphragms)	Sloping Site (full story difference across site) Near-fault location (250ft, DOGAMI Active Faults) Inadequate Foundation Ties Split Levels Non-redundant (< 2 bays in < 2 lines) Heavy Cladding System Deep Spandrels/Narrow Piers (50%, interfering walls) Inadequate In-Plane Shear (concrete walls) Under-Reinforced Walls No Diaphragm-Wall Connection Inadequate Wall-Foundation Connection Discontinuous Cross Ties Straight Sheathing (2:1, 24') Inadequate In-Plane Shear (Wood Walls) Plaster or Gypsum Shear Walls Unbraced Cripple Walls Large Unbraced Openings No Floor-to-Floor Connections (Shear and OT) No Wood Post-Foundation Connections Inadequate Wood Sill-Foundation Connections (6 ft) No Girder-Column Connections Roof Chord Discontinuity		2003 partial seismic upgrade at roof level only Building poorly documented, exploratory demo required to enable further assessment.

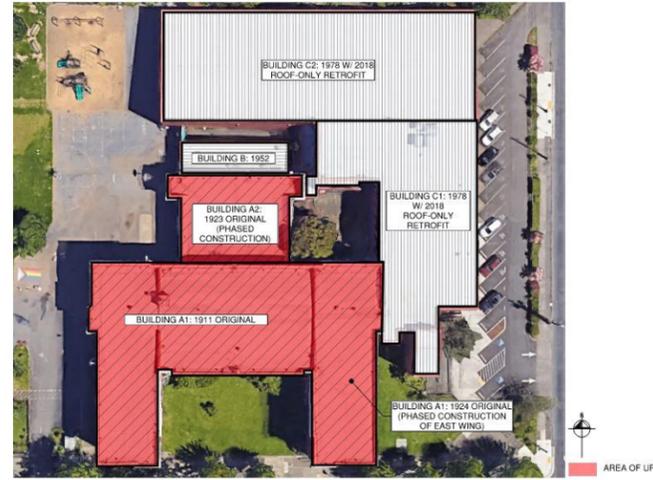
**Building Year Plan:**  
(see below for deficiencies)

Building Part (See Diagram Above)	Year Built	URM (SF)	ROM URM Only Retrofit	ROM Total Retrofit	No. of Stories	Basement	Penthouse	Drawings Referenced	Structural Horizontal Gravity System(s)	Structural Vertical Gravity System(s)	Lateral System (ASCE Designation)	Lateral System (Description)	Likely Deficiencies	Deficiency Notes	Additional Notes
Bldg. A1	1911-1924	44000	\$13,200,000	\$13,200,000	2	Daylight	No	Approximately Complete Original Documents	Concrete Pan-Joists, Concrete Beams	Unreinforced Brick Walls, Concrete Columns	URMa	Unreinforced Masonry Bearing Walls (Stiff Diaphragms)	Misc. Load Path Issue Inadequate Wall Anchorage Reentrant Corners Overturning Seismic Separation (< 1%) Masonry Partition Walls Masonry ceiling URM Appendages over Exitway Beams, Girders, or Trusses bear on URM wall/pilaster	Tall slender URM (brick) piers no gap to A1, potentially insufficient gap to C1 HCT in basement HCT infill of pan joists

Bldg. A2	1924	4000	\$1,200,000	\$1,200,000	1	None	No	Approximately Complete Original Documents	Concrete Beams, Concrete 1-way Slab, Steel Truss	Unreinforced Brick Walls, Concrete Columns	URMa	Unreinforced Masonry Bearing Walls (Stiff Diaphragms)	Misc. Load Path Issue Inadequate Wall Anchorage Seismic Separation (< 1%) Beams, Girders, or Trusses bear on URM wall/pilaster Inadequate In-Plane Shear No Diaphragm-Wall Connection Diaphragm Reinforcement at Openings Beams, Girders, or Trusses bear on URM wall/pilaster	No Seismic Gap to A1 or B N-S direction	
Bldg. B	1924	0	\$0	\$150,000	1	None	No	Approximately Complete Original Documents	Wood Joists, Wood Plywood/OSB	Conc. CIP Walls	C2a	Concrete Shear Walls (Flexible Diaphragms)	Seismic Separation (< 1%) Masonry Partition Walls Heavy Cladding System Inadequate In-Plane Shear Under-Reinforced Walls No Diaphragm-Wall Connection Inadequate Wall-Foundation Connection Other Diaphragms Incomplete gravity frame	No Seismic Gap to A2 HCT Interior Walls Brick Veneer Reinforcement unknown

Bldg. C1	1978	0	\$0	\$2,775,000	2	None	No	Approximately Complete Original Documents	Wood Beams, Wood Plywood/OSB, Hollow-Core Floor, Concrete Beams	Reinforced CMU Walls, Concrete Columns	RM1	Reinforced Masonry Bearing Walls (Flexible Diaphragms)	Overturning Reinforcement Provided at Wall Openings Inadequate In-Plane Shear Under-Reinforced Walls Wood Ledgers loaded across grain No Diaphragm-Wall Connection No Topping Slab-Wall Connection Other Diaphragms Deep Spandrels/Narrow Piers	No Seismic Gap to A2 HCT Interior Walls Brick Veneer Reinforcement unknown	
Bldg. C2	1978	0	\$0	\$1,300,000	1	None	No	Approximately Complete Original Documents	Wood Beams, Wood Plywood/OSB	Reinforced CMU Walls	RM1	Reinforced Masonry Bearing Walls (Flexible Diaphragms)	Reinforcement Provided at Wall Openings Proportions (h/t < 30) Under-Reinforced Walls Wood Ledgers loaded across grain	Double height space

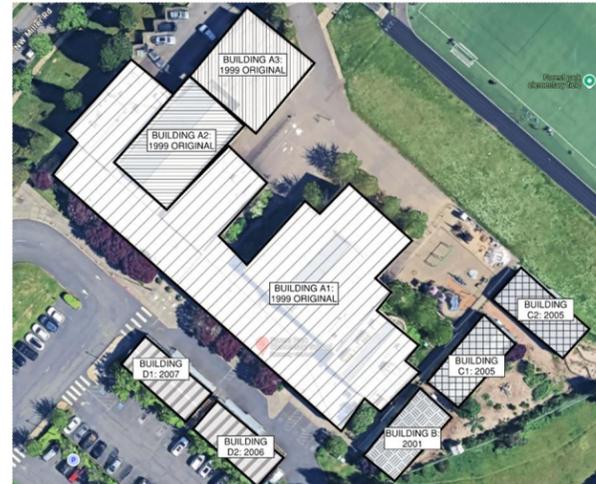
Building Part (See Diagram Above)	Year Built	URM (SF)	ROM URM Only Retrofit	ROM Total Retrofit	No. of Stories	Basement	Penthouse	Drawings Referenced	Structural Horizontal Gravity System(s)	Structural Vertical Gravity System(s)	Lateral System (ASCE Designation)	Lateral System (Description)	Likely Deficiencies	Deficiency Notes	Additional Notes
Bldg. A1	1999	0	\$0	\$2,887,500	2	None	No	Approximately Complete Original Documents	Steel Sheet Deck, Concrete 1-way Slab, Steel Joists, Steel Beams, Steel Truss	Steel Columns	S2, S2a	Steel Braced Frames (Stiff & Flexible Diaphragms)	High Landslide Susceptibility (DOGAMI State Overview) Near-fault location (250ft, DOGAMI Active Faults) Reentrant Corners Non-redundant (< 2 bays in < 2 lines) Seismic Separation (< 1%) Inadequate Column Capacity Non-compact Braces Chevron/V-Braces - Inadequate Beam Eccentrically Braced Frames Inadequate brace connections Diaphragm Reinforcement at Openings	Requires in-depth geotech analysis  Attached to adj. structures Columns lighter than braces  Grid J, east Braced framed detailing pre-dates current code

Bldg. A2	1999	0	\$0	\$225,000	1	None	No	Approximately Complete Original Documents	Steel Sheet Deck, Steel Joists	Reinforced CMU Walls	RM1	Reinforced Masonry Bearing Walls (Flexible Diaphragms)	Discontinuous Cross Ties	Verify chord at joints	
Bldg. A3	1999	0	\$0	\$175,000	1	None	No	Approximately Complete Original Documents	Steel Sheet Deck, Steel Joists, Steel Beams	Steel Columns, Concrete Columns	S2a	Steel Braced Frames (Flexible Diaphragms)	Inadequate Foundation Ties Slender Braces Inadequate brace connections	Tension rod braces Braced framed detailing pre-dates current code	
Bldg. B	2001	0	\$0	\$55,000	1	None	No	Approximately Complete Original Documents	Wood Plywood/OSB, Wood Joists, Wood Beams	Wood Framed Walls	W2	Wood Frames (Commercial and Industrial Buildings)	Inadequate Foundation Ties Severe Vertical Element Size Discontinuity (<50%) Unbraced Cripple Walls No Wood Post-Foundation Connections Inadequate Wood Sill-Foundation Connections (6 ft) Roof Chord Discontinuity Unblocked Diaphragms (4:1, 40')	Wood fnd, not embeded in soil	We recommend investigating treated wood foundations for possible deterioration.

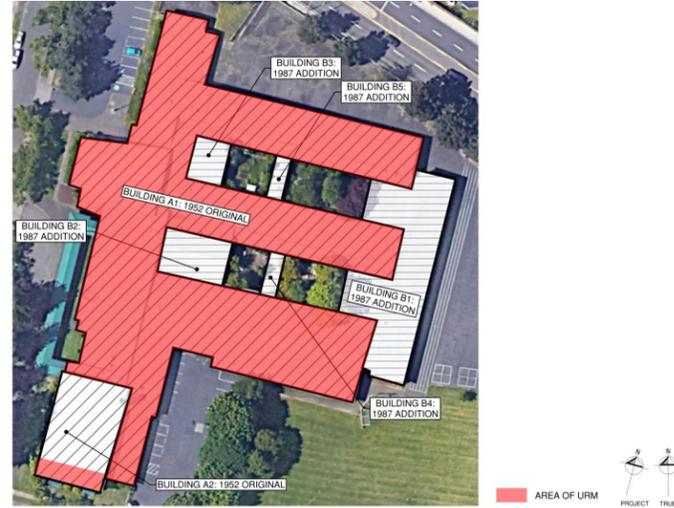
**Building Year Plan:**  
(see below for deficiencies)

Building Part (See Diagram Above)	Year Built	URM (SF)	ROM URM Only Retrofit	ROM Total Retrofit	No. of Stories	Basement	Penthouse	Drawings Referenced	Structural Horizontal Gravity System(s)	Structural Vertical Gravity System(s)	Lateral System (ASCE Designation)	Lateral System (Description)	Likely Deficiencies	Deficiency Notes	Additional Notes
Bldg. A1	1952	55000	\$11,000,000	\$11,000,000	1	Partial	No	Approximately Complete Original Documents	Wood Joists, Wood Beams, Steel Truss	Unreinforced Brick Walls, Wood Framed Walls	W2	Wood Frames (Commercial and Industrial Buildings)	Misc. Load Path Issue Inadequate Foundation Ties Reentrant Corners Torsional Irregularity In-Plane Stress Inadequate Post-Foundation Connection Straight Sheathed Diaphragms Beams, Girders, or Trusses bear on URM wall/pilaster Thin Walls (9 top, 15 first, 13 other/single) Cavity Wall Construction Other Diaphragms Masonry Partition Walls Heavy Cladding System	Glass block clerestory at roof of corridor wing offsets No connection shown at URM Center of mass offset from center of rigidity Sheathing is unknown from drawings and site visit Unknown, no connection shown Shiplap sheathing, T&G sheathing URM Shiplap sheathing, T&G sheathing Hollow clay tile walls in locker room extents Brick veneer on wood framed walls	URM present at exterior corridor wing walls, boiler room, and double height auditorium.

Bldg. A2	1952	700	\$175,000	\$1,350,000	1	None	No	Approximately Complete Original Documents	Steel Beams	Unreinforced Brick Walls, Steel Columns	S1a	Steel Moment Frames (Flexible Diaphragm)	Misc. Load Path Issue Inadequate Foundation Ties Inadequate System Capacity Inadequate Moment-Resisting Connections (non-ductile) Inadequate Panel Zones Non-Compact Frame Members Beams, Girders, or Trusses bear on URM wall/pilaster Inadequate In-Plane Shear Thin Walls (9 top, 15 first, 13 other/single) Cavity Wall Construction No Diaphragm-Wall Connection Other Diaphragms Masonry Partition Walls	Glass block clerestory at gymnasium, tectum No connection shown at URM Clerestory at URM Tectum Hollow clay tile walls in locker room extents	URM present in the gymnasium (double height). Tectum is present in the gym, structural diaphragm is likely to be plywood
Bldg. B1, B2, B3, B4, B5	1987	0	\$0	\$1,162,500	1	None	No	Insufficient Original Documents	Wood Joists, Wood Beams	Wood Framed Walls, Reinforced Brick Walls	W2	Wood Frames (Commercial and Industrial Buildings)	Misc. Load Path Issue Seismic Separation (< 1%) Under-Reinforced Walls	Likely insufficient OOP strength at brick walls Buildings Interconnected Brick Walls

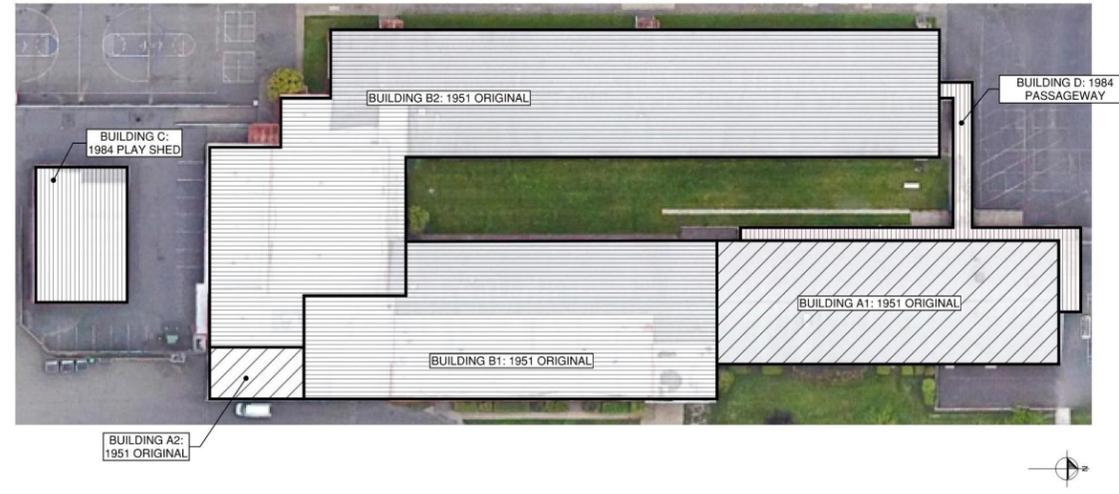
Building Part (See Diagram Above)	Year Built	URM (SF)	ROM URM Only Retrofit	ROM Total Retrofit	No. of Stories	Basement	Penthouse	Drawings Referenced	Structural Horizontal Gravity System(s)	Structural Vertical Gravity System(s)	Lateral System (ASCE Designation)	Lateral System (Description)	Likely Deficiencies	Deficiency Notes	Additional Notes
Bldg. A	1951	0	\$0	\$4,140,000	1	Daylight	No	Approximately Complete Original Documents	Wood Plywood/OSB, Wood Joists, Concrete Pan-Joists, Concrete Beams	Wood Framed Walls, Wood Framed Walls, Steel Columns, Conc. CIP Walls	W2, C2	Wood Frames (Commercial and Industrial Buildings), Concrete Shear Walls (Stiff Diaphragms)	Sloping Site (full story difference across site) High Landslide Susceptibility (DOGAMI) Unbraced Mezzanine Non-redundant (< 2 bays in < 2 lines) Masonry Partition Walls Heavy Cladding System Inadequate In-Plane Shear Plaster or Gypsum Shear Walls No Floor-to-Floor Connections (Shear and OT) Roof Chord Discontinuity Unblocked Diaphragms (4:1, 40') Under-Reinforced Walls Under-Reinforced Flat Slabs No Diaphragm-Wall Connection Inadequate Wall-Foundation Connection Deflection Compatibility	CMU mezzanine in boiler room Open front basement, few ext. wd walls CMU walls in basement Brick Façade thin slabs hooked bars not shown unreinforced footings	Basement portion 1984 interior improvements

Bldg. B	1951	0	\$0	\$5,687,500	1	Partial, Crawlspace	No	Approximately Complete Original Documents	Wood Plywood/OSB, Wood Joists, Wood Beams, Wood Trusses	Wood Framed Walls	W2	Wood Frames (Commercial and Industrial Buildings)	High Landslide Susceptibility (DOGAMI) Split Levels Non-redundant (< 2 bays in < 2 lines) Seismic Separation (< 1%) Heavy Cladding System Inadequate In-Plane Shear Plaster or Gypsum Shear Walls Large Unbraced Openings No Floor-to-Floor Connections (Shear and OT) No Wood Post-Foundation Connections No Girder-Column Connections Roof Chord Discontinuity Unblocked Diaphragms (4:1, 40') Bowstring Truss	Building has few exterior walls adjacent to part A Brick façade Large windows at gym/café Gymnasium	No basement portion
Bldg. C	1984	0	\$0	\$190,000	1	None	No	None	Wood Plywood/OSB, Wood Joists, Wood Beams	Timber Frame	Non-compliant	Cantilevered Wood Posts	Post Capacity Foundation Capacity

Bldg. D	1984	0	\$0	\$170,000	1	None	No	None	0	0	Non-compliant	Cantilevered Steel Posts	High Landslide Susceptibility (DOGAMI) Seismic Separation (< 1%) Inadequate base connection Inadequate foundation	poorly attached to parts A & B

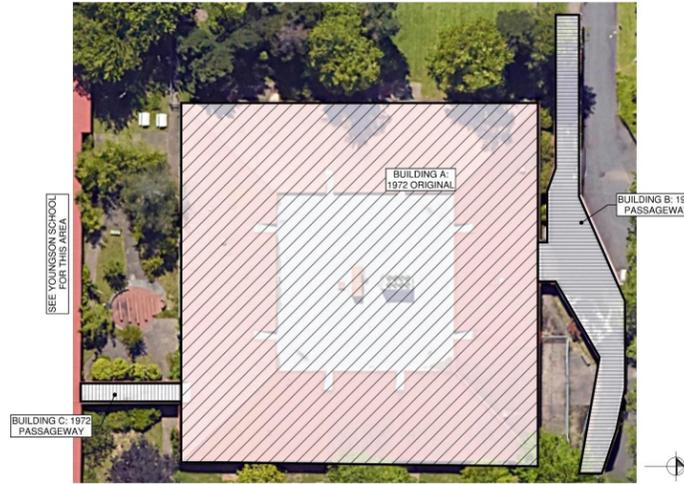
**Building Year Plan:**  
(see below for deficiencies)

Building Part (See Diagram Above)	Year Built	URM (SF)	ROM URM Only Retrofit	ROM Total Retrofit	No. of Stories	Basement	Penthouse	Drawings Referenced	Structural Horizontal Gravity System(s)	Structural Vertical Gravity System(s)	Lateral System (ASCE Designation)	Lateral System (Description)	Likely Deficiencies	Deficiency Notes	Additional Notes
Bldg. A	1972	0	\$0	\$5,355,000	1	None	No	Approximately Complete Original Documents	Wood T+G Plank, Wood Beams	Concrete Columns, Concrete Tilt-up Walls	PC1	Precast or Tilt-up Concrete Shear Walls (Flexible Diaphragm)	Inadequate Foundation Ties Unbraced Mezzanine Split Levels Walls Spaced Far Apart Under-Reinforced Walls Wood Ledgers loaded across grain No Diaphragm-Wall Connection Discontinuous Cross Ties Straight Sheathing (2:1, 24") Inadequate wall chord detailing No opening reinforcement	Mezzanine not torsionally braced  Mezzanine	2018 - partial reroof somewhere on this campus (drawings not available)

Bldg. B	1972	0	\$0	\$210,000	1	None	No	Approximately Complete Original Documents	Wood T+G Plank, Wood Beams	Concrete Columns	Non-compliant	Cantilevered concrete columns	High Landslide Susceptibility (DOGAMI State Overview) Seismic Separation (< 1%) Inadequate Column Shear Capacity Inadequate Column-Foundation Fastening Inadequate Column-Bar Splices (35db, tied) Inadequate Column Ties (d/4, 8db at hinges)		
Bldg. C	1972	0	\$0	\$45,000	1	None	No	Approximately Complete Original Documents	Wood T+G Plank, Wood Beams	Steel Columns	Non-compliant	None identified in drawings	Seismic Separation (< 1%) No lateral system detailed

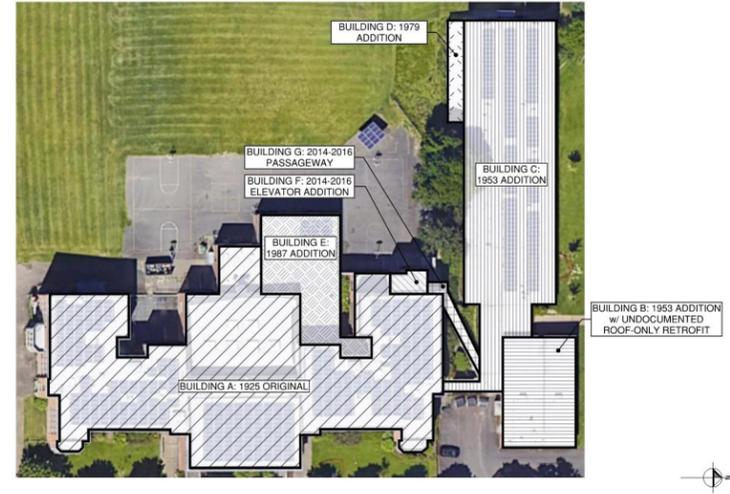
Building Part (See Diagram Above)	Year Built	URM (SF)	ROM URM Only Retrofit	ROM Total Retrofit	No. of Stories	Basement	Penthouse	Drawings Referenced	Structural Horizontal Gravity System(s)	Structural Vertical Gravity System(s)	Lateral System (ASCE Designation)	Lateral System (Description)	Likely Deficiencies	Deficiency Notes	Additional Notes
Bldg. A	1925	0	\$0	\$14,850,000	2	Crawlspace	No	Insufficient Original Documents	Concrete 1-way Slab, Concrete Beams, Wood Trusses, Steel Truss	Conc. CIP Walls, Concrete Columns	C2	Concrete Shear Walls (Stiff Diaphragms)	Inadequate Foundation Ties Reentrant Corners Masonry Partition Walls Concrete Parapets exceed 2.5:1 Heavy Cladding System Deep Spandrels/Narrow Piers (50%, interfering walls) Inadequate In-Plane Shear Under-Reinforced Walls Under-Reinforced Flat Slabs No Diaphragm-Wall Connection Inadequate Wall-Foundation Connection Deflection Compatibility		Drawing scan of extremely poor quality and very difficult to read Gym Truss added in 1987

Bldg. B	1953	0	\$0	\$645,000	1	None	No	Approximately Complete Original Documents	Wood T+G Plank, Wood Beams, Concrete Beams	Reinforced Brick Walls	RM1	Reinforced Masonry Bearing Walls (Flexible Diaphragms)	Non-redundant (< 2 bays in < 2 lines) Walls Spaced Far Apart Under-Reinforced Walls No Diaphragm-Wall Connection No Wall-Foundation Connection Discontinuous Cross Ties Straight Sheathing (2:1, 24')	Shear key only	Partial roof level retrofit observed (drawings not available, approximate year unknown)
Bldg. C	1953	0	\$0	\$2,580,000	1	Partial, Daylight	No	Approximately Complete Original Documents	Wood T+G Plank, Wood Beams, Concrete 2-way Slab	Timber Frame, Concrete Columns, Conc. CIP Walls	W2, C2	Wood Frames (Commercial and Industrial Buildings), Concrete Shear Walls (Stiff Diaphragms)	Sloping Site (full story difference across site) Very High Liquefaction Potential (DOGAMI) Torsional Irregularity Seismic Separation (< 1%) Inadequate In-Plane Shear Plaster or Gypsum Shear Walls Large Unbraced Openings No Floor-to-Floor Connections (Shear and OT) Inadequate Wood Sill-Foundation Connections (6 ft) Roof Chord Discontinuity Straight Sheathing (2:1, 24') Under-Reinforced Walls Deflection Compatibility Diaphragm Reinforcement at Openings	West End Large cantilever at walkout basement Inadequate attachment to parts A & B	W2 at first floor, C2 at daylight basement Recommend monitoring possible settlement at south end

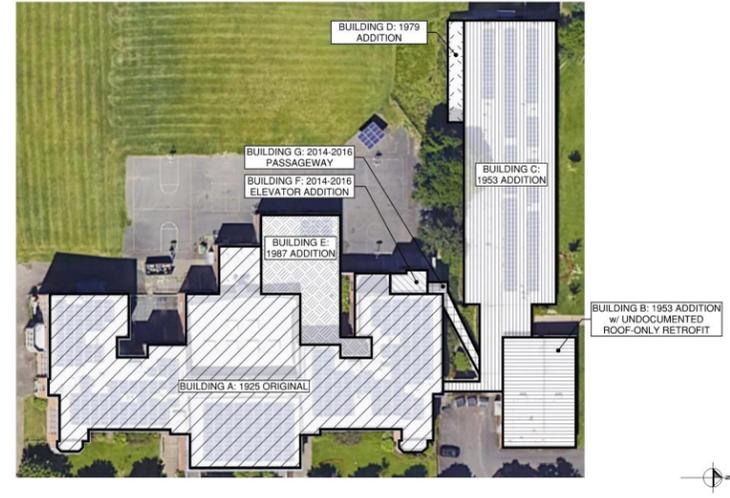
**Building Year Plan:**  
(see below for deficiencies)

Building Part (See Diagram Above)	Year Built	URM (SF)	ROM URM Only Retrofit	ROM Total Retrofit	No. of Stories	Basement	Penthouse	Drawings Referenced	Structural Horizontal Gravity System(s)	Structural Vertical Gravity System(s)	Lateral System (ASCE Designation)	Lateral System (Description)	Likely Deficiencies	Deficiency Notes	Additional Notes
Bldg. E	1987	0	\$0	\$470,000	1	None	No	Approximately Complete Original Documents	Steel Sheet Deck, Steel Joists, Concrete Beams	Reinforced CMU Walls, Reinforced Brick Walls	RM1	Reinforced Masonry Bearing Walls (Flexible Diaphragms)	Seismic Separation (< 1%) Heavy Cladding System Walls Spaced Far Apart Inadequate In-Plane Shear Under-Reinforced Walls Discontinuous Cross Ties	Attached to part A	
Bldg. F	2014	0	\$0	\$0	2	None	No	None	unknown	unknown	unknown	-			Appears to be a benchmark building
Bldg. G	2014	0	\$0	\$0	1	None	No	None	Steel Sheet Deck, Steel Beams	Steel Columns	S1a	Steel Moment Frames (Flexible Diaphragm)			Appears to be a benchmark building
