# 2024 PPS Seismic Assessments: All Schools

Version 1.1  
June 03, 2025

Submitted to:  
Portland Public Schools  
501 N. Dixon Street  
Portland, OR 97227

Submitted by:  
Holmes US  
555 SE MLK Jr. Blvd  
Portland, OR 97214

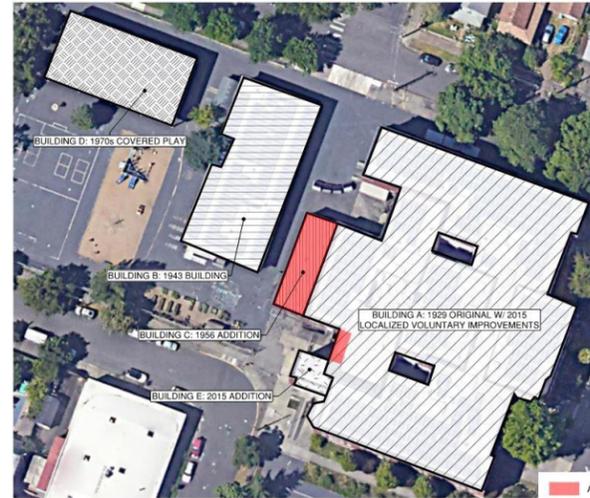
Building Part (See Diagram Above)	Year Built	URM (SF)	ROM URM Only Retrofit	ROM Total Retrofit	No. of Stories	Basement	Penthouse	Drawings Referenced	Structural Horizontal Gravity System(s)	Structural Vertical Gravity System(s)	Lateral System (ASCE Designation)	Lateral System (Description)	Likely Deficiencies	Deficiency Notes	Additional Notes
Bldg. A	1929	100	\$60,000	\$16,135,000	2	Crawlspace, Partial	No	Approximately Complete Original Documents	Concrete Pan-Joists, Concrete Beams, Steel Trusses	Unreinforced Brick Walls, Reinforced Concrete Walls	C2	Concrete Shear Walls (Stiff Diaphragms)	Misc. Load Path Issue Inadequate Wall Anchorage Reentrant Corners Inadequate In-Plane Shear Under-Reinforced Walls Under-Reinforced Flat Slabs No Diaphragm-Wall Connection Beams, Girders, or Trusses bear on URM wall/pilaster Thin Walls (9 top, 15 first, 13 other/single) Masonry Partition Walls URM Parapets exceed 1.5:1 Heavy Cladding System Other observed nonstructural falling hazard	Reinforcing not adequate throughout Concrete deck to walls Lack of continuous full-height concrete wall sections in N-S direction Wire mesh reinforcement only Concrete walls to foundations unknown from drawings and site visit. Large openings, retrofit 2014 HCT partition walls throughout, HCT cavity walls parapets were braced during 2014 seismic retrofit Brick veneer Large concrete cornices	After 2014 Seismic Retrofit, it appears there is still URM present at west entry way. Unable to confirm presence of this URM on site. Tectum is present in the gym, structural diaphragm is deficient concrete pan joists.

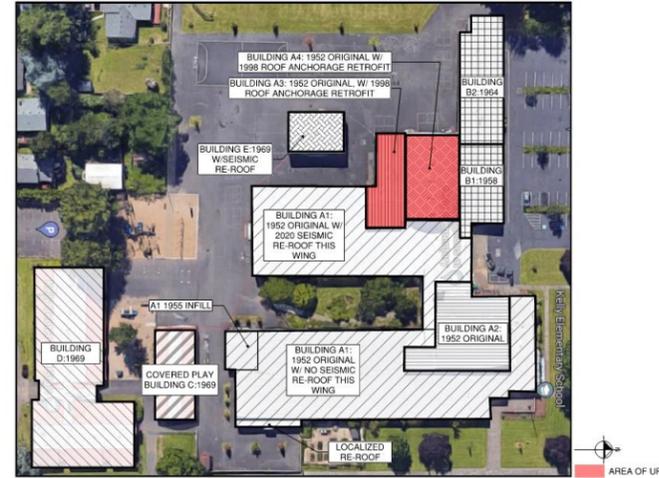
**Building Year Plan:**  
(see below for deficiencies)

Building Part (See Diagram Above)	Year Built	URM (SF)	ROM URM Only Retrofit	ROM Total Retrofit	No. of Stories	Basement	Penthouse	Drawings Referenced	Structural Horizontal Gravity System(s)	Structural Vertical Gravity System(s)	Lateral System (ASCE Designation)	Lateral System (Description)	Likely Deficiencies	Deficiency Notes	Additional Notes
Bldg. A1	1952	0	\$0	\$2,812,500	1	None	No	Approximately Complete Original Documents	Wood Straight/Diag Shtg, Wood Joists, Wood Beams	Wood Framed Walls	W2	Wood Frames (Commercial and Industrial Buildings)	Misc. Load Path Issue Inadequate Foundation Ties Split Levels Reentrant Corners Seismic Separation (< 1%) Heavy Cladding System Inadequate In-Plane Shear Plaster or Gypsum Shear Walls No Floor-to-Floor Connections (Shear and OT)	Steps in roof None Roman brick veneer, attachment unknown Walls have dapped in wood bracing only	
Bldg. A2	1952	0	\$0	\$912,500	1	None	No	Approximately Complete Original Documents	Wood Straight/Diag Shtg, Wood Joists, Wood Beams	Wood Framed Walls	W2	Wood Frames (Commercial and Industrial Buildings)	Misc. Load Path Issue Inadequate Foundation Ties Inadequate Wall Anchorage Seismic Separation (< 1%) URM Chimneys Other observed nonstructural falling hazard Inadequate In-Plane Shear Plaster or Gypsum Shear Walls No Floor-to-Floor Connections (Shear and OT)	Clerestory windows Concrete walls at boiler room None Above boiler room Wall glazing not isolated for story drift Walls have dapped in wood bracing only

Bldg. A3	1952	2500	\$625,000	\$625,000	1	None	No	Approximately Complete Original Documents	Plywood/OSB Sheathing, Wood Joists, Wood Beams	Unreinforced Brick Walls	URM	Unreinforced Masonry Bearing Walls (Flexible Diaphragms)	Inadequate Foundation Ties Vertical LRFS elements are offset Misc. Plan Irregularity Masonry Partition Walls Heavy Cladding System Beams, Girders, or Trusses bear on URM wall/pilaster Inadequate In-Plane Shear Thin Walls (9 top, 15 first, 13 other/single) Cavity Wall Construction	Wood walls on roof arch are offset from brick walls (b)	
Bldg. A4	1952	5200	\$1,300,000	\$1,300,000	1	None	No	Wood Straight/Diag Sheathing, Wood Joists, Wood Beams	Large Diaphragm Openings Adj. Walls (25%, 8' at Ext.)	Unreinforced Brick Walls	URM	Unreinforced Masonry Bearing Walls (Flexible Diaphragms)	Inadequate Foundation Ties Inadequate Wall Anchorage Vertical LRFS elements are offset Heavy Cladding System Beams, Girders, or Trusses bear on URM wall/pilaster Walls Spaced Far Apart Inadequate In-Plane Shear Thin Walls (9 top, 15 first, 13 other/single) Thin Walls (9 top, 15 first, 13 other/single)

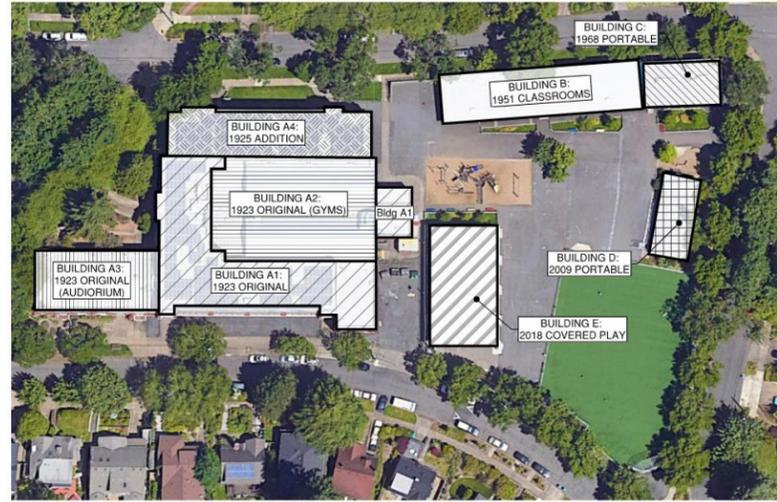
Building Part (See Diagram Above)	Year Built	URM (SF)	ROM URM Only Retrofit	ROM Total Retrofit	No. of Stories	Basement	Penthouse	Drawings Referenced	Structural Horizontal Gravity System(s)	Structural Vertical Gravity System(s)	Lateral System (ASCE Designation)	Lateral System (Description)	Likely Deficiencies	Deficiency Notes	Additional Notes
Bldg. A1	1923	0	\$0	\$5,375,000	2	None	No	Approximately Complete Original Documents	Concrete Pan-Joists, Concrete Beams	Conc. CIP Walls	C2	Concrete Shear Walls (Stiff Diaphragms)	Inadequate Wall Anchorage Reentrant Corners Seismic Separation (< 1%) Masonry Partition Walls URM Chimneys Heavy Cladding System Other observed nonstructural falling hazard Inadequate In-Plane Shear Under-Reinforced Walls Under-Reinforced Flat Slabs No Diaphragm-Wall Connection Inadequate Wall-Foundation Connection Deflection Compatibility	Appears chimney height has been reduced. Unknown time/scope of work brick veneer Cast stone coping typ Check	1923 classrooms + boiler room.

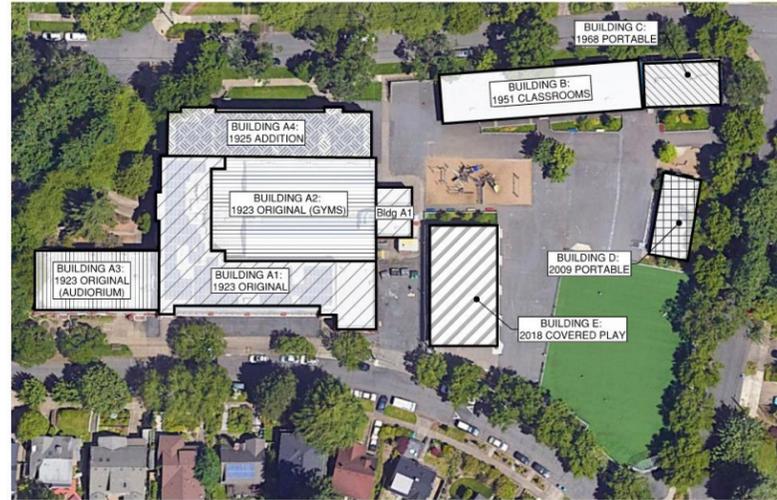
Building Part (See Diagram Above)	Year Built	URM (SF)	ROM URM Only Retrofit	ROM Total Retrofit	No. of Stories	Basement	Penthouse	Drawings Referenced	Structural Horizontal Gravity System(s)	Structural Vertical Gravity System(s)	Lateral System (ASCE Designation)	Lateral System (Description)	Likely Deficiencies	Deficiency Notes	Additional Notes
Bldg. A4	1925	0	\$0	\$3,075,000	2	None	No	Insufficient Original Documents	Concrete Pan-Joists, Concrete 1-way Slab, Concrete Beams	Conc. CIP Walls	C2	Concrete Shear Walls (Stiff Diaphragms)	Inadequate Wall Anchorage Masonry Partition Walls Heavy Cladding System Other observed nonstructural falling hazard Under-Reinforced Walls Under-Reinforced Flat Slabs No Diaphragm-Wall Connection Inadequate Wall-Foundation Connection Deflection Compatibility	Brick veneer Cast stone coping typ	1925 Addition to north side of building. Construction of south wall to playshed is unclear. 1923/1937 drawings indicate that the original 1923 wall was designed to accommodate an addition. However, the 1925 drawings for the addition suggest that the wall part adjacent to the playshed was reconstructed. The provided 1925 set did not include structural drawings or a section of this area.

Bldg. B	1951	0	\$0	\$540,000	1	None	No	Insufficient Original Documents	Wood Straight/Diag Sheathing, Wood Beams	Wood Framed Walls	W2	Wood Frames (Commercial and Industrial Buildings)	Inadequate Wall Anchorage Heavy Cladding System Roof Chord Discontinuity Straight Sheathing (2:1, 24')	Check roof-wall connection. Drawings not available Brick veneer on east & west walls only Check - drawings not available	1951 Classroom Building. Northeast of original building. Provided drawings were incomplete and did not include sections detailing wall/roof connections
Bldg. C	1968	0	\$0	\$142,500	1	None	No	Insufficient Original Documents	Wood Plywood/OSB	Timber Frame	W2	Wood Frames (Commercial and Industrial Buildings)	Inadequate Wall Anchorage Roof Chord Discontinuity	Check roof-wall connection. Drawings not available Requires check	1968 portable classroom unit. Located east of 1951 classroom building. Appears to be two units adjacent to one another. Minimal information available - Roof repair in 2004 showed some details of roof framing.

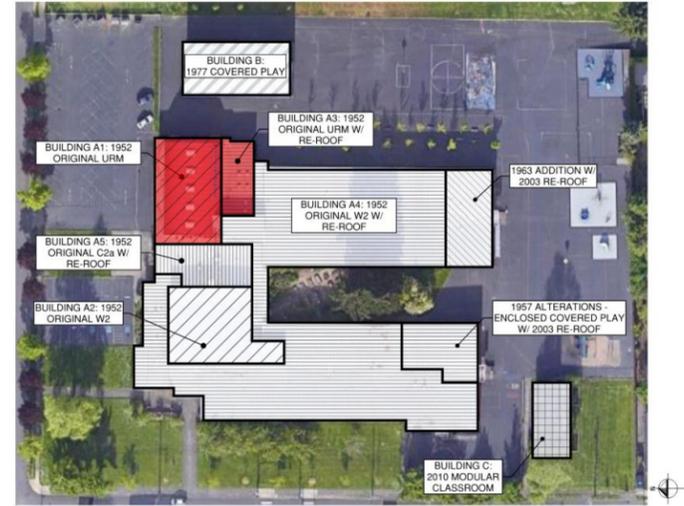
Building Part (See Diagram Above)	Year Built	URM (SF)	ROM URM Only Retrofit	ROM Total Retrofit	No. of Stories	Basement	Penthouse	Drawings Referenced	Structural Horizontal Gravity System(s)	Structural Vertical Gravity System(s)	Lateral System (ASCE Designation)	Lateral System (Description)	Likely Deficiencies	Deficiency Notes	Additional Notes
Bldg. A1	1952	5700	\$1,430,000	\$1,430,000	1	None	No	Approximately Complete Original Documents	Wood Straight/Diag Sheathing, Wood Joists, Wood Beams	Unreinforced Brick Walls	URM	Unreinforced Masonry Bearing Walls (Flexible Diaphragms)	Inadequate Foundation Ties Inadequate Wall Anchorage Vertical LRFs elements are offset Heavy Cladding System Beams, Girders, or Trusses bear on URM wall/pilaster Walls Spaced Far Apart Inadequate In-Plane Shear Thin Walls (9 top, 15 first, 13 other/single) Cavity Wall Construction No Diaphragm-Wall Connection Straight Sheathing (2:1, 24')	Doesn't appear to be a positive connection between fdn base and stem 2003 upgrade did not include OOP connection @ gym walls Wood walls on roof arch are offset from brick walls Rafters for hallway to west bear on URM Perimeter walls only b=8", h=10.583', h/b=15.9>13 Exterior walls appear to have cavity w/ ties only at the top Non-quantifiable load paths - no nailing info	Gym. Walls are unreinforced brick masonry (double leaf w/ cavity). Roof is comprised of large glulam arch. NOT part of 2003 re-roof/seismic strengthening project.

Bldg. A2	1952	0	\$0	\$830,000	1	None	Yes	Approximately Complete Original Documents	Wood Straight/Diag Sheathing, Wood Joists, Wood Beams	Wood Framed Walls	W2	Wood Frames (Commercial and Industrial Buildings)	Misc. Load Path Issue Inadequate Foundation Ties Unbraced Mezzanine Split Levels Misc. Plan Irregularity Inadequate In-Plane Shear Plaster or Gypsum Shear Walls No Floor-to-Floor Connections (Shear and OT) Roof Chord Discontinuity Straight Sheathing (2:1, 24')	West wall does not extent to diaphragm Doesn't appear to be a positive connection between fdn base and stem Mezz near stage & fan rooms Cafeteria roof & fan room floor/roof (Bldg A4) Possible stiffness incompatibility with conc. walls @ boiler room Walls have dapped in wood bracing only	Cafeteria w/ stage & area with fan room (penthouse). NOT part of 2003 re-roof/seismic strengthening project.
Bldg. A3	1952	1900	\$475,000	\$475,000	1	None	No	Approximately Complete Original Documents	Wood Straight/Diag Sheathing, Wood Joists, Wood Beams	Structural Glazed Tile Walls	URM	Unreinforced Masonry Bearing Walls (Flexible Diaphragms)	Inadequate Foundation Ties Inadequate Wall Anchorage Misc. Plan Irregularity Masonry Partition Walls Heavy Cladding System Thin Walls (9 top, 15 first, 13 other/single) No Diaphragm-Wall Connection Diagonal Sheathing (4:1, 40')	Doesn't appear to be a positive connection between foundation base and stem Stiffness incompatibility with timber framed portion of structure 6" glazed tile walls typ brick veneer b=6", h=10.583', h/b=21.2>13 Re-roof in 2003 - confirm adequate	Locker rooms. Glazed tile walls typ. Area was part of 2003 re-roof & partial seismic strengthening. However those plans do not have a glazed tile wall detail.

Bldg. A4	1952	0	\$0	\$3,139,875	1	Partial	No	Approximately Complete Original Documents	Wood Straight/Diag Sheathing, Wood Joists, Wood Beams	Wood Framed Walls	W2	Wood Frames (Commercial and Industrial Buildings)	Inadequate Foundation Ties Split Levels Reentrant Corners Misc. Plan Irregularity Heavy Cladding System Inadequate In-Plane Shear Roof Chord Discontinuity	No positive connection between foundation base and stem Cafeteria roof Stiffness incompatibility with boiler room area (conc. walls) Brick veneer Walls have dapped in wood bracing only	Basement storage area under kindergarten classroom (see section A/10). 1957 alterations include enclosing covered play w/ same details and materials as original construction. 1963 Addition was a two classroom extension added to the south end of the east classroom wing. Also matched materials and detailing of original design. 2003 re-roof and partial lateral upgrade.

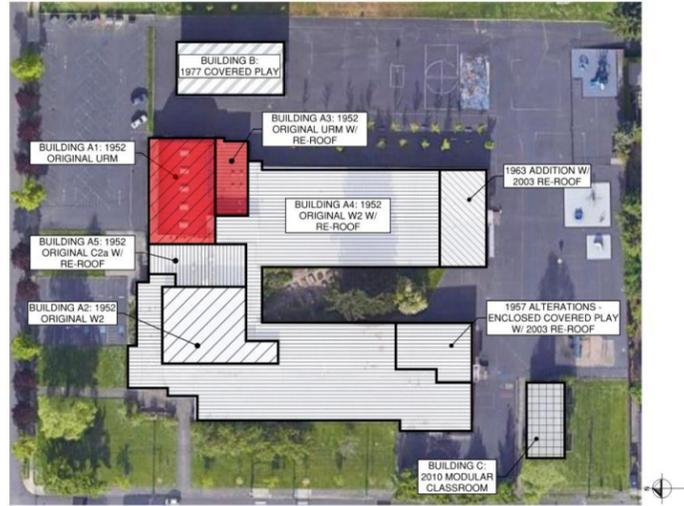
Building Part (See Diagram Above)	Year Built	URM (SF)	ROM URM Only Retrofit	ROM Total Retrofit	No. of Stories	Basement	Penthouse	Drawings Referenced	Structural Horizontal Gravity System(s)	Structural Vertical Gravity System(s)	Lateral System (ASCE Designation)	Lateral System (Description)	Likely Deficiencies	Deficiency Notes	Additional Notes
Bldg. A5	1952	0	\$0	\$717,500	1	None	No	Approximately Complete Original Documents	Wood Straight/Diag Sheathing, Wood Joists, Wood Beams	Conc. CIP Walls	C2a	Concrete Shear Walls (Flexible Diaphragms)	Inadequate Wall Anchorage Misc. Plan Irregularity URM Chimneys Heavy Cladding System Under-Reinforced Walls No Diaphragm-Wall In-Plane Connection Discontinuous Cross Ties	OOP wall anchorage not upgraded in 2003 re-roof possible stiffness incompatibility w/ surrounding timber frame structure 8" thick wall, 1/2" di @ 16" o.c. e.w., p=0.0015 part of 2003 re-roof, check adequacy	see section A/11 for wall reinforcement. 2003 re-roof & partial lateral strengthening.

Bldg. B	1977	0	\$0	\$288,750	1	None	No	None	Wood Plywood/OSB, Wood Beams, Wood Truss	Timber Frame	N/C	Cantilevered Wood Posts	Post Capacity Foundation Capacity		Play structure constructed circa 1977. Roof is timber truss with steel tubes used for webs.
Bldg. C	2010	0	\$0	\$0	1	Crawlspace	No	Approximately Complete Original Documents	Wood Plywood/OSB, Wood Joists, Wood Beams	Wood Framed Walls	W2	Wood Frames (Commercial and Industrial Buildings)			Benchmark Building.

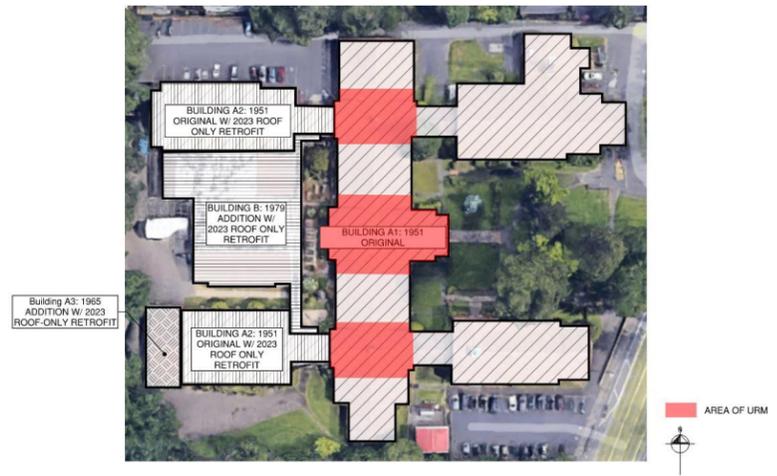
Building Part (See Diagram Above)	Year Built	URM (SF)	ROM URM Only Retrofit	ROM Total Retrofit	No. of Stories	Basement	Penthouse	Drawings Referenced	Structural Horizontal Gravity System(s)	Structural Vertical Gravity System(s)	Lateral System (ASCE Designation)	Lateral System (Description)	Likely Deficiencies	Deficiency Notes	Additional Notes
Bldg. A1	1951	11000	\$2,200,000	\$6,410,000	1	None	No	Approximately Complete Original Documents	Wood Trusses w/ straight sheathing	Wood Framed Bearing Walls	W2, URM	Wood and URM shear walls	Misc. Load Path Issue Reentrant Corners Overturning Seismic Separation (< 1%) Inadequate In-Plane Shear Diagonal Sheathing (4:1, 40') Beams, Girders, or Trusses bear on URM wall/pilaster Thin Walls (9 top, 15 first, 13 other/single) Discontinuous Cross Ties Heavy Cladding System	Indirect connection of roof to walls No holddowns at shear walls Buildings Interconnected Likely at larger spaces like the Auditorium and Lunch Room URM bearing walls only at 4 locations within the central portion of the building Perpendicular to truss spans Brick Veneer

Bldg. A2	1951	0	\$0	\$1,830,000	1	None	No	Approximately Complete Original Documents	Wood Trusses w/ straight sheathing, Wood Trusses w/ straight sheathing & plywood overlay	Wood Framed Bearing Walls	W2	Wood Frames (Commercial and Industrial Buildings)	Reentrant Corners Overturning Seismic Separation (< 1%) Heavy Cladding System	No holddowns at shear walls Buildings Interconnected Brick Veneer	
Bldg. A3	1951	0	\$0	\$265,000	1	None	No	Approximately Complete Original Documents	Wood Trusses w/ straight sheathing	Wood Framed Bearing Walls	W2	Wood Frames (Commercial and Industrial Buildings)	Overturning Heavy Cladding System	No holddowns at shear walls Brick Veneer	
Bldg. B	1979	0	\$0	\$862,500	1	None	No	Approximately Complete Original Documents	Wood Joists, Wood Beams	Concrete Tilt-up Walls	PC1	Precast or Tilt-up Concrete Shear Walls (Flexible Diaphragm)	No Wall-Foundation Connection	Walls connected to slab only

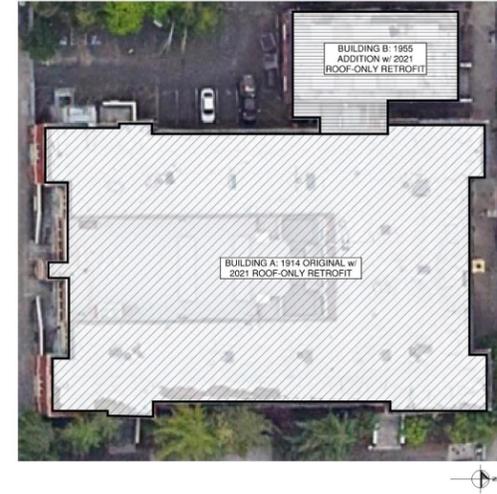
Building Part (See Diagram Above)	Year Built	URM (SF)	ROM URM Only Retrofit	ROM Total Retrofit	No. of Stories	Basement	Penthouse	Drawings Referenced	Structural Horizontal Gravity System(s)	Structural Vertical Gravity System(s)	Lateral System (ASCE Designation)	Lateral System (Description)	Likely Deficiencies	Deficiency Notes	Additional Notes
Bldg. A	1914	0	\$0	\$18,645,000	2	Daylight	No	Approximately Complete Original Documents	Concrete 1-way Slab, Concrete Pan-Joists, Concrete Beams	Concrete Columns, Conc. CIP Walls, Unreinforced Brick Walls	C2, C3	Concrete Shear Walls (Stiff Diaphragms), Concrete Frames with Infill Masonry Shear Walls (Stiff Diaphragms)	Split Levels Misc. Moderate Vertical Irregularity Reentrant Corners Large Diaphragm Openings (50%) Masonry Partition Walls Heavy Cladding System Inadequate In-Plane Shear Under-Reinforced Walls Under-Reinforced Flat Slabs No Diaphragm-Wall Connection (Conc.) Inadequate Wall-Foundation Connection Deflection Compatibility Diaphragm Reinforcement at Openings Thin Walls (>1:9) Inadequate In-Plane Shear No diaphragm-wall connection (URM)	Diaphragm steps at auditorium Conc. Walls over infilled frames Large skylights Brick façade Thin slabs HCT	1999 CMU elevator shaft 2021 roof-only seismic upgrade

Bldg. B	1955	0	\$0	\$360,000	1	None	No	Approximately Complete Original Documents	Concrete 1-way Slab, Concrete Beams, Steel Beams	Conc. CIP Walls	C2	Concrete Shear Walls (Stiff Diaphragms)	Split Levels Seismic Separation (< 1%) Heavy Cladding System Inadequate In-Plane Shear Under-Reinforced Walls Under-Reinforced Flat Slabs No Diaphragm-Wall Connection (Conc.) Inadequate Wall-Foundation Connection Diaphragm Reinforcement at Openings	Entryway steps Attached lobby between part A	2021 roof-only seismic upgrade

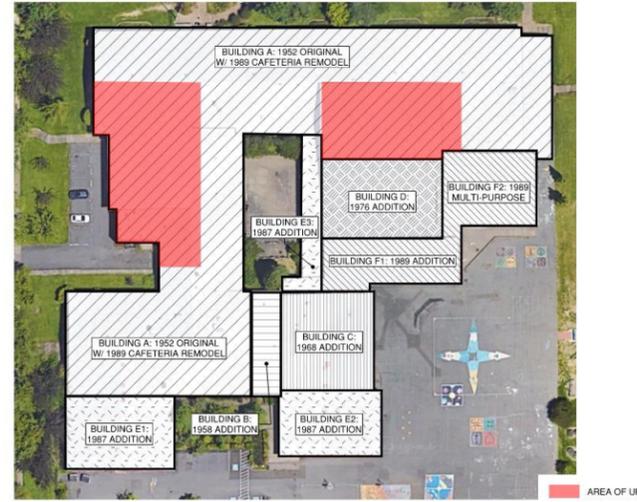
Building Part (See Diagram Above)	Year Built	URM (SF)	ROM URM Only Retrofit	ROM Total Retrofit	No. of Stories	Basement	Penthouse	Drawings Referenced	Structural Horizontal Gravity System(s)	Structural Vertical Gravity System(s)	Lateral System (ASCE Designation)	Lateral System (Description)	Likely Deficiencies	Deficiency Notes	Additional Notes
Bldg. A	1952	14000	\$4,900,000	\$8,500,000	1	None	No	Approximately Complete Original Documents	Wood Joists, Wood Trusses	Unreinforced Brick Walls, Wood Framed Walls	W2	Wood Frames (Commercial and Industrial Buildings)	Inadequate Foundation Ties Vertical LRFS elements are offset Reentrant Corners Deep Spandrels/Narrow Piers (50%, interfering walls) In-Plane Stress Gypsum Wall board or Plaster Shear walls Inadequate Diaphragm-Wall Connection Other Diaphragms Beams, Girders, or Trusses bear on URM wall/pilaster Inadequate In-Plane Shear Thin Walls (9 top, 15 first, 13 other/single) Cavity Wall Construction Heavy Cladding System	URM walls not adequately tied to foundation Narrow piers Unknown from drawings and unable to determine on site Tectum at Gymnasium Narrow piers at gym URM walls Applicable to URM walls Brick veneer, glass block	URM double height bordering walls of gymnasium and cafeteria.

Bldg. B	1958	0	\$0	\$220,000	1	None	No	Approximately Complete Original Documents	Wood Joists, Wood Trusses	Wood Framed Walls	W2	Wood Frames (Commercial and Industrial Buildings)	Seismic Separation (< 1%) In-Plane Stress Gypsum Wall board or Plaster Shear walls Inadequate Diaphragm-Wall Connection Diagonally Sheathed/Unblocked Diaphragms > 40' or 1:4 Heavy Cladding System	Buildings interconnected Inadequate connection to tie to adjacent structures for lateral Diagonal sheathing Brick veneer	
Bldg. C	1968	0	\$0	\$510,000	1	None	No	Approximately Complete Original Documents	Wood Trusses, Steel Column	Wood Framed Walls	W2	Wood Frames (Commercial and Industrial Buildings)	In-Plane Stress Gypsum Wall board or Plaster Shear walls Heavy Cladding System	Brick veneer	
Bldg. D	1976	0	\$0	\$490,000	1	None	No	Approximately Complete Original Documents	Wood Trusses, Steel Column	Wood Framed Walls	W2	Wood Frames (Commercial and Industrial Buildings)	Seismic Separation (< 1%) Inadequate Sill-Foundation Connection Heavy Cladding System	Buildings interconnected Brick veneer

Bldg. E1 + E2 + E3	1987	0	\$0	\$1,010,000	1	None	No	Approximately Complete Original Documents	Wood Trusses, Wood Beams	Wood Framed Walls	W2	Wood Frames (Commercial and Industrial Buildings)	Seismic Separation (< 1%) Heavy Cladding System	Buildings interconnected Brick Veneer	
Bldg. F1	1989	0	\$0	\$490,000	1	None	No	Approximately Complete Original Documents	Wood Trusses, Wood Beams	Wood Framed Walls	W2	Wood Frames (Commercial and Industrial Buildings)	Seismic Separation (< 1%) Inadequate Sill-Foundation Connection Heavy Cladding System	Brick Veneer	
Bldg. F2	1989	0	\$0	\$487,500	1	None	No	Approximately Complete Original Documents	Wood Beams	Reinforced CMU Walls	RM1	Reinforced Masonry Bearing Walls (Flexible Diaphragms)	Seismic Separation (< 1%) Under-Reinforced Walls No Topping Slab-Wall Connection	Slab not tied into wall footing

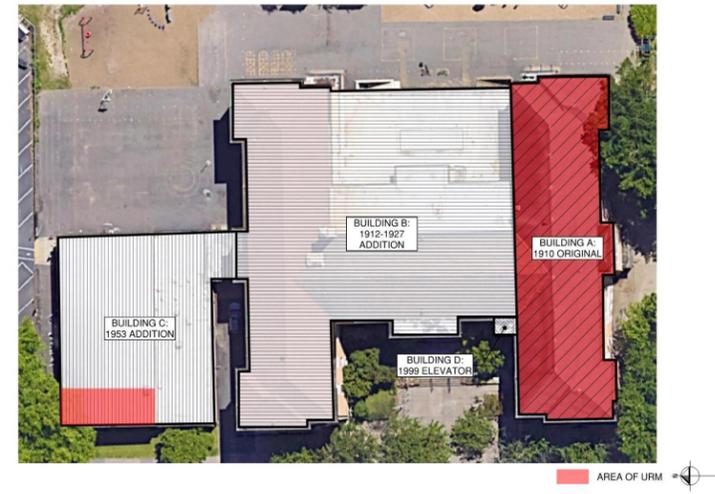
Building Part (See Diagram Above)	Year Built	URM (SF)	ROM URM Only Retrofit	ROM Total Retrofit	No. of Stories	Basement	Penthouse	Drawings Referenced	Structural Horizontal Gravity System(s)	Structural Vertical Gravity System(s)	Lateral System (ASCE Designation)	Lateral System (Description)	Likely Deficiencies	Deficiency Notes	Additional Notes
Bldg. A	1910	8000	\$1,600,000	\$4,000,000	2	Daylight	No	None	Wood Plywood/OSB, Plaster & Lathe, Wood Joists, Steel Truss, Steel Beams	Wood Framed Walls, Conc. CIP Walls, Concrete Columns, Unreinforced Brick Walls	URM, W2	Unreinforced Masonry Bearing Walls (Flexible Diaphragms), Wood Frames (Commercial and Industrial Buildings)	Reentrant Corners Beams, Girders, or Trusses bear on URM wall/pilaster Walls Spaced Far Apart Inadequate In-Plane Shear (URM) Thin Walls (9 top, 15 first, 13 other/single) Wood Ledgers loaded across grain No Diaphragm-Wall Connection No Girder-Column Connections Discontinuous Cross Ties Straight Sheathing (2:1, 24') Inadequate In-Plane Shear (Wood) Plaster or Gypsum Shear Walls Large Unbraced Openings No Floor-to-Floor Connections (Shear and OT) Inadequate Wood Sill-Foundation Connections (6 ft) Roof Chord Discontinuity Masonry Partition Walls		Basement appears to be URM Brick, Wood walls above Original construction: Center wing in 1912, North wing in 1914, gym in 1914 or 1927 1999 - Partial seismic upgrade at URM portion 2023 - roof-only retrofit (assumed seismic retrofit, documentation not available)

Bldg. B	1912	0	\$0	\$8,452,500	2	Daylight	No	Insufficient Original Documents	Wood Plywood/OSB, Plaster & Lathe, Wood Joists, Steel Truss, Concrete Pan-Joists, Steel Beams	Wood Framed Walls, Conc. CIP Walls, Concrete Columns	C3a, W2	Concrete Frames with Infill Masonry Shear Walls, Wood Frames (Commercial and Industrial Buildings)	Reentrant Corners Thin Walls (>1:9) Cavity Wall Construction Inadequate In-Plane Shear Under-Reinforced Flat Slabs No diaphragm-wall connection Deflection Compatibility Discontinuous Cross Ties Straight Sheathing (2:1, 24') Other Diaphragms Inadequate In-Plane Shear Plaster or Gypsum Shear Walls Large Unbraced Openings No Floor-to-Floor Connections (Shear and OT) Inadequate Wood Sill-Foundation Connections (6 ft) Roof Chord Discontinuity Masonry Partition Walls Heavy Cladding System	Slender basement columns. west side plaster & lathe at B1	Documents available: Central Portion: none North Wing: partial East Gym: the 1914 drawings include this area and generally match field observations. However, 1999 drawings indicate this region was constructed in 1927. 2023 - reroof (documentation not available)

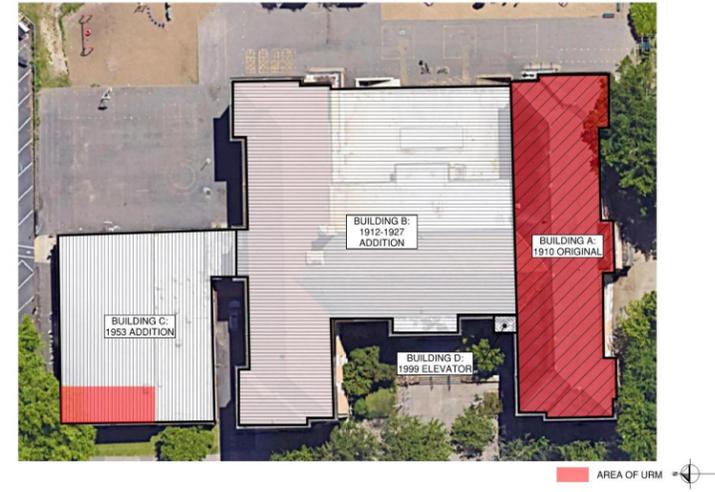
Building Part (See Diagram Above)	Year Built	URM (SF)	ROM URM Only Retrofit	ROM Total Retrofit	No. of Stories	Basement	Penthouse	Drawings Referenced	Structural Horizontal Gravity System(s)	Structural Vertical Gravity System(s)	Lateral System (ASCE Designation)	Lateral System (Description)	Likely Deficiencies	Deficiency Notes	Additional Notes
Bldg. C	1953	800	\$120,000	\$1,020,000	1	None	No	Approximately Complete Original Documents	Wood T+G Plank, Wood Beams, Wood Plywood/OSB, Wood Joists	Timber Frame, Wood Framed Walls	W2	Wood Frames (Commercial and Industrial Buildings)	Split Levels Seismic Separation (< 1%) Inadequate In-Plane Shear Plaster or Gypsum Shear Walls Narrow Wood Shear Walls Large Unbraced Openings No Floor-to-Floor Connections (Shear and OT) Roof Chord Discontinuity Straight Sheathing (2:1, 24') Possible URM bearing wall below stage Heavy Cladding System	cafeteria, kitchen, entry level varies transverse walls at kitchen plan west wall	The only potential URM identified was the stage support

Bldg. D	1999	0	\$0	\$5,000	2	Daylight	No	No	Wood Plywood/OSB, Wood Joists	Wood Framed Walls	W2	Wood Frames (Commercial and Industrial Buildings)	Inadequate tie-backs

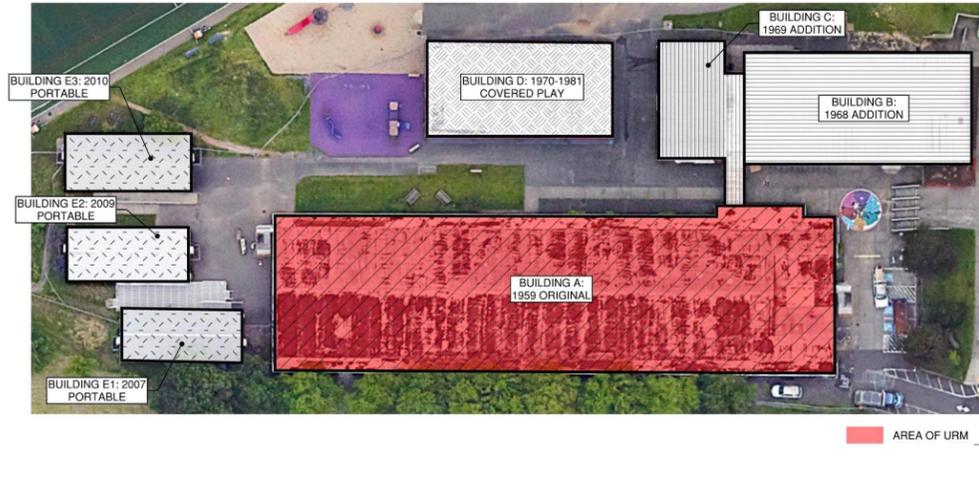
Building Part (See Diagram Above)	Year Built	URM (SF)	ROM URM Only Retrofit	ROM Total Retrofit	No. of Stories	Basement	Penthouse	Drawings Referenced	Structural Horizontal Gravity System(s)	Structural Vertical Gravity System(s)	Lateral System (ASCE Designation)	Lateral System (Description)	Likely Deficiencies	Deficiency Notes	Additional Notes
Bldg. A	1959	20800	\$4,160,000	\$4,160,000	1	Crawlspace	No	Approximately Complete Original Documents	Tectum, Steel Truss, Wood Plywood/OSB	Steel Columns, Unreinforced CMU Walls	URM	Unreinforced Masonry Bearing Walls (Flexible Diaphragms)	High Landslide Susceptibility (DOGAMI State Overview) Inadequate Foundation Ties Split Levels Non-redundant (< 2 bays in < 2 lines) Beams, Girders, or Trusses bear on URM wall/pilaster Inadequate In-Plane Shear Thin Walls (9 top, 15 first, 13 other/single) Unbraced Gable Walls No Diaphragm-Wall Connection Discontinuous Cross Ties URM Chimneys Heavy Cladding System	Roof Diaphragm split at East end Exterior Windows No longitudinal ties shown	Recommend investigating crawlspace for potential joist deterioration (gravity concern) 2000 - partial seismic upgrade 2023 - roof-only seismic upgrade

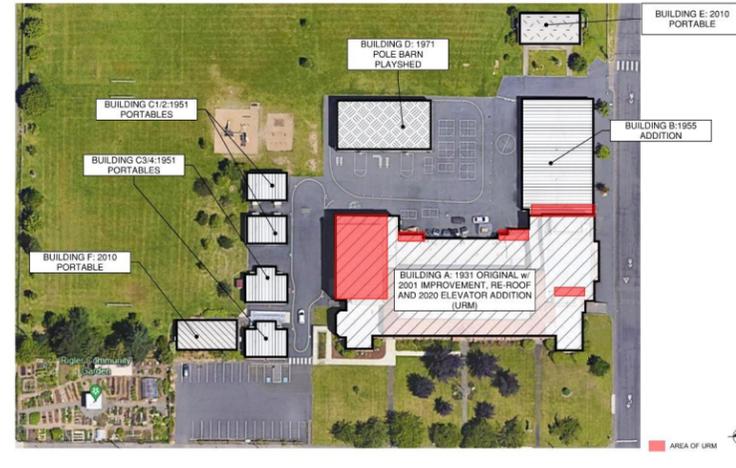
Building Part (See Diagram Above)	Year Built	URM (SF)	ROM URM Only Retrofit	ROM Total Retrofit	No. of Stories	Basement	Penthouse	Drawings Referenced	Structural Horizontal Gravity System(s)	Structural Vertical Gravity System(s)	Lateral System (ASCE Designation)	Lateral System (Description)	Likely Deficiencies	Deficiency Notes	Additional Notes
Bldg. A	1931	7700	\$2,695,000	\$13,870,000	2	Partial	Yes	Approximately Complete Original Documents	Wood Joists, Concrete Pan-Joists	Concrete Columns, Reinforced Concrete Walls, Unreinforced Brick Walls	C2, URMa	Unreinforced Masonry Bearing Walls (Stiff Diaphragms)	High Landslide Susceptibility (DOGAMI State Overview) High, per dogami, lvl site otherwise Inadequate Foundation Ties URM North Restrooms, Gym, and Corridors Inadequate Wall Anchorage URM North Restrooms, Gym, and Corridors Moderate Vertical Element Size Discontinuity (50-75%) Conc Walls at Lvl 2, not lvl 1 and B (library, conservatory, projector room) Misc. Moderate Vertical Irregularity Conc Walls at Lvl 2, not lvl 1 and B (library, conservatory, projector room) Reentrant Corners Gym and Auditorium Wing Misc. Plan Irregularity 1955 Addition flexible but tied to Orig. Torsional Irregularity 1955 Addition flexible but tied to Orig. Seismic Separation (< 1%) Building A and B Interconnected Deep Spandrels/Narrow Piers (50%, interfering walls) At Gymnasium Inadequate In-Plane Shear Likely insufficient No Diaphragm-Wall Connection Likely insufficient Inadequate Wall-Foundation Connection Likely insufficient Deflection Compatibility (Check conc column detailing) Beams, Girders, or Trusses bear on URM wall/pilaster Likely at Gymnasium Walls Spaced Far Apart Gymnasium Inadequate In-Plane Shear Likely at URM walls Cavity Wall Construction Lvl 1 Restrooms 101 Gym, North Restrooms Sheet 11 Masonry Partition Walls HCT Partitions in plan and on site URM Parapets exceed 1.5:1 Longitudinal section A-A at Gym Concrete Parapets exceed 2.5:1 Longitudinal section A-A at Gym Heavy Cladding System Brick veneer

Bldg. B	1955	1000	\$150,000	\$910,000	1	None	No	Approximately Complete Original Documents	Wood Joists, Wood Beams, Wood Plywood/OSB	Wood Framed Walls	W2	Wood Frames (Commercial and Industrial Buildings)	High Landslide Susceptibility (DOGAMI State Overview) High, per dogami, lvl site otherwise Inadequate Foundation Ties Corridor shared with Orig. Bldg. A, wood frame likely inadequate Inadequate Wall Anchorage Corridor shared with Orig. Bldg. A, wood frame likely inadequate Reentrant Corners Addition creates new corner with Orig. Bldg. A Misc. Plan Irregularity 1955 Addition flexible but tied to Orig. Bldg. A Torsional Irregularity 1955 Addition flexible but tied to Orig. Bldg. A Seismic Separation (< 1%) Building A and B Interconnected Inadequate In-Plane Shear Likely Insufficient Inadequate Wood Sill-Foundation Connections (6 ft) Likely Insufficient Straight Sheathing (2:1, 24') Unknown, likely straight/diagonal Other Diaphragms Conc. Diaphragm shown (likely over corridor) Masonry Partition Walls Corridor shared with A URM Parapets exceed 1.5:1 At Restroom Corridor near Orig. Bldg. A URM Appendages over Exit way Likely at Restroom Corridor near Orig. Bldg. A

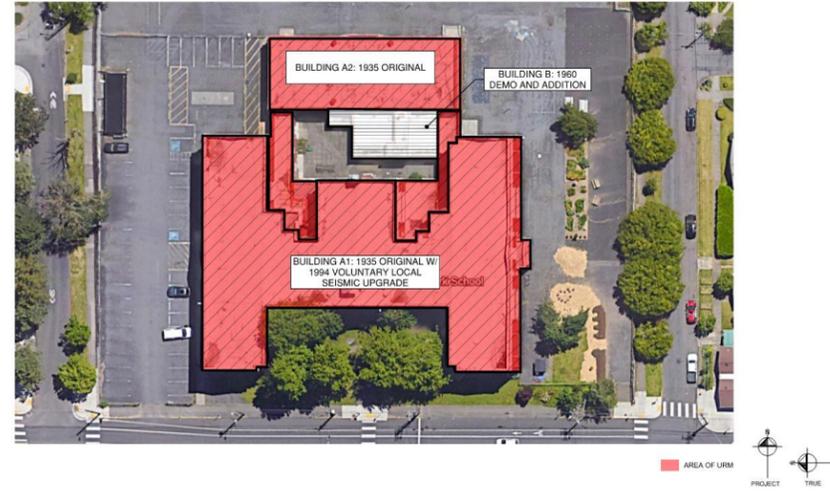
Building Part (See Diagram Above)	Year Built	URM (SF)	ROM URM Only Retrofit	ROM Total Retrofit	No. of Stories	Basement	Penthouse	Drawings Referenced	Structural Horizontal Gravity System(s)	Structural Vertical Gravity System(s)	Lateral System (ASCE Designation)	Lateral System (Description)	Likely Deficiencies	Deficiency Notes	Additional Notes
Bldg. A1	1935	63300	\$18,990,000	\$18,990,000	2	Crawlspace, Partial	No	Insufficient Original Documents	Concrete 1-way Slab, Concrete Beams, Steel Truss	Unreinforced Brick Walls	URMa	Unreinforced Masonry Bearing Walls (Stiff Diaphragms)	Misc. Load Path Issue Inadequate Foundation Ties Inadequate Wall Anchorage Vertical LRFS elements are offset Split Levels Reentrant Corners Seismic Separation (< 1%) Beams, Girders, or Trusses bear on URM wall/pilaster Walls Spaced Far Apart Deep Spandrels/Narrow Piers (50%, interfering walls) Inadequate In-Plane Shear No Diaphragm-Wall Connection Masonry Partition Walls URM Parapets exceed 1.5:1 URM Appendages over Exit way Other observed nonstructural falling hazard	Step in roof diaphragm in passages Not documented or seen on site Not documented or seen on site Center vs Wings Split Buildings Interconnected At Level 2 Assembly Hall at URM at Not Documented or seen on site HCT At Exterior URM Walls Brick Arch Above Main Entrance Brick Arch Above Main Entrance, Plaster Cornice Above Entry

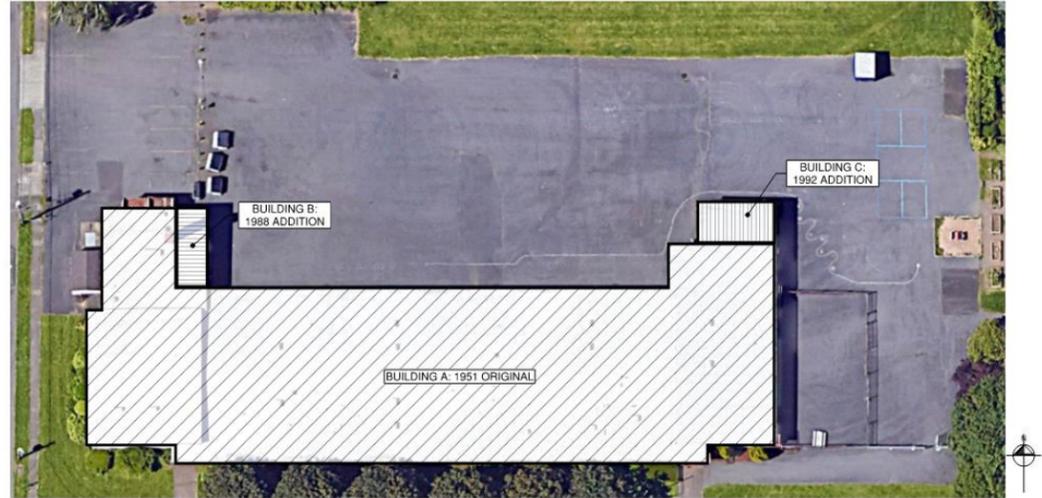
Building Part (See Diagram Above)	Year Built	URM (SF)	ROM URM Only Retrofit	ROM Total Retrofit	No. of Stories	Basement	Penthouse	Drawings Referenced	Structural Horizontal Gravity System(s)	Structural Vertical Gravity System(s)	Lateral System (ASCE Designation)	Lateral System (Description)	Likely Deficiencies	Deficiency Notes	Additional Notes
Bldg. A	1951	0	\$0	\$1,840,000	1	None	No	Approximately Complete Original Documents	Wood Straight/Diag Sheathing, Wood Joists	Wood Framed Walls	W2	Wood Frames (Commercial and Industrial Buildings)	Split Levels Reentrant Corners URM Chimneys Heavy Cladding System Inadequate In-Plane Shear Roof Chord Discontinuity Straight Sheathing (2:1, 24')	At roof only Appears to have some strengthening but extent is unknown. Brick veneer. Shiplap sheathing	Original Structure
Bldg. B	1988	0	\$0	\$30,000	1	None	No	Approximately Complete Original Documents	Wood Straight/Diag Sheathing, Wood Joists	Wood Framed Walls	W2	Wood Frames (Commercial and Industrial Buildings)	Straight Sheathing (2:1, 24')	28'-0" span	1988 storage addition. Encloses original outdoor corridor. Original roof structure.

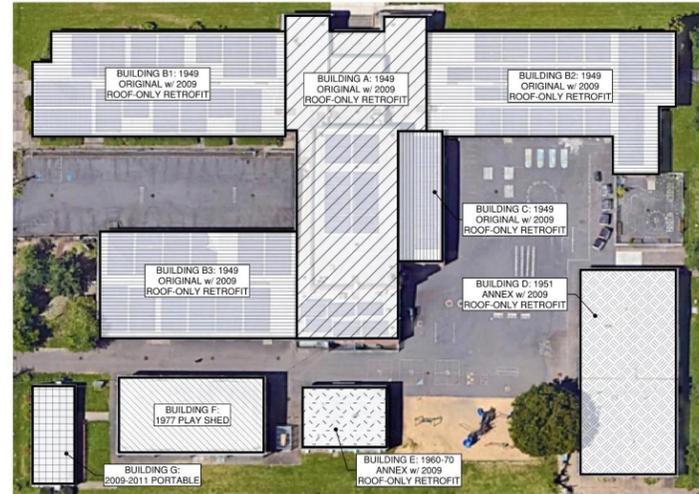
**Building Year Plan:**  
(see below for deficiencies)

Building Part (See Diagram Above)	Year Built	URM (SF)	ROM URM Only Retrofit	ROM Total Retrofit	No. of Stories	Basement	Penthouse	Drawings Referenced	Structural Horizontal Gravity System(s)	Structural Vertical Gravity System(s)	Lateral System (ASCE Designation)	Lateral System (Description)	Likely Deficiencies	Deficiency Notes	Additional Notes
Bldg. A	1949	0	\$0	\$3,200,000	1	Daylight	No	Insufficient Original Documents	Wood T+G Plank, Steel Joists, Wood Plywood/OSB, Wood Joists, Concrete Pan-Joists, Concrete Beams, Concrete 1-way Slab	Conc. CIP Walls	C2, C2a	Concrete Shear Walls (Stiff & Flexible Diaphragms)	Split Levels Reentrant Corners Masonry Partition Walls URM Chimneys Heavy Cladding System Deep Spandrels/Narrow Piers (50%, interfering walls) Inadequate In-Plane Shear Under-Reinforced Walls Under-Reinforced Flat Slabs Inadequate Wall-Foundation Connection Deflection Compatibility Discontinuous Cross Ties	Thin slabs	2009 seismic upgrade at roof level only

Bldg. B1	1949	0	\$0	\$2,310,000	1	None	No	Insufficient Original Documents	Wood Straight/Diag Sheathing, Wood Joists	Wood Framed Walls, Steel Columns	W2	Wood Frames (Commercial and Industrial Buildings)	Reentrant Corners Non-redundant (< 2 bays in < 2 lines) Seismic Separation (< 1%) Heavy Cladding System Inadequate In-Plane Shear Plaster or Gypsum Shear Walls Large Unbraced Openings No Floor-to-Floor Connections (Shear and OT) Inadequate Wood Sill-Foundation Connections (6 ft)	Adjacent to parts A	2009 seismic upgrade at roof level only
Bldg. B2	1949	0	\$0	\$2,310,000	1	None	No	Insufficient Original Documents	Wood Straight/Diag Sheathing, Wood Joists	Wood Framed Walls, Steel Columns	W2	Wood Frames (Commercial and Industrial Buildings)	Reentrant Corners Non-redundant (< 2 bays in < 2 lines) Seismic Separation (< 1%) Heavy Cladding System Inadequate In-Plane Shear Plaster or Gypsum Shear Walls Large Unbraced Openings No Floor-to-Floor Connections (Shear and OT) Inadequate Wood Sill-Foundation Connections (6 ft)	Adjacent to parts A & C	2009 seismic upgrade at roof level only

Bldg. B3	1949	0	\$0	\$2,310,000	1	None	No	Insufficient Original Documents	Wood Straight/Diag Sheathing, Wood Joists	Wood Framed Walls, Steel Columns	W2	Wood Frames (Commercial and Industrial Buildings)	Reentrant Corners Non-redundant (< 2 bays in < 2 lines) Seismic Separation (< 1%) Heavy Cladding System Inadequate In-Plane Shear Plaster or Gypsum Shear Walls Large Unbraced Openings No Floor-to-Floor Connections (Shear and OT) Inadequate Wood Sill-Foundation Connections (6 ft)	Adjacent to parts A	2009 seismic upgrade at roof level only
Bldg. C	1949	0	\$0	\$250,000	1	None	No	Insufficient Original Documents	Wood Plywood/OSB, Wood T+G Plank, Steel Joists, Steel Beam	Conc. CIP Walls, Steel Columns	C2a	Concrete Shear Walls (Flexible Diaphragms)	Inadequate Foundation Ties Torsional Irregularity Masonry Partition Walls URM Bearing walls	Asphalt slab Open-fronted structure	2009 seismic upgrade at roof level only

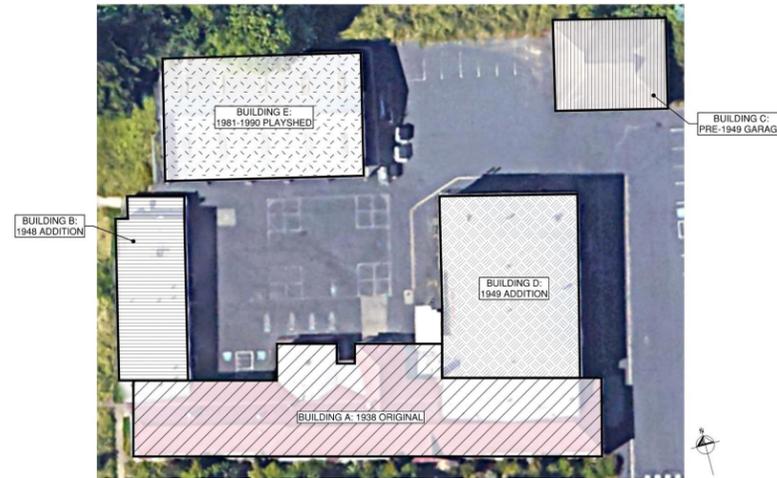
**Building Year Plan:**  
(see below for deficiencies)

Building Part (See Diagram Above)	Year Built	URM (SF)	ROM URM Only Retrofit	ROM Total Retrofit	No. of Stories	Basement	Penthouse	Drawings Referenced	Structural Horizontal Gravity System(s)	Structural Vertical Gravity System(s)	Lateral System (ASCE Designation)	Lateral System (Description)	Likely Deficiencies	Deficiency Notes	Additional Notes
Bldg. A	1938	0	\$0	\$2,925,000	1	Daylight	No	Insufficient Original Documents	Wood Battens, Wood Joists, Concrete 1-way Slab, Concrete Beams	Wood Framed Walls, Conc. CIP Walls	W2, C2a, C2	Wood Frames (Commercial and Industrial Buildings), Concrete Shear Walls (Flexible and Stiff Diaphragms)	<ul style="list-style-type: none"> <li>Inadequate Foundation Ties</li> <li>Split Levels</li> <li>Reentrant Corners</li> <li>Non-redundant (&lt; 2 bays in &lt; 2 lines)</li> <li>URM Chimneys</li> <li>Heavy Cladding System</li> <li>Inadequate In-Plane Shear</li> <li>Plaster or Gypsum Shear Walls</li> <li>Large Unbraced Openings</li> <li>No Floor-to-Floor Connections (Shear and OT)</li> <li>No Wood Post-Foundation Connections</li> <li>Inadequate Wood Sill-Foundation Connections (6 ft)</li> <li>No Girder-Column Connections</li> <li>Roof Chord Discontinuity</li> <li>Other Diaphragms</li> <li>Under-Reinforced Walls</li> <li>Under-Reinforced Flat Slabs</li> <li>No Diaphragm-Wall Connection</li> <li>Inadequate Wall-Foundation Connection</li> <li>Deflection Compatibility</li> <li>Discontinuous Cross Ties</li> <li>Skip sheathing</li> <li>Straight Sheathing (2:1, 24')</li> </ul>		Constructed in 1938 and 1942 2023 Partial roof-only seismic upgrade somewhere on this campus reported by PPS (no drawings available)

Bldg. B	1942	0	\$0	\$775,000	1	Daylight	No	None	Wood Straight/Diag Sheathing, Wood Trusses, Wood Joists	Wood Framed Walls, Conc. CIP Walls	W2, C2	Wood Frames (Commercial and Industrial Buildings), Concrete Shear Walls (Stiff Diaphragms)	<ul style="list-style-type: none"> <li>High Landslide Susceptibility (DOGAMI State Overview)</li> <li>Inadequate Foundation Ties</li> <li>Split Levels</li> <li>Reentrant Corners</li> <li>Non-redundant (&lt; 2 bays in &lt; 2 lines)</li> <li>URM Chimneys</li> <li>Heavy Cladding System</li> <li>Inadequate In-Plane Shear</li> <li>Plaster or Gypsum Shear Walls</li> <li>Large Unbraced Openings</li> <li>No Floor-to-Floor Connections (Shear and OT)</li> <li>No Wood Post-Foundation Connections</li> <li>Inadequate Wood Sill-Foundation Connections (6 ft)</li> <li>No Girder-Column Connections</li> <li>Roof Chord Discontinuity</li> <li>Straight Sheathing (2:1, 24')</li> <li>Under-Reinforced Walls</li> <li>Under-Reinforced Flat Slabs</li> <li>No Diaphragm-Wall Connection</li> <li>Inadequate Wall-Foundation Connection</li> <li>Deflection Compatibility</li> <li>Diaphragm Reinforcement at Openings</li> </ul>		1956 second floor & furnace room added

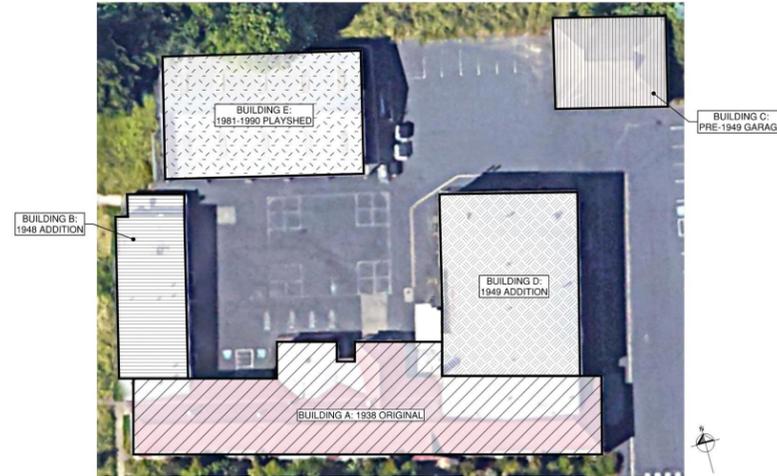
**Building Year Plan:**  
(see below for deficiencies)

Building Part (See Diagram Above)	Year Built	URM (SF)	ROM URM Only Retrofit	ROM Total Retrofit	No. of Stories	Basement	Penthouse	Drawings Referenced	Structural Horizontal Gravity System(s)	Structural Vertical Gravity System(s)	Lateral System (ASCE Designation)	Lateral System (Description)	Likely Deficiencies	Deficiency Notes	Additional Notes
Bldg. C	1938	0	\$0	\$187,500	1	None	No	None	Wood Battens, Wood Trusses	Wood Framed Walls, Conc. CIP Walls	W2	Wood Frames (Commercial and Industrial Buildings)	Sloping Site (full story difference across site) Inadequate Foundation Ties Inadequate In-Plane Shear Narrow Wood Shear Walls Unbraced Cripple Walls Large Unbraced Openings No Floor-to-Floor Connections (Shear and OT) No Wood Post-Foundation Connections Inadequate Wood Sill-Foundation Connections (6 ft) No Girder-Column Connections Roof Chord Discontinuity Other Diaphragms	Skip sheathing	
Bldg. D	1949	0	\$0	\$1,890,000	1	Full	No	Insufficient Original Documents	Wood Plywood/OSB, Wood Joists, Wood Trusses, Concrete 2-way Slab, Concrete Beams	Wood Framed Walls	W2, C2	Wood Frames (Commercial and Industrial Buildings), Concrete Shear Walls (Stiff Diaphragms)	Inadequate Foundation Ties Seismic Separation (< 1%) Masonry Partition Walls Inadequate In-Plane Shear Narrow Wood Shear Walls No Floor-to-Floor Connections (Shear and OT) No Wood Post-Foundation Connections Inadequate Wood Sill-Foundation Connections (6 ft) Roof Chord Discontinuity Unblocked Diaphragms (4:1, 40') wood barrel vault Inadequate In-Plane Shear Under-Reinforced Walls Under-Reinforced Flat Slabs No Diaphragm-Wall Connection Inadequate Wall-Foundation Connection Diaphragm Reinforcement at Openings

Bldg. E	1981	0	\$0	\$300,000	1	None	No	None	CFS Joists, Steel Beams	Steel Columns	S3	Metal Building Frames	Misc. Plan Irregularity Inadequate Frame Moment Capacity Inadequate Brace Axial Capacity No Beam Bottom Flange Bracing No Bracing of Beam-Column Joints Inadequate Diaphragm-Frame Connection Inadequate Column-Foundation Connection Inadequate Connection Moment Capacity No Attachment of Roof Diaphragm Panels

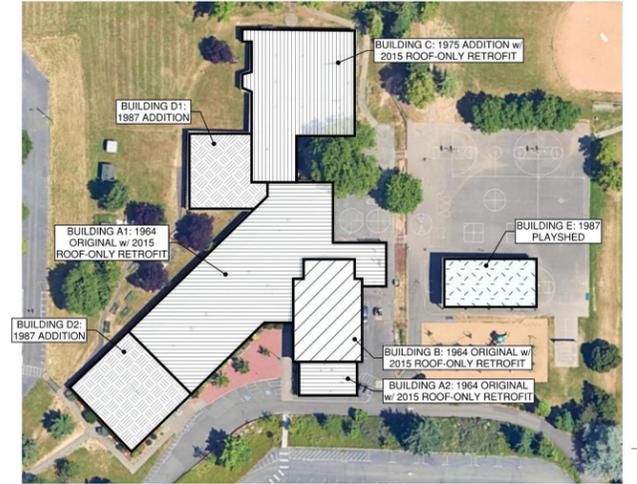
**Building Year Plan:**  
(see below for deficiencies)

Building Part (See Diagram Above)	Year Built	URM (SF)	ROM URM Only Retrofit	ROM Total Retrofit	No. of Stories	Basement	Penthouse	Drawings Referenced	Structural Horizontal Gravity System(s)	Structural Vertical Gravity System(s)	Lateral System (ASCE Designation)	Lateral System (Description)	Likely Deficiencies	Deficiency Notes	Additional Notes
Bldg. A1	1964	0	\$0	\$1,660,000	1	Crawlspace	No	Approximately Complete Original Documents	Wood Plywood/OSB, Wood Trusses	Wood Framed Walls	W2	Wood Frames (Commercial and Industrial Buildings)	Sloping Site (full story difference across site) Inadequate Foundation Ties Reentrant Corners Inadequate In-Plane Shear Plaster or Gypsum Shear Walls Unbraced Cripple Walls Large Unbraced Openings No Floor-to-Floor Connections (Shear and OT) Inadequate Wood Sill-Foundation Connections (6 ft)	S.O.G. in some areas	2015 - partial roof-only seismic upgrade (structural drawings not available)

Bldg. A2	1964	0	\$0	\$140,000	1	Crawlspace	No	Approximately Complete Original Documents	Wood Plywood/OSB, Wood Trusses	Wood Framed Walls	W2	Wood Frames (Commercial and Industrial Buildings)	Sloping Site (full story difference across site) Inadequate Foundation Ties Reentrant Corners Inadequate In-Plane Shear Plaster or Gypsum Shear Walls Unbraced Cripple Walls Large Unbraced Openings No Floor-to-Floor Connections (Shear and OT) Inadequate Wood Sill-Foundation Connections (6 ft)	S.O.G. in some areas	2015 - partial roof-only seismic upgrade (structural drawings not available)
Bldg. B	1964	0	\$0	\$4,020,000	1	None	No	Approximately Complete Original Documents	Wood T+G Plank, Concrete Beams	Concrete Columns, Concrete Tilt-up Walls	PC1	Precast or Tilt-up Concrete Shear Walls (Flexible Diaphragm)	Inadequate Foundation Ties Reentrant Corners Seismic Separation (< 1%) URM Chimneys Walls Spaced Far Apart Inadequate In-Plane Shear Under-Reinforced Walls Inadequate Girder-Wall/Pilaster Connections No Wall-Foundation Connection	Attached to concrete construction	2015 - partial roof-only seismic upgrade (structural drawings not available)

Bldg. C	1975	0	\$0	\$772,500	3	None	No	Approximately Complete Original Documents	Wood Plywood/OSB, Wood Truss-Joists, Wood Beams	Wood Framed Walls, Timber Frame	W2	Wood Frames (Commercial and Industrial Buildings)	Split Levels Reentrant Corners Inadequate In-Plane Shear Narrow Wood Shear Walls Large Unbraced Openings		2015 - partial roof-only seismic upgrade (structural drawings not available)
Bldg. D1	1987	0	\$0	\$277,500	1	None	No	None	Wood Plywood/OSB, Wood Trusses	Wood Framed Walls	W2	Wood Frames (Commercial and Industrial Buildings)	Split Levels Inadequate In-Plane Shear Plaster or Gypsum Shear Walls Large Unbraced Openings Roof Chord Discontinuity Unblocked Diaphragms (4:1, 40')

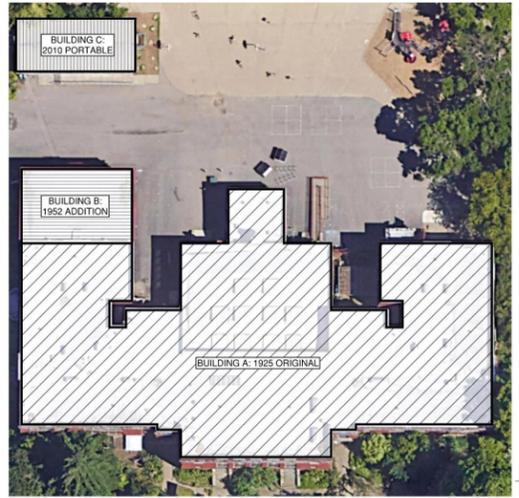
**Building Year Plan:**  
(see below for deficiencies)

Building Part (See Diagram Above)	Year Built	URM (SF)	ROM URM Only Retrofit	ROM Total Retrofit	No. of Stories	Basement	Penthouse	Drawings Referenced	Structural Horizontal Gravity System(s)	Structural Vertical Gravity System(s)	Lateral System (ASCE Designation)	Lateral System (Description)	Likely Deficiencies	Deficiency Notes	Additional Notes
Bldg. A	1925	0	\$0	\$11,950,000	2	Crawlspace	No	Approximately Complete Original Documents	Concrete 1-way Slab, Steel Truss, Concrete Beams	Conc. CIP Walls	C2	Concrete Shear Walls (Stiff Diaphragms)	Reentrant Corners Misc. Plan Irregularity Masonry Partition Walls Concrete Parapets exceed 2.5:1 Heavy Cladding System Inadequate In-Plane Shear Under-Reinforced Walls Under-Reinforced Flat Slabs No Diaphragm-Wall Connection Inadequate Wall-Foundation Connection Deflection Compatibility	Soft end of wings	1977 - cafeteria floor elevated
Bldg. B	1952	0	\$0	\$540,000	2	Crawlspace	No	Approximately Complete Original Documents	Concrete Pan-Joists, Concrete 1-way Slab, Concrete Beams	Conc. CIP Walls, Steel Columns	C2	Concrete Shear Walls (Stiff Diaphragms)	Seismic Separation (< 1%) Heavy Cladding System Deep Spandrels/Narrow Piers (50%, interfering walls) Inadequate In-Plane Shear Under-Reinforced Walls Under-Reinforced Flat Slabs No Diaphragm-Wall Connection Inadequate Wall-Foundation Connection	Fastening to part A not identified Thin slabs

Bldg. C	2010	0	\$0	\$0	1	Crawlspace	No	None	Wood Plywood/OSB, Wood Joists	Wood Framed Walls	W2	Wood Frames (Commercial and Industrial Buildings)			Appears to be a benchmark building

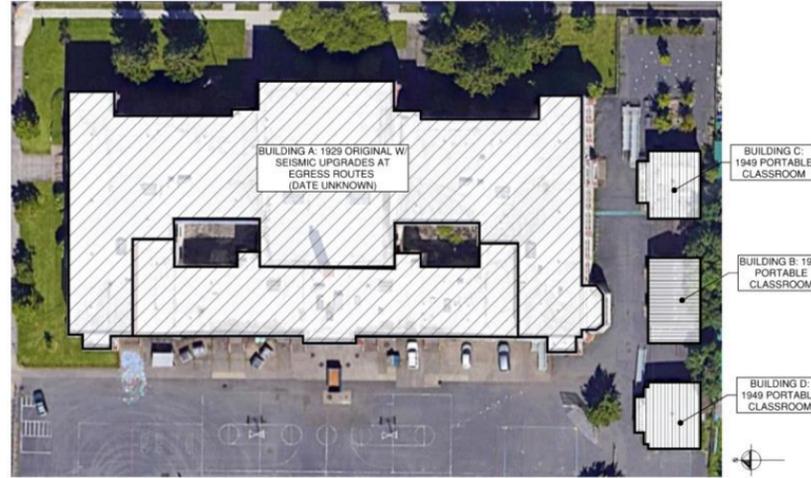
**Building Year Plan:**  
(see below for deficiencies)

Building Part (See Diagram Above)	Year Built	URM (SF)	ROM URM Only Retrofit	ROM Total Retrofit	No. of Stories	Basement	Penthouse	Drawings Referenced	Structural Horizontal Gravity System(s)	Structural Vertical Gravity System(s)	Lateral System (ASCE Designation)	Lateral System (Description)	Likely Deficiencies	Deficiency Notes	Additional Notes
Bldg. A	1929	0	\$0	\$17,150,000	2	Crawlspace	No	Approximately Complete Original Documents	Concrete 1-way Slab, Concrete Pan-Joists, Concrete Beams, Steel Joists, Steel Truss	Conc. CIP Walls, Concrete Columns	C2	Concrete Shear Walls (Stiff Diaphragms)	Misc. Load Path Issue Inadequate Wall Anchorage Split Levels Reentrant Corners Masonry Partition Walls URM Parapets exceed 1.5:1 Concrete Parapets exceed 2.5:1 URM Chimneys Heavy Cladding System Inadequate In-Plane Shear Under-Reinforced Walls No Diaphragm-Wall Connection Inadequate Wall-Foundation Connection Deflection Compatibility	Mild steel truss with rivets. Check connections. Also cut concrete beam seen in basement may cause local instability. minimal anchorage between walls and diaphragm At roof 2nd story Hollow clay tile between many classrooms. West walls of kitchen & play room are brick. Also the exterior walls of the second floor North and south corridor is two layers of hollow clay tile plus veneer per 1929 drawings plans. Exterior walls at second floor N & S corridors brick URM per 1929 drawings Appears to have some strengthening but extent is unknown. Brick veneer Check. Exterior walls heavily perforated. Only wall piers appear to be reinforced per sheet 21 Minimal anchorage between walls and diaphragm Beam and column reinforcement is not well confined - widely spaced ties	1929 Original two story building. Appears to have had seismic upgrades which included restraining the chimney and providing strongbacks along exit routes. The time and extent of the seismic upgrades is unknown as drawings for this intervention were not provided. Note that a beam which frames into the south wall of the basement storage room was observed to have been cut to fit a switchboard. The time of this intervention is unknown, but the switchboard appears to have been in place before the 1998 FIT IT Infrastructure Improvement Drawings were made.

Bldg. B	1948	0	\$0	\$97,500	1	Crawlspace	No	Insufficient Original Documents	Wood Straight/Diag Sheathing, Wood Beams	Wood Framed Walls	W2	Wood Frames (Commercial and Industrial Buildings)	Misc. Load Path Issue Split Levels Inadequate In-Plane Shear Inadequate Wood Sill-Foundation Connections (6 ft) Roof Chord Discontinuity Straight Sheathing (2:1, 24')	Drawings don't show positive conn. between floor framing and foundations At roof Drawings do not detail a connection Straight sheathing assumed	Center portable classroom unit. Classroom was moved to site in 1948. Available drawings show the foundation. No drawings for the superstructure were provided.
Bldg. C	1949	0	\$0	\$105,000	1	Crawlspace	No	Insufficient Original Documents	Wood Straight/Diag Sheathing, Wood Beams	Wood Framed Walls	W2	Wood Frames (Commercial and Industrial Buildings)	Split Levels Inadequate In-Plane Shear No Wood Post-Foundation Connections Inadequate Wood Sill-Foundation Connections (6 ft) Straight Sheathing (2:1, 24')	To toilet area Detail doesn't show positive connection between post & foundation Metal straps set in concrete @ 8'-0" o.c. Connection to floor framing unknown. Assumed straight sheathing	Eastern portable classroom unit. Identical to Building D. Classroom was moved to site in 1949. Available drawings show the foundation. No drawings for the superstructure were provided.

Bldg. D	1949	0	\$0	\$97,500	1	Crawlspace	No	Insufficient Original Documents	Wood Straight/Diag Sheathing, Wood Beams	Wood Framed Walls	W2	Wood Frames (Commercial and Industrial Buildings)	Split Levels Inadequate In-Plane Shear No Wood Post-Foundation Connections Inadequate Wood Sill-Foundation Connections (6 ft) Straight Sheathing (2:1, 24')	To toilet area Detail doesn't show positive connection between post & foundation Metal straps set in concrete @ 8'-0" o.c. Connection to floor framing unknown. Assumed straight sheathing	Western portable classroom unit. Identical to Building C. Classroom was moved to site in 1949. Available drawings show the foundation. No drawings for the superstructure were provided.
