# 2024 PPS Seismic Assessments: All Schools

Version 1.1  
June 03, 2025

Submitted to:  
Portland Public Schools  
501 N. Dixon Street  
Portland, OR 97227

Submitted by:  
Holmes US  
555 SE MLK Jr. Blvd  
Portland, OR 97214

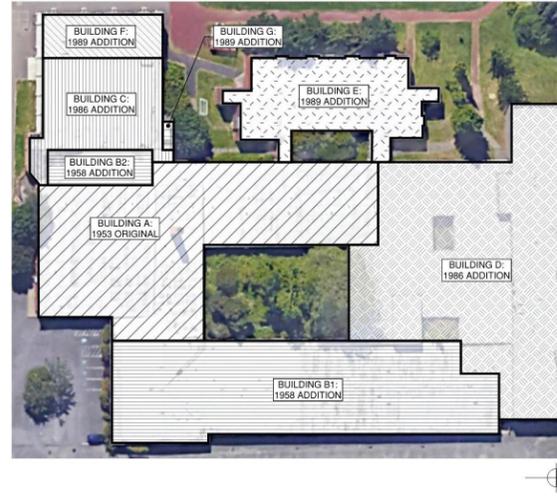
**Building Year Plan:**  
(see below for deficiencies)

Building Part (See Diagram Above)	Year Built	URM (SF)	ROM URM Only Retrofit	ROM Total Retrofit	No. of Stories	Basement	Penthouse	Drawings Referenced	Structural Horizontal Gravity System(s)	Structural Vertical Gravity System(s)	Lateral System (ASCE Designation)	Lateral System (Description)	Likely Deficiencies	Deficiency Notes	Additional Notes
Bldg. A	1953	0	\$0	\$2,440,000	1	None	No	Insufficient Original Documents	Wood T+G Plank, Wood Beams, Wood Trusses	Wood Framed Walls, Timber Frame	W2	Wood Frames (Commercial and Industrial Buildings)	Reentrant Corners Non-redundant (< 2 bays in < 2 lines) Heavy Cladding System Other observed nonstructural falling hazard Inadequate In-Plane Shear Plaster or Gypsum Shear Walls No Floor-to-Floor Connections (Shear and OT) No Wood Post-Foundation Connections Inadequate Wood Sill-Foundation Connections (6 ft) Roof Chord Discontinuity Straight Sheathing (2:1, 24')		King post trusses in gym 2023 roof-only seismic upgrade reported by PPS at this campus (documents not available)

Bldg. B1	1958	0	\$0	\$2,050,000	1	None	No	Insufficient Original Documents	Wood T+G Plank, Wood Beams	Wood Framed Walls, Timber Frame	W2	Wood Frames (Commercial and Industrial Buildings)	Reentrant Corners Non-redundant (< 2 bays in < 2 lines) Heavy Cladding System Other observed nonstructural falling hazard Inadequate In-Plane Shear Plaster or Gypsum Shear Walls No Floor-to-Floor Connections (Shear and OT) No Wood Post-Foundation Connections Inadequate Wood Sill-Foundation Connections (6 ft) Roof Chord Discontinuity Straight Sheathing (2:1, 24')	Brick piers by egress doors	Constructed in 1958, 1960, 1963
Bldg. B2	1958	0	\$0	\$290,000	1	None	No	Insufficient Original Documents	Wood T+G Plank, Wood Beams	Wood Framed Walls, Timber Frame	W2	Wood Frames (Commercial and Industrial Buildings)	Reentrant Corners Non-redundant (< 2 bays in < 2 lines) Heavy Cladding System Inadequate In-Plane Shear Plaster or Gypsum Shear Walls No Floor-to-Floor Connections (Shear and OT) No Wood Post-Foundation Connections Inadequate Wood Sill-Foundation Connections (6 ft) Roof Chord Discontinuity Straight Sheathing (2:1, 24')

Bldg. C	1986	0	\$0	\$1,275,000	1	None	No	Approximately Complete Original Documents	Tectum, Wood Plywood/OSB, Wood Joists, Wood Beams	Wood Framed Walls, Concrete Tilt-up Walls	PC1	Precast or Tilt-up Concrete Shear Walls (Flexible Diaphragm)	Inadequate Foundation Ties Inadequate Wall Anchorage Unbraced Mezzanine Non-redundant (< 2 bays in < 2 lines) Walls Spaced Far Apart Under-Reinforced Walls No Wall-Foundation Connection Discontinuous Cross Ties Unblocked Diaphragms (4:1, 40') Other Diaphragms	Wood East Wall

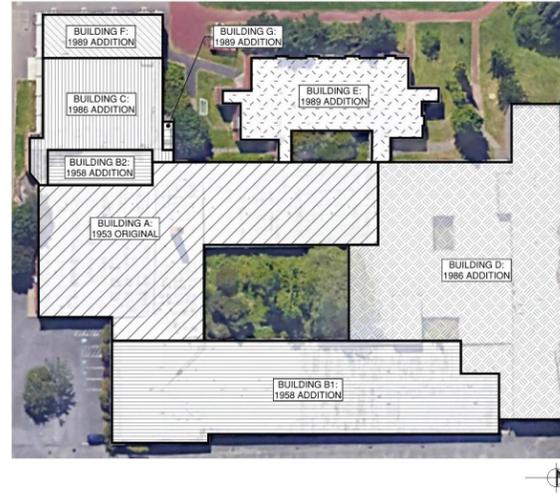
**Building Year Plan:**  
(see below for deficiencies)

Building Part (See Diagram Above)	Year Built	URM (SF)	ROM URM Only Retrofit	ROM Total Retrofit	No. of Stories	Basement	Penthouse	Drawings Referenced	Structural Horizontal Gravity System(s)	Structural Vertical Gravity System(s)	Lateral System (ASCE Designation)	Lateral System (Description)	Likely Deficiencies	Deficiency Notes	Additional Notes
Bldg. D	1986	0	\$0	\$3,462,500	1	None	No	Approximately Complete Original Documents	Tectum, Wood Plywood/OSB, Wood Joists, Wood Beams	Wood Framed Walls	W2	Wood Frames (Commercial and Industrial Buildings)	Split Levels Reentrant Corners Heavy Cladding System Inadequate In-Plane Shear Plaster or Gypsum Shear Walls Unbraced Cripple Walls No Floor-to-Floor Connections (Shear and OT) Roof Chord Discontinuity Unblocked Diaphragms (4:1, 40') Other Diaphragms	Tectum	
Bldg. E	1989	0	\$0	\$2,500,000	1	Daylight	No	Approximately Complete Original Documents	Steel Sheet Deck	Concrete Columns	S2, S2a, C2	Steel Braced Frames (Flexible & Stiff Diaphragms) & Concrete Shear Walls (Stiff Diaphragms)	Reentrant Corners Non-redundant (< 2 bays in < 2 lines) Inadequate Column Capacity Inadequate Brace Capacity Slender Braces Inadequate brace connections

Bldg. F	1989	0	\$0	\$525,000	1	None	No	Approximately Complete Original Documents	Wood Plywood/OSB, Wood Joists, Wood Beams	Concrete Tilt-up Walls	PC1	Precast or Tilt-up Concrete Shear Walls (Flexible Diaphragm)	Inadequate Foundation Ties Inadequate Wall Anchorage Walls Spaced Far Apart No Wall-Foundation Connection Unblocked Diaphragms (4:1, 40')		
Bldg. G	1989	0	\$0	\$10,000	2	None	No	Approximately Complete Original Documents	Wood T+G Plank, Steel Sheet Deck	CFS Walls, Conc. CIP Walls	C2	Concrete Shear Walls (Stiff Diaphragms)	Seismic Separation (< 1%)	Inadequate ties between buildings

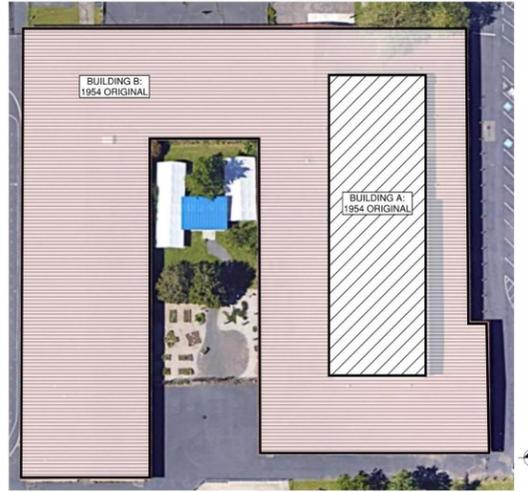
**Building Year Plan:**  
(see below for deficiencies)

Building Part (See Diagram Above)	Year Built	URM (SF)	ROM URM Only Retrofit	ROM Total Retrofit	No. of Stories	Basement	Penthouse	Drawings Referenced	Structural Horizontal Gravity System(s)	Structural Vertical Gravity System(s)	Lateral System (ASCE Designation)	Lateral System (Description)	Likely Deficiencies	Deficiency Notes	Additional Notes
Bldg. A	1954	0	\$0	\$1,605,000	1	Partial	Yes	Approximately Complete Original Documents	Wood T+G Plank, Wood Beams, Concrete Pan-Joists, Concrete 1-way Slab, Concrete Beams	Reinforced Brick Walls	RM1	Reinforced Masonry Bearing Walls (Flexible Diaphragms)	Inadequate Foundation Ties Inadequate Wall Anchorage Masonry Partition Walls URM Chimneys Walls Spaced Far Apart Inadequate In-Plane Shear Under-Reinforced Walls Wood Ledgers loaded across grain No Diaphragm-Wall Connection No Wall-Foundation Connection Discontinuous Cross Ties Straight Sheathing (2:1, 24') Inadequate Composite Behavior	HCT observed in bathrooms          Inadequate reinforcing

Bldg. B	1954	0	\$0	\$5,150,000	1	None	No	Approximately Complete Original Documents	Wood T+G Plank, Wood Beams	Wood Framed Walls, Steel Columns	W2	Wood Frames (Commercial and Industrial Buildings)	Inadequate Foundation Ties Reentrant Corners Non-redundant (< 2 bays in < 2 lines) Seismic Separation (< 1%) Masonry Partition Walls Inadequate In-Plane Shear Plaster or Gypsum Shear Walls Large Unbraced Openings No Floor-to-Floor Connections (Shear and OT) Inadequate Wood Sill-Foundation Connections (6 ft) Roof Chord Discontinuity Straight Sheathing (2:1, 24')	Adjacent to part A Tile in bathrooms & brick at south classroom	1955 - South playshed infilled in-kind

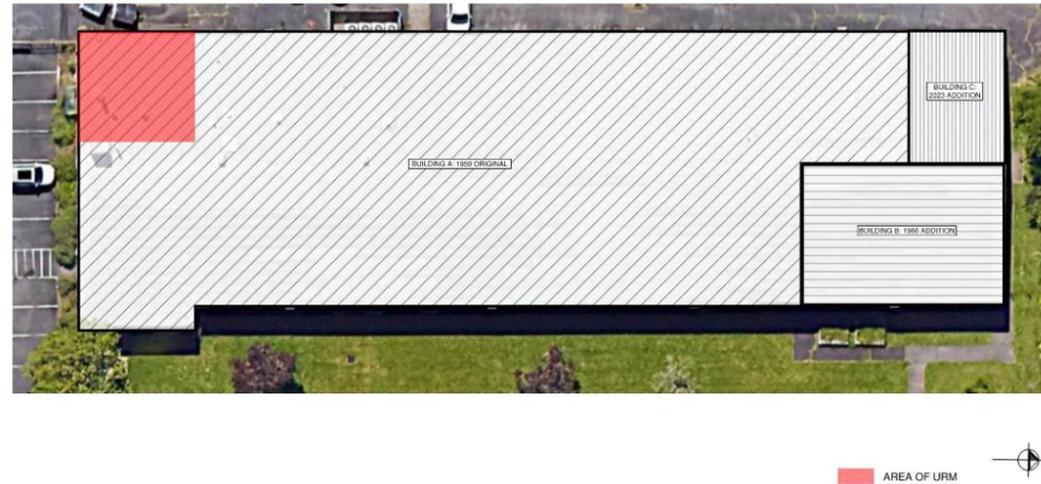
**Building Year Plan:**  
(see below for deficiencies)

Building Part (See Diagram Above)	Year Built	URM (SF)	ROM URM Only Retrofit	ROM Total Retrofit	No. of Stories	Basement	Penthouse	Drawings Referenced	Structural Horizontal Gravity System(s)	Structural Vertical Gravity System(s)	Lateral System (ASCE Designation)	Lateral System (Description)	Likely Deficiencies	Deficiency Notes	Additional Notes
Bldg. A	1959	1300	\$455,000	\$1,632,500	1	None	No	Approximately Complete Original Documents	Steel Truss Joists, Steel Sheet Deck	Unreinforced Brick Walls, Steel Columns, CFS Walls	S2b	Strap-Braced Wall System	Inadequate Foundation Ties Inadequate Wall Anchorage Inadequate Brace Capacity Narrow Strap-Braced Walls No Diaphragm-Frame Connection Strap Brace Axial Capacity Heavy Cladding System	Modifications during 1998, but most wall elements otherwise not tied to fdn Unknown from insufficient drawings and unable to determine on site Brick veneer	URM present at unreinforced CMU boiler room exterior wall and west interior fireblock wall. Further exploratory recommended for unreinforced CMU. URM present at chimney stack. 1998 Retrofit of metal stud braces and selective URM walls.

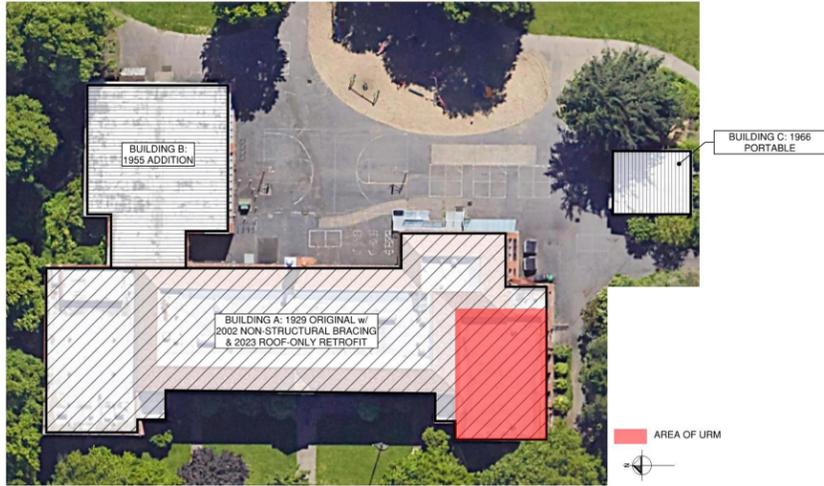
**Building Year Plan:**  
(see below for deficiencies)

Building Part (See Diagram Above)	Year Built	URM (SF)	ROM URM Only Retrofit	ROM Total Retrofit	No. of Stories	Basement	Penthouse	Drawings Referenced	Structural Horizontal Gravity System(s)	Structural Vertical Gravity System(s)	Lateral System (ASCE Designation)	Lateral System (Description)	Likely Deficiencies	Deficiency Notes	Additional Notes
Bldg. A	1929	2700	\$810,000	\$7,807,500	2	Crawlspace, Partial	No	Approximately Complete Original Documents	Concrete 1-way Slab, Steel Truss, Concrete Pan-Joists, Concrete Beams	Concrete Columns, Conc. CIP Walls, Unreinforced Brick Walls	C2, URMa	Concrete Shear Walls (Stiff Diaphragms), Unreinforced Masonry Bearing Walls (Stiff Diaphragms)	Inadequate Foundation Ties Reentrant Corners Deep Spandrels/Narrow Piers (50%, interfering walls) Inadequate In-Plane Shear Under-Reinforced Walls Under-Reinforced Flat Slabs No Diaphragm-Wall Connection Deflection Compatibility Beams, Girders, or Trusses bear on URM wall/pilaster Walls Spaced Far Apart Deep Spandrels/Narrow Piers (50%, interfering walls) Inadequate In-Plane Shear Thin Walls (9 top, 15 first, 13 other/single) No Diaphragm-Wall Connection Masonry Partition Walls Masonry ceiling URM Parapets exceed 1.5:1 Heavy Cladding System	Likely insufficient  Corridor walls braced in 2002 Tile SIP forms in drawings Exit ways braced in 2002	2002 - partial seismic upgrade 2023 - roof-only retrofit (assumed seismic retrofit, documentation not available)

Bldg. B	1955	0	\$0	\$750,000	1	Crawlspace	No	Insufficient Original Documents	Wood T+G Plank, Wood Joists, Wood Beams	Wood Framed Walls, Steel Columns	W2	Wood Frames (Commercial and Industrial Buildings)	Inadequate Foundation Ties Moderate Vertical Element Size Discontinuity (50-75%) Reentrant Corners Seismic Separation (< 1%) Inadequate In-Plane Shear Plaster or Gypsum Shear Walls Narrow Wood Shear Walls Large Unbraced Openings No Floor-to-Floor Connections (Shear and OT) No Wood Post-Foundation Connections Inadequate Wood Sill-Foundation Connections (6 ft) Roof Chord Discontinuity Straight Sheathing (2:1, 24') Heavy Cladding System	Interior transverse walls not cont.  North/South Window Walls	
Bldg. C	1966	0	\$0	\$75,000	1	Crawlspace	No	Insufficient Original Documents	Wood Plywood/OSB, Wood Joists, Wood Beams	Wood Framed Walls	W2	Wood Frames (Commercial and Industrial Buildings)	Misc. Plan Irregularity Inadequate In-Plane Shear Plaster or Gypsum Shear Walls No Floor-to-Floor Connections (Shear and OT) Inadequate Wood Sill-Foundation Connections (6 ft) Roof Chord Discontinuity	Diaphragm discontinuity between units

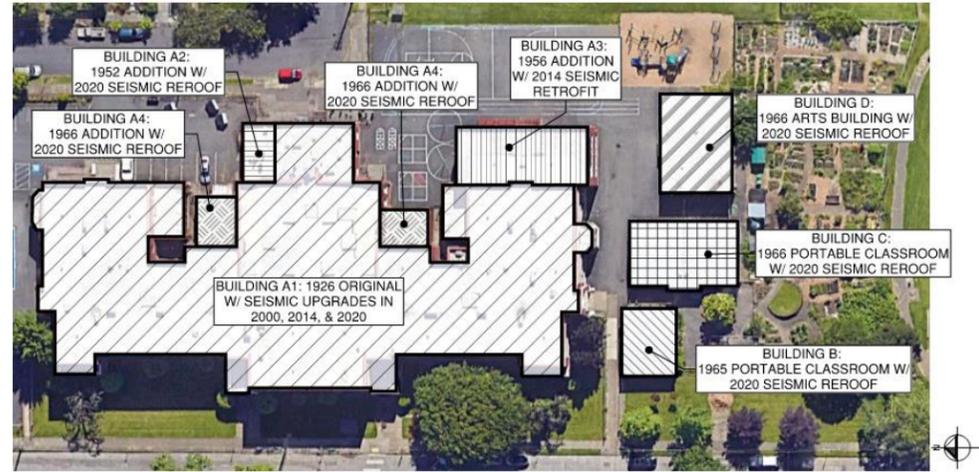
**Building Year Plan:**  
(see below for deficiencies)

Building Part (See Diagram Above)	Year Built	URM (SF)	ROM URM Only Retrofit	ROM Total Retrofit	No. of Stories	Basement	Penthouse	Drawings Referenced	Structural Horizontal Gravity System(s)	Structural Vertical Gravity System(s)	Lateral System (ASCE Designation)	Lateral System (Description)	Likely Deficiencies	Deficiency Notes	Additional Notes
Bldg. A1	1926	0	\$0	\$14,425,000	1	Partial, Crawlspace	No	Approximately Complete Original Documents	Concrete Pan-Joists, Concrete Beams, Steel Joists, Steel Truss	Conc. CIP Walls, Concrete Columns	C2	Concrete Shear Walls (Stiff Diaphragms)	Inadequate Wall Anchorage Setback: vertical LRFS inboard of story below Split Levels Reentrant Corners Masonry Partition Walls Concrete Parapets exceed 2.5:1 Heavy Cladding System Inadequate In-Plane Shear Under-Reinforced Walls Under-Reinforced Flat Slabs No Diaphragm-Wall Connection Inadequate Wall-Foundation Connection Deflection Compatibility	Check anchorage of steel trusses and "I"-joists At single story portions At roof Some have been removed, but several still outstanding Brick veneer Requires check Check adequacy of connections to slabs & steel members Walls appear to be typically unreinforced	1926 Original Structure - Jones school. Two-story structure with classrooms, auditorium and gyms (boys & girls). Roof and floors typically pan joist system with topping slab. Auditorium and gyms have 3.5" conc. slab supported by steel I-joists and steel trusses. Seismic upgrades in 2000, 2014, and 2020. 2000 upgrades include tying the building together through the expansion joint at the center win and strengthening URM walls in some areas. 2014 upgrades include reducing the height of the chimney, replacing a URM wall with a CMU shear wall, and bracing URM walls along egress routes on the south side of the building. 2020 Seismic upgrades included parapet bracing at lower roofs.

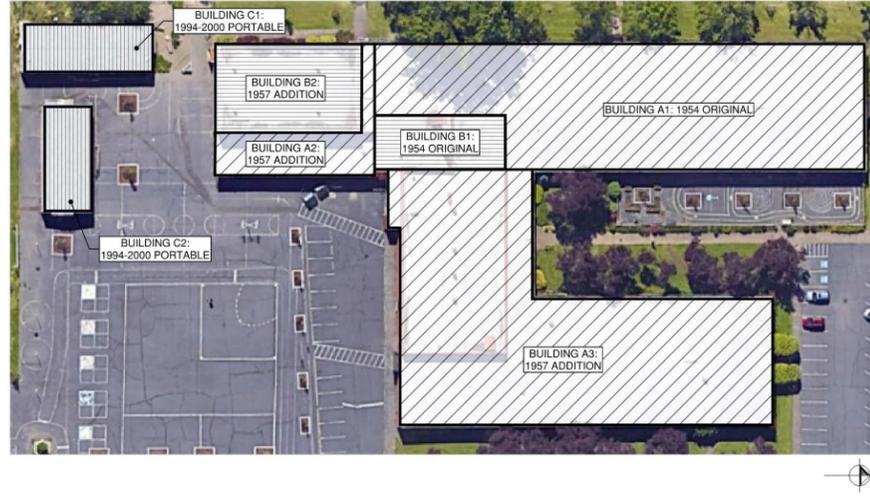
**Building Year Plan:**  
(see below for deficiencies)

Building Part (See Diagram Above)	Year Built	URM (SF)	ROM URM Only Retrofit	ROM Total Retrofit	No. of Stories	Basement	Penthouse	Drawings Referenced	Structural Horizontal Gravity System(s)	Structural Vertical Gravity System(s)	Lateral System (ASCE Designation)	Lateral System (Description)	Likely Deficiencies	Deficiency Notes	Additional Notes
Bldg. A1	1954	0	\$0	\$4,090,000	1	None	No	Insufficient Original Documents	Wood Straight/Diag Sheathing, Wood Joists, Wood Beams	Timber Frame, Wood Framed Walls	W2	Wood Frames (Commercial and Industrial Buildings)	Non-redundant (< 2 bays in < 2 lines) Heavy Cladding System Other observed nonstructural falling hazard Inadequate In-Plane Shear Plaster or Gypsum Shear Walls Large Unbraced Openings No Floor-to-Floor Connections (Shear and OT) Inadequate Wood Sill-Foundation Connections (6 ft) No Girder-Column Connections Roof Chord Discontinuity Straight Sheathing (2:1, 24')	Brick pilasters near exit doors	No structural drawings

Bldg. A2	1954	0	\$0	\$4,090,000	1	None	No	Insufficient Original Documents	Wood Straight/Diag Sheathing, Wood Joists, Wood Beams	Timber Frame, Wood Framed Walls	W2	Wood Frames (Commercial and Industrial Buildings)	Non-redundant (< 2 bays in < 2 lines) Heavy Cladding System Other observed nonstructural falling hazard Inadequate In-Plane Shear Plaster or Gypsum Shear Walls Large Unbraced Openings No Floor-to-Floor Connections (Shear and OT) Inadequate Wood Sill-Foundation Connections (6 ft) No Girder-Column Connections Roof Chord Discontinuity Straight Sheathing (2:1, 24')	Brick pilasters near exit doors	
Bldg. A3	1954	0	\$0	\$4,090,000	1	None	No	Insufficient Original Documents	Wood Straight/Diag Sheathing, Wood Joists, Wood Beams	Timber Frame, Wood Framed Walls	W2	Wood Frames (Commercial and Industrial Buildings)	Non-redundant (< 2 bays in < 2 lines) Heavy Cladding System Other observed nonstructural falling hazard Inadequate In-Plane Shear Plaster or Gypsum Shear Walls Large Unbraced Openings No Floor-to-Floor Connections (Shear and OT) Inadequate Wood Sill-Foundation Connections (6 ft) No Girder-Column Connections Roof Chord Discontinuity Straight Sheathing (2:1, 24')	Brick pilasters near exit doors

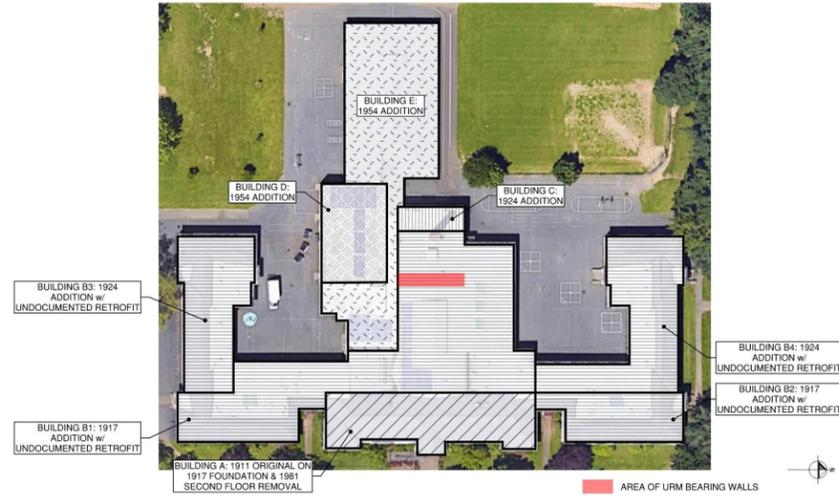
**Building Year Plan:**  
(see below for deficiencies)

Building Part (See Diagram Above)	Year Built	URM (SF)	ROM URM Only Retrofit	ROM Total Retrofit	No. of Stories	Basement	Penthouse	Drawings Referenced	Structural Horizontal Gravity System(s)	Structural Vertical Gravity System(s)	Lateral System (ASCE Designation)	Lateral System (Description)	Likely Deficiencies	Deficiency Notes	Additional Notes
Bldg. A	1910	0	\$0	\$1,140,000	1	Crawlspace	No	None	Wood Battens, Wood Straight/Diag Sheathing, Wood Joists, Wood Trusses	Timber Frame, Wood Framed Walls	W2	Wood Frames (Commercial and Industrial Buildings)	Inadequate Foundation Ties Severe Vertical Element Size Discontinuity (<50%) Reentrant Corners Non-redundant (< 2 bays in < 2 lines) Inadequate In-Plane Shear Plaster or Gypsum Shear Walls Unbraced Cripple Walls Large Unbraced Openings Inadequate Wood Sill-Foundation Connections (6 ft) Roof Chord Discontinuity Unblocked Diaphragms (4:1, 40') Bowstring truss	Interior walls not continuous to foundation	1917 - current structure relocated to new foundation 1981 - second floor burned/removed & roof level constructed

Bldg. B1	1917	1700	\$255,000	\$2,630,000	1	Crawlspace	No	Insufficient Original Documents	Wood Battens, Wood Straight/Diag Sheathing, Wood Joists, Wood Trusses	Timber Frame, Wood Framed Walls	W2, URM	Wood Frames (Commercial and Industrial Buildings), Unreinforced Masonry Bearing Walls (Flexible Diaphragms)	Inadequate Foundation Ties Inadequate Wall Anchorage Severe Vertical Element Size Discontinuity (<50%) Split Levels Reentrant Corners Non-redundant (< 2 bays in < 2 lines) Masonry Partition Walls Inadequate In-Plane Shear Plaster or Gypsum Shear Walls Unbraced Cripple Walls Large Unbraced Openings No Floor-to-Floor Connections (Shear and OT) No Wood Post-Foundation Connections Inadequate Wood Sill-Foundation Connections (6 ft) No Girder-Column Connections Roof Chord Discontinuity Other Diaphragms Bowstring truss Beams, Girders, or Trusses bear on URM wall/pilaster Thin Walls (9 top, 15 first, 13 other/single) No Diaphragm-Wall Connection No Girder-Column Connections Discontinuous Cross Ties Other Diaphragms	Interior walls not continuous to foundation Boiler Room, Cafetorium windows Battens North Wall of Gym	Partial retrofit observed in attic (retrofit drawings not available) 1987 & 1990 - truss repairs

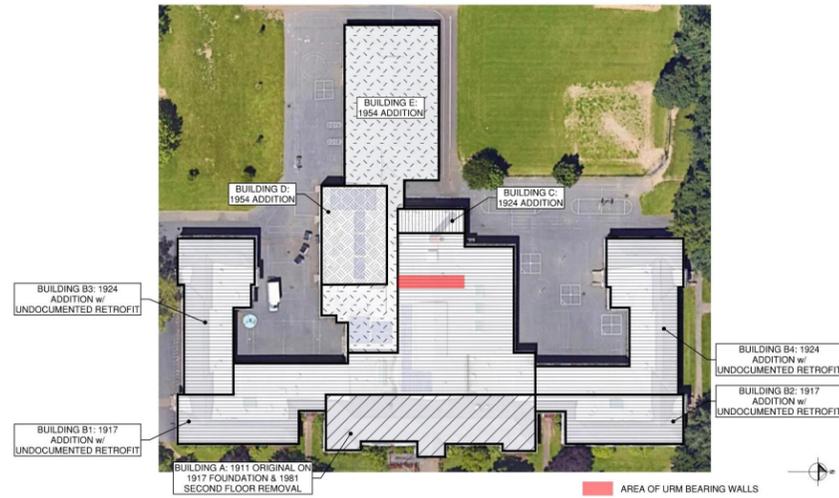
**Building Year Plan:**  
(see below for deficiencies)

Building Part (See Diagram Above)	Year Built	URM (SF)	ROM URM Only Retrofit	ROM Total Retrofit	No. of Stories	Basement	Penthouse	Drawings Referenced	Structural Horizontal Gravity System(s)	Structural Vertical Gravity System(s)	Lateral System (ASCE Designation)	Lateral System (Description)	Likely Deficiencies	Deficiency Notes	Additional Notes
Bldg. B2	1917	0	\$0	\$512,500	1	Crawlspace	No	Insufficient Original Documents	Wood Battens, Wood Straight/Diag Sheathing, Wood Joists, Wood Trusses	Wood Framed Walls	W2	Wood Frames (Commercial and Industrial Buildings)	Inadequate Foundation Ties Severe Vertical Element Size Discontinuity (<50%) Reentrant Corners Non-redundant (< 2 bays in < 2 lines) Masonry Partition Walls Inadequate In-Plane Shear Plaster or Gypsum Shear Walls Unbraced Cripple Walls Large Unbraced Openings No Floor-to-Floor Connections (Shear and OT) No Wood Post-Foundation Connections Inadequate Wood Sill-Foundation Connections (6 ft) No Girder-Column Connections Roof Chord Discontinuity Other Diaphragms	Interior walls not continuous to foundation Boiler Room, Cafetorium windows Battens	Partial retrofit observed in attic (retrofit drawings not available) 1987 & 1990 - truss repairs

Bldg. B3	1924	0	\$0	\$787,500	1	Crawlspace	No	Insufficient Original Documents	Wood Battens, Wood Straight/Diag Sheathing, Wood Joists, Wood Trusses	Wood Framed Walls	W2	Wood Frames (Commercial and Industrial Buildings)	Inadequate Foundation Ties Severe Vertical Element Size Discontinuity (<50%) Reentrant Corners Non-redundant (< 2 bays in < 2 lines) Masonry Partition Walls Inadequate In-Plane Shear Plaster or Gypsum Shear Walls Unbraced Cripple Walls Large Unbraced Openings No Floor-to-Floor Connections (Shear and OT) No Wood Post-Foundation Connections Inadequate Wood Sill-Foundation Connections (6 ft) No Girder-Column Connections Roof Chord Discontinuity Other Diaphragms	Interior walls not cont. to fnd Boiler Room, Cafetorium windows Battens	Partial retrofit observed in attic (retrofit drawings not available) 1987 & 1990 - truss repairs
Bldg. B4	1924	0	\$0	\$1,062,500	1	Crawlspace	No	Insufficient Original Documents	Wood Straight/Diag Sheathing, Wood Joists, Wood Beams, Conc. CIP Walls	Conc. CIP Walls	C2a	Wood Frames (Commercial and Industrial Buildings)	Inadequate Foundation Ties Severe Vertical Element Size Discontinuity (<50%) Reentrant Corners Non-redundant (< 2 bays in < 2 lines) Masonry Partition Walls Inadequate In-Plane Shear Plaster or Gypsum Shear Walls Unbraced Cripple Walls Large Unbraced Openings No Floor-to-Floor Connections (Shear and OT) No Wood Post-Foundation Connections Inadequate Wood Sill-Foundation Connections (6 ft) No Girder-Column Connections Roof Chord Discontinuity Other Diaphragms	Interior walls not continuous to foundation Boiler Room, Cafetorium windows Battens	Partial retrofit observed in attic (retrofit drawings not available) 1987 & 1990 - truss repairs

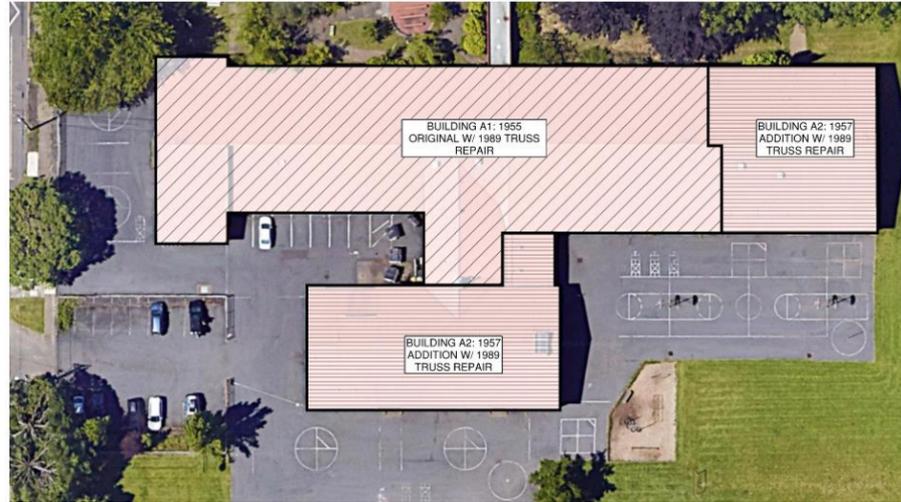
**Building Year Plan:**  
(see below for deficiencies)

Building Part (See Diagram Above)	Year Built	URM (SF)	ROM URM Only Retrofit	ROM Total Retrofit	No. of Stories	Basement	Penthouse	Drawings Referenced	Structural Horizontal Gravity System(s)	Structural Vertical Gravity System(s)	Lateral System (ASCE Designation)	Lateral System (Description)	Likely Deficiencies	Deficiency Notes	Additional Notes
Bldg. A1	1954	0	\$0	\$1,730,000	1	None	No	Approximately Complete Original Documents	Wood Straight/Diag Sheathing, Wood Trusses, Concrete 2-way Slab	Timber Frame, Conc. CIP Walls	W2, C2	Wood Frames (Commercial and Industrial Buildings), Concrete Shear Walls (Stiff Diaphragms)	Inadequate Foundation Ties Split Levels Reentrant Corners Misc. Plan Irregularity Seismic Separation (< 1%) URM Chimneys Heavy Cladding System Inadequate In-Plane Shear No Girder-Column Connections Straight Sheathing (2:1, 24') Inadequate Wall-Foundation Connection	Some stem walls don't appear to have positive connections At roof and attic Stiffness incompatibility between concrete and timber walls at transformer vault No gap to walkway to Holladay center Brick veneer Very few structural walls in E/W direction Connection detail for post for Truss A not found Limited information on roof sheathing. Described as roof boards. Section J/5 does not show wall-foundation connection	Original structure. Typically wood framed structure with brick veneer. RC walls at the transformer vault. Air floor units under kindergarten classrooms. Truss repair in 1989. Metal roof installed circa 1995 (no drawings)

Bldg. A2	1957	0	\$0	\$1,400,000	1	None	Yes	Approximately Complete Original Documents	Wood Plywood/OSB	Timber Frame, Reinforced CMU Walls	W2, RM1	Wood Frames (Commercial and Industrial Buildings), Reinforced Masonry Bearing Walls (Flexible Diaphragms)	Inadequate Foundation Ties Inadequate Wall Anchorage Split Levels Reentrant Corners Heavy Cladding System Inadequate In-Plane Shear Roof Chord Discontinuity Under-Reinforced Walls No Wall-Foundation Connection	Some stem walls don't appear to have positive connections Check adequacy of OOP connections At roof to fan room Brick veneer Per detail F/4, no vert reinforcement in interior walls CMU wall-foundations details don't show positive connection between wall and foundation No information in general notes on pg 2	Additions to east (classrooms) and south (cafeteria, etc.). Truss repairs were undertaken in 1988-1989. Ceiling around opening above stage appeared to be slightly bowed. Cafeteria walls appear to have some post-installed thru-bolts - time of installation and purpose is unknown.
